Prompt analysis of condition priority for road improvement planning

E Buchari*¹, D Oktaviansyah¹, D D A P Putranto¹ and N Nawawi¹

¹ Engineering Sciences Study Program, Doctor of Philosophy Program, Engineering Faculty, Sriwijaya University, Indonesia

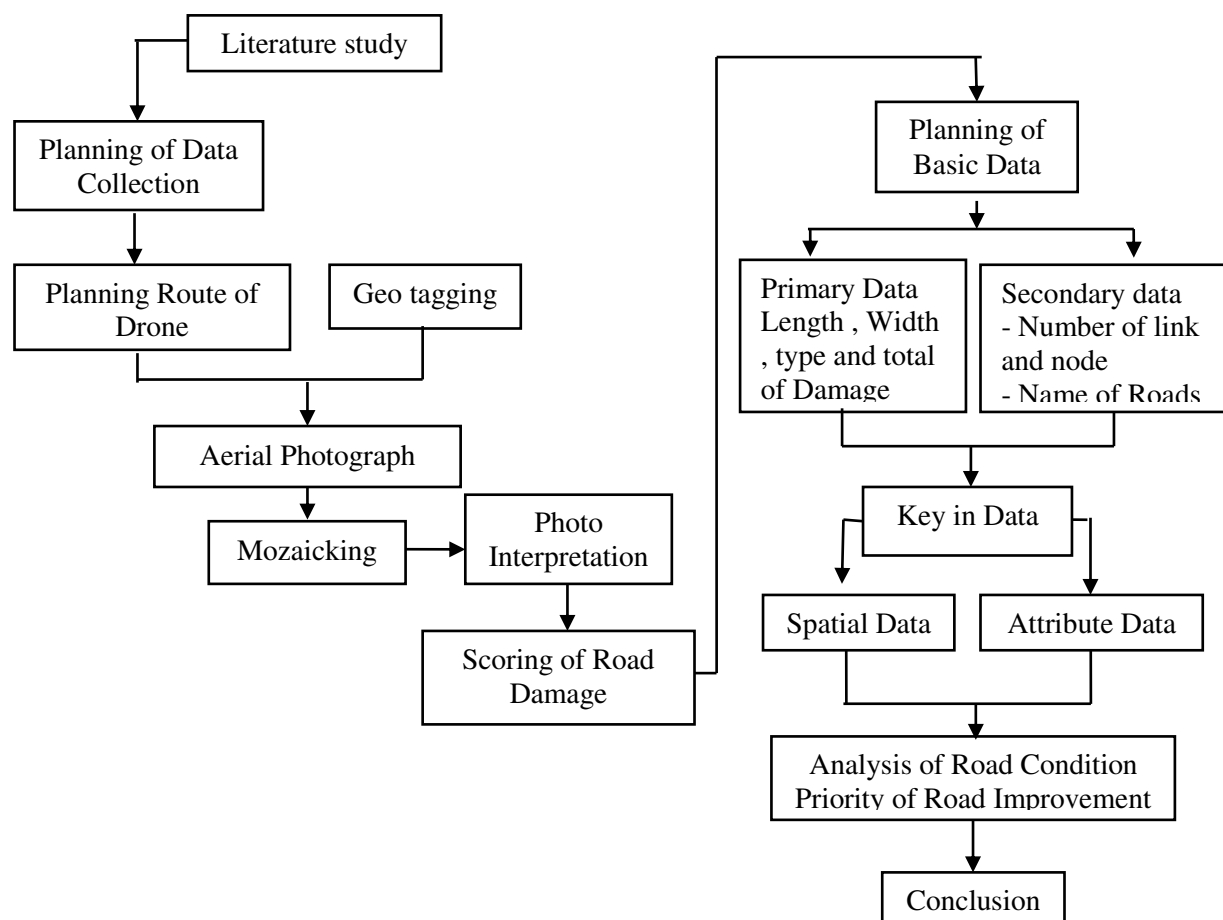
Figure 1. Flow chart of research.

Survey location was at H. M. Noerdin Pandji street, a primary collector road, at Kelurahan Kebun Sayur, kecamatan Alang-alang Lebar, Palembang. The survey is done on March 2017. First, the data was collected by using a drone. A manual data collection was done to confirm the data accuracy. The research programme was carried out according to the flow chart in Figure 1.

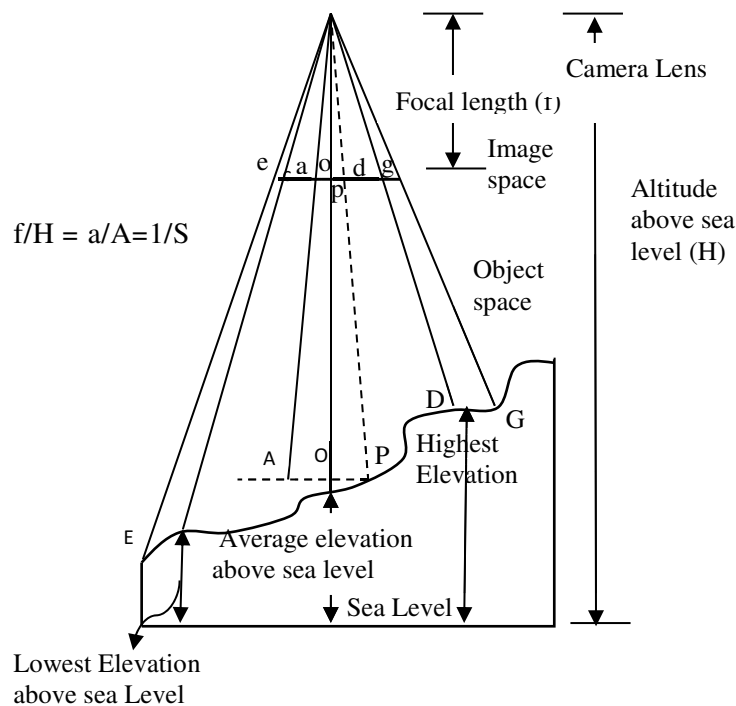
Camera used for this research has photo format 24 x 36 mm, and length of camera focus (f) 18 mm. That specification is used to achieve the height and to find the minimum designed hole of 1cm [3]. Time needed to fly drone and to record the data is 15-20 minute for 600 meter length of road. The road width is 50 meter. For H.M Noerdin Pandji Street, which has 5200 length, it takes 130 minute to take aerial photo. From the survey experience, it can be concluded that the less wide the road, the faster photo recording on the field. To get sufficient coverage and resolution of spatial photo that is able to do interpretation of measurement, types of holes and road damages then the altitude of flying drone is planned initially as the following Figure 2.

Figure 2. Correlation between Heights of flying, camera focuses and photo coverage.

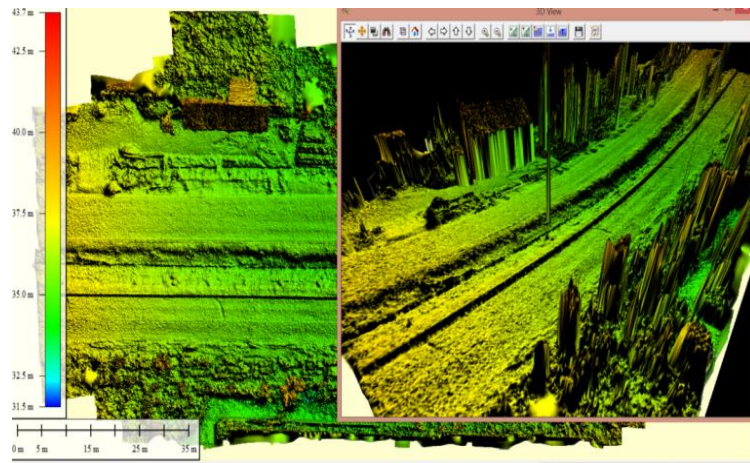
By using software Arc-GIS 10.3, extraction of aerial photo is carried out with the steps of mozaicking and aerial triangulation as the following Figure 3.

Figure 3. Three dimension of DEM results.

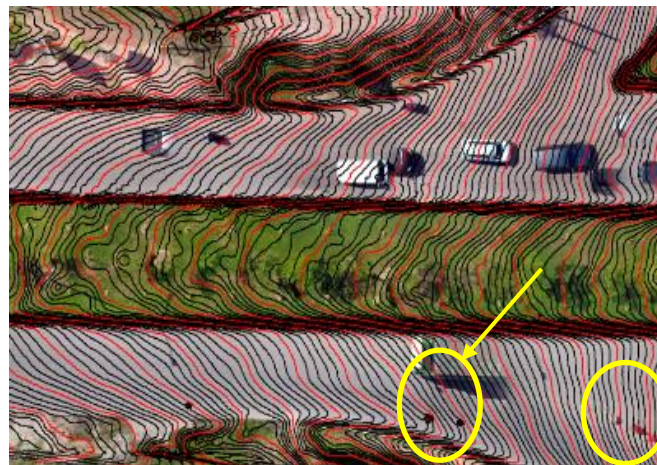
3.2.1 Providing contour line at the road damage. Providing contour line is done in order to get the potholes picture on the road. In this research interpretation is done with 2 cm interval and 10 cm index. The following picture shows the contour of road and side road.

Figure 4. Identification results by Contouring.

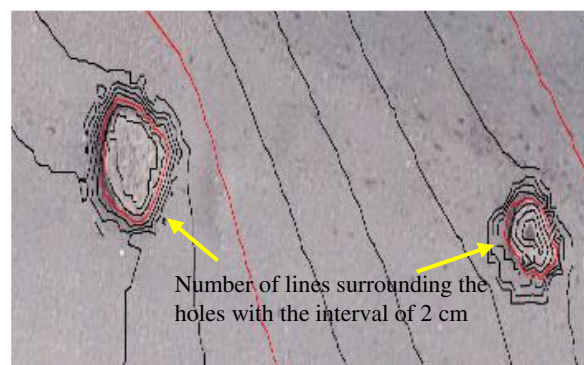
The depth of potholes are presented and calculated from the picture, as it is described in Figure 5.

Figure 5. The depth of holes with interval of contour lines.

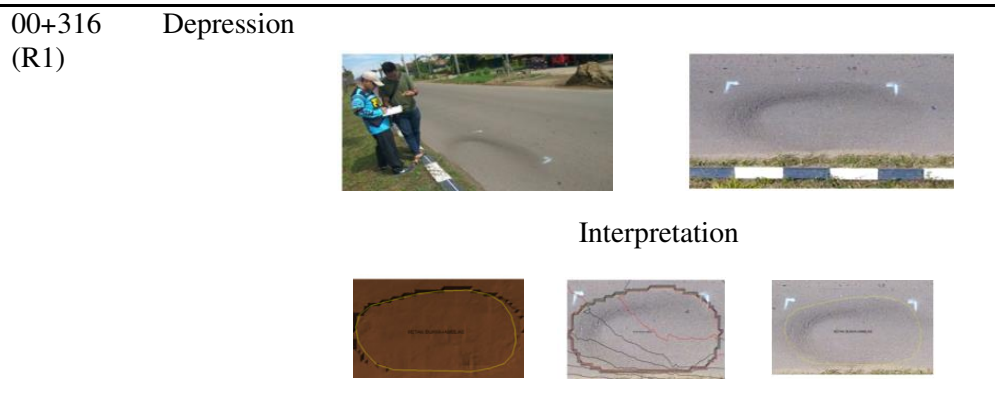
Table 1. Comparison of manual photo and Aerial photo interpretation of potholes.

3.2.2 Types of Potholes. On station, STA 00 + 054 (left picture) after comparison and validation of manual photo and Aerial photo interpretation of potholes it reveals, the area of potholes is 0.054 m², length is 30 cm and width is 18 cm. The comparison can be seen as the following photo inside the Table 1.

Station	Type of Damage	Manual photo	Aerial Photo
00+054 (L.2)	Potholes

00+402 (R1)	Alligator crack

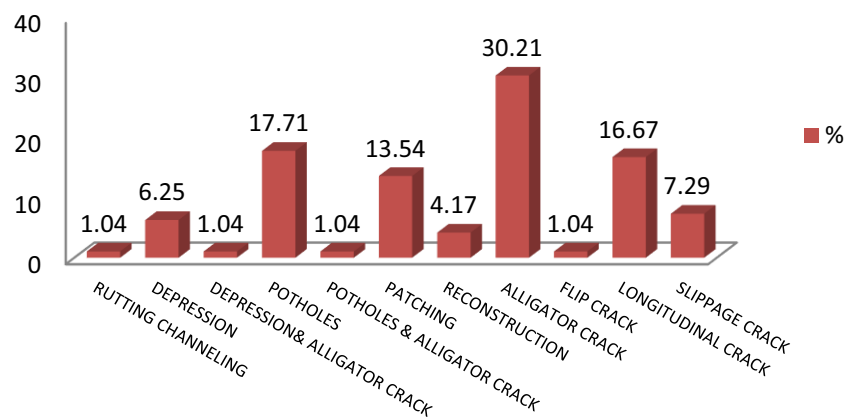
3.2.3 Characteristics of damage condition. Pavement damages in this research are classified into 7 types, namely depressions, potholes, alligator crack, longitudinal crack, slip crack, patching, and reconstruction. Number of damage according to type of damage in the study area is shown in the following Table 2.

Figure 6. Percentage of number of damages according to damage types.
