Electronic and microscopic researches of dislocation structure of metal near crack top

Abstract. The most important element of fuel and energy complex is the system of the main pipelines for transport of gas, oil and products of their processing. On a surface of the main pipes in the presence of cathode protection there can be corrosion cracks. It is connected with simultaneous influence of two factors - soil electrolytes and the stretching tension. One of the most dangerous types of destruction of main gas pipelines is stress-crack corrosion (SCC). Defects on an outer surface of a pipe are shown in the form of single cracks or their system focused generally along the forming pipe. In work studying of the multiple cracks formed on the main gas pipeline under the exfoliated isolation is presented. Researches were conducted on a sample of X70 steel of the Japanese production which is selected from a focal zone of destruction of the main gas pipeline. On a sample there were cracks, characteristic of corrosion cracking. For the proof that cracks had corrosion and mechanical origin electronic and microscopic researches of dislocation structure of metal near crack top were conducted by

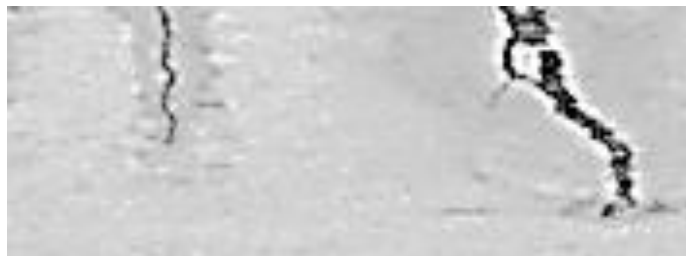
In figure 1 the studied sample of the main gas pipeline after preparation for researches - grindings and macroetchings in the mix of ice acetic and nitric acids (1:1) offered at MSCP USPTU department is presented.

Figure 1. Group of cracks on the surface of the tested sample.

Apparently in figure 1 the delay of distribution of the deepest crack when crossing the segregation strip having the hardness, big on 60 MPas, is observed than the average hardness of metal. Such behavior, apparently, is connected with influence of mechanical loads of metal at the time of accident.

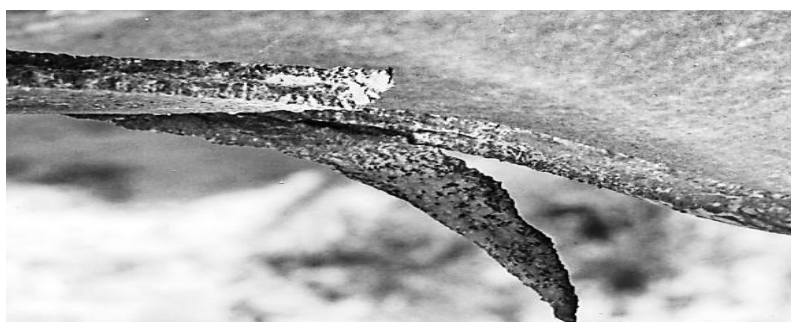
Cracks on the studied operating main gas pipeline arose on an outer surface of the pipeline within 5 - 7 hours of the conditional dial. It is revealed that development of refusal happened by formation of the main cracks; due to merge of their groups in the destruction center; and also due to formation of fistulas at through defeat of a wall of a pipe. At the same time the nature of development of destruction – fragile (from an outer surface of a pipe at an angle about 90 °) and with a viscous mechanical rupture area (at an angle about 45 °). In figure 2 disclosure of colony of cracks in the destruction center is shown.

Figure 2. Disclosure of colony of cracks at destruction of the pipeline (X70 steel).
