To cite this article: P. Kotásková *et al* 2019 *IOP Conf. Ser.: Mater. Sci. Eng.* **566** 012018

# Assessment of the possibility of using modern diagnostic methods to determine the changes in the properties of timber elements installed in a river bed

**Abstract.** The aim of the research was to find out which non-destructive methods can be used for determining the properties of wood placed in humid area and water. The research was carried out in order to propose suitable methods for detecting state of timber during regular inspection and maintenance of timber structures and elements in the watercourse. Wooden thresholds located in the watercourse belonging to the Divoká Orlice River Basin were selected for the measurement. The measured timber elements were already 9 years in the flow and the degree of damage to the built-in wood had to be assessed. The extent of biotic damage to water-soaked wood cannot only be determined by sensory methods. Resistance stop devices, a non-destructive ultrasonic device, a micro drill and an acoustic tomograph were selected for the evaluation. However, all commonly used modern diagnostic methods used for measurements in dry environment surveys can

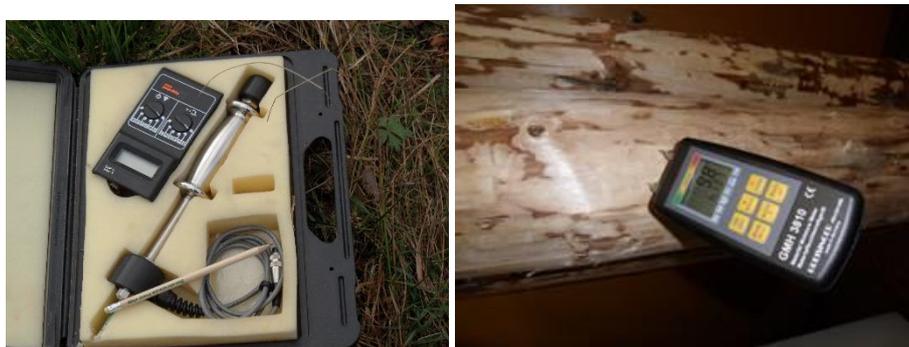
**Figures 2 and 3.** Hygrotest 6500 Resistance Hygrometer and Resistive Moisture Meter with GMH 3810 Integrated Probes.

Increased water content can affect the results of non-destructive testing, so the moisture of wood elements was determined before each measurement. Hygrotest 6500 resistance hygrometer with stop probe was used to measure the humidity, a resistance humidity meter with integrated GMH 3810 measuring tips was used to measure the sample in the laboratory (see Figures 2 and 3). The principle of the method lies in the influence of moisture in the wood on the electrical resistance. Resistance hygrometers utilize electrical one-way resistance and wood conductivity.

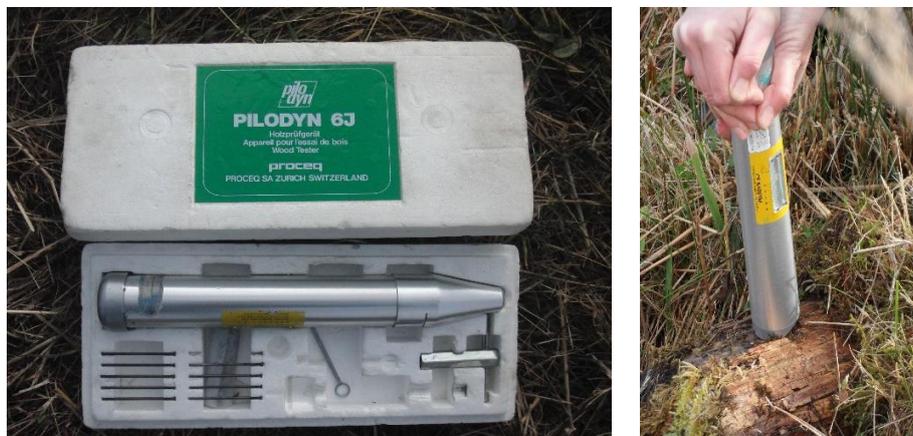
**Figures 4 and 5.** Pilodyn 6J Resistance Stroke Instrument - Measurement on Threshold Side Wing.

Measurement with the Pilodyn 6J Forest is a semi-destructive diagnostic method because the damage to the test material is very small and almost negligible. It is a simple mechanical device to measure the penetration depth of a 2.5 mm mandrel fired in wood at a constant driving force of 6 J (see Figures 4 and 5). The tip penetrates the surface of the material while the penetration depth is measured. The maximum penetration depth of the mandrel is limited to 40 mm by the device design. With Pilodyn, a low-invasive wood density estimate can be made. Density is a parameter closely related to the hardness of the wood, as Bonamini et al. [4] suggest; Kasal and Antony [5].

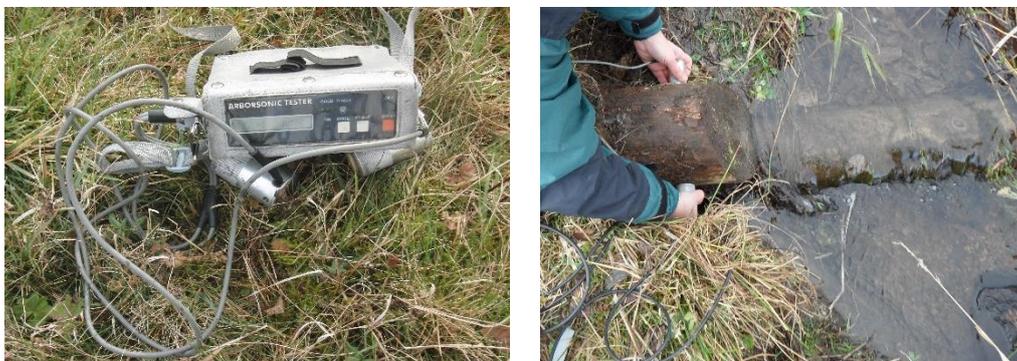
**Figures 6 and 7.** Non-destructive Arborsonic Decay Detector - Measurement on the sill side.

Arborsonic is a detector that uses ultrasound to detect and evaluate the internal state of the wood based on ultrasound rate (see Figures 6 and 7).

The instrument measures the speed of the 77 kHz ultrasonic signal passing through the measured material between the two sensors (transmitter and receiver). Since the signal propagates the fastest in the solid wood mass, the signal rate slows down in each decay or defect area. In damaged areas by rotting, the sound speed will be significantly lower than in intact wood. [7]

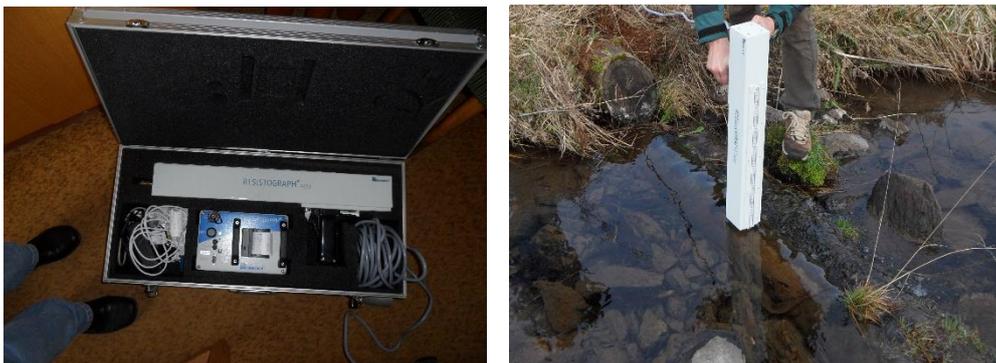
**Figure 8 and 9.** Resistograph 4453 Resistance Micrometer - Measurement on Overflow Edge in the Middle (Wood in Water).

Thin drill senses resistance when penetrating wood. This implies that less drilling resistance, which requires less engine torque, is due to less wood density, cavities, damage, splintering, and cracks. Resistograph output is a graphical record (density profile, dendrogram).

The drilling record corresponds to the energy consumed to maintain a constant drilling speed on the y-axis and the x-axis shows the distance from the surface of the measured element. The peaks in the graphical record correspond to higher energy, ie higher resistance and higher density, while lower points are associated with lower energy, ie lower resistance and density. [11]

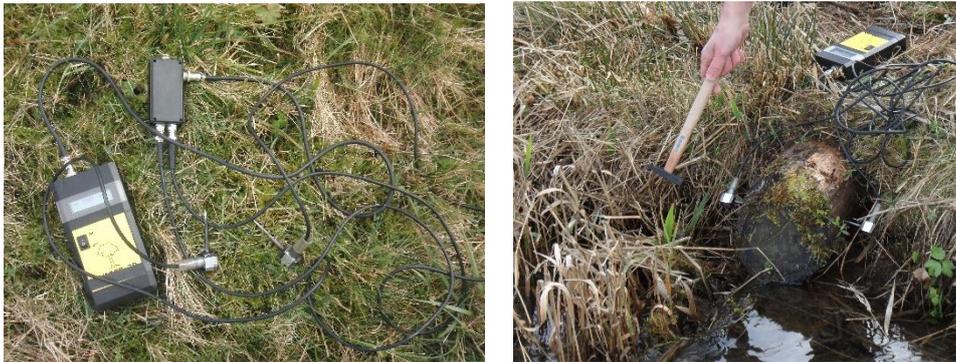
**Figures 10 and 11.** Acoustic tomograph Fakopp 2D.

The Fakopp is capable of reconstructing the internal state of the strain by measuring the speed of the sound pulse caused by hammer blows into 2 interconnected probes (see Figures 10).

Two sensors are connected to each other and are connected to the meter (see Figures 11). An acoustic signal is emitted by tapping the hammer on the probe and the instrument senses the time it takes to pass the signal from the currently activated probe to the opposite probe. The generated pulse spreads through the material for some time and reaches the second probe - the receiver. The ultrasonic pulse transmission time is displayed on the device display in microseconds. Based on the passage times and the geometry of the cross-section, the velocity is calculated and the state of the strain is reconstructed.
