## Research on Discharge Characteristic of Free Metal Particles in DC Bushing

# Research on Discharge Characteristic of Free Metal Particles in DC Bushing

**Abstract.** Free metal particle was a common impurity in fault DC bushing, which was produced while its operation. This paper mainly focused on analyzing the typical fault of DC bushing, morphology and motion characteristic of mental particles. A experiment platform was built to study the discharge characteristic, and the result consistently with analysis was obtained. The mental particles would aggregate and accumulate due to the unevenly temperature distribution, and lead to distortion of electric field. The location and width of mental particles would have impact on discharge characteristic. The research result could be used as structural optimization and design of DC bushings, which was worth a further study both in academic and engineering application.

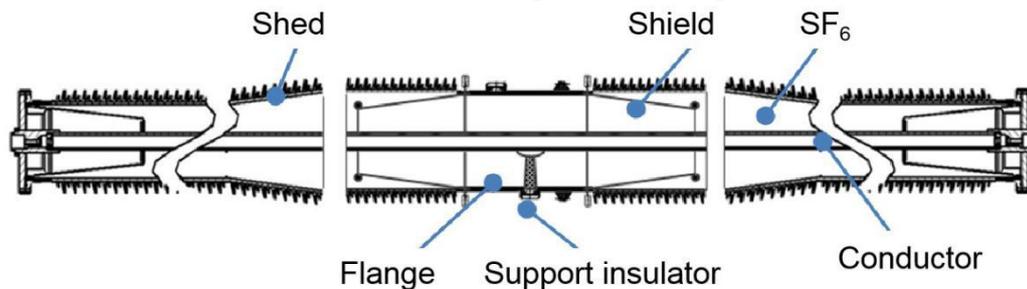
An internal discharge fault occurred in a pure SF<sub>6</sub> gas insulated DC wall bushing for a ±800kV converter station in China. Three epoxy supporting insulators that uniformly distributed in the cross section of DC bushing were used to support the current carrying conductor. And SF<sub>6</sub> was used for auxiliary insulation. The inner structure of the bushing is shown in figure 1.

Figure 1. Inner scheme of pure SF<sub>6</sub> gas insulated DC wall bushing

An internal discharge fault occurred in a pure SF<sub>6</sub> gas insulated DC wall bushing for a ±800kV converter station in China, and the inner structure of the bushing is shown in figure 1. Flashover

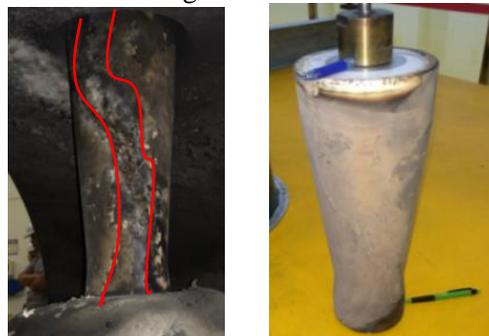
When the fault occurred, the supporting insulator at 12 o'clock direction flashovered. There were many metal particles on the surface of the insulator and the conductor, and more particles were found near the fault insulator. There were obvious discharge traces on the surface of the fault supporting insulator. Under long-term and heavy-load operating conditions, the temperature of the connector that connected the indoor and outdoor conductors would increase significantly, and resulting in the uneven distribution of temperature and DC electric field on the surface of the insulator. Meanwhile, the changing of bushing temperature made the conductor stretch and rub, which might produce mental particles. Metal particles drifted to the surface of the supporting insulator under the influence of SF<sub>6</sub> airflow, and caused the electric field distorting on the surface of insulator.

Figure 2. Particles and flashover discharge traces on supporting insulator in fault bushing

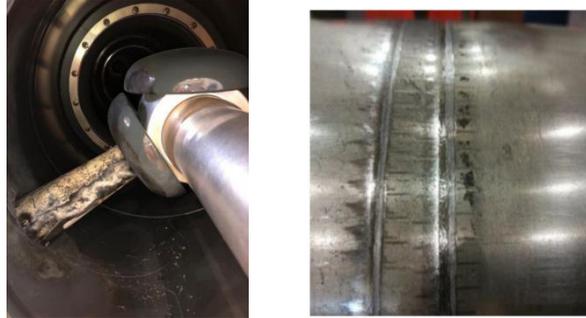
occurred on one side of the insulator, explosion-proof membrane cracked, and flange burned. Many particles were found on the conductor, the supporting insulator, and the outer surface of shield.

Figure 3. Flashover discharge channels on supporting insulator and particles on conductor

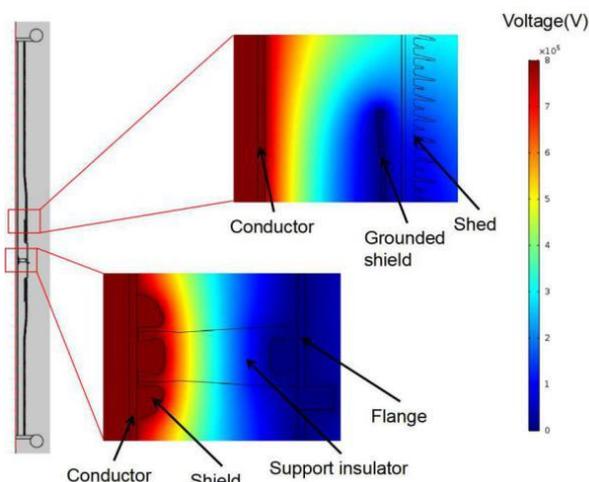
The COMSOL Multiphysics was used to analyze the electric field of the bushing with epoxy support insulator. 800kV DC voltage was applied to the conductor, and the result is shown in figure 4. It is clearly to see that electric field on the surface of the support insulator and the shield was concentrated. The surface of support insulator near the shield was the most concentrated area, and the field strength decreased along the surface of the insulator.

Figure 4. Electric field distribution of bushing with support insulator

Particles were mainly distributed in the location where the electric field was concentrated inside the DC bushing, which was consistently with the simulation results. In bushing with epoxy support insulator, particles were mainly attached to the surface of support insulator, conductor near insulator, and grounded shield. In bushing with epoxy capacitor core, particles were mainly attached to the surface of capacitor core and the junction of conductor. In DC bushing, the conductor was usually segmented, connected with spring finger strap. The metal particles inside the bushing mainly originated from the metal friction at the current carrying conductor and the defects in the manufacturing process. In general, the particles were spherical, with a few microns to tens of microns in diameter.

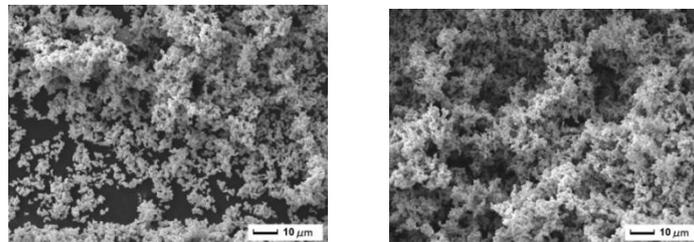
Figure 5. Microstructure of particles collected in a fault bushing

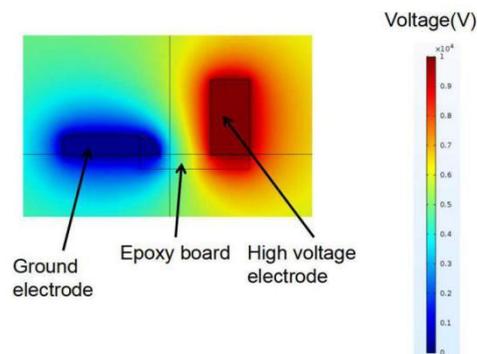
The experiment platform was made of Polytetrafluoroethylene (PTFE). The particle discharge characteristic experiment was carried out on the platform. The epoxy sample board was placed on the platform, and the particles were arranged on the board. High voltage electrode and ground electrode were arranged above the board. The ground electrode structure was hemispherical, and the high voltage electrode structure was cylindrical, with a diameter of 25 mm and a distance of 35 mm. When a 10kV DC voltage was applied to the high voltage electrode, the electric field distribution is shown in figure 6.

Figure 6. experiment electrode electric field distribution

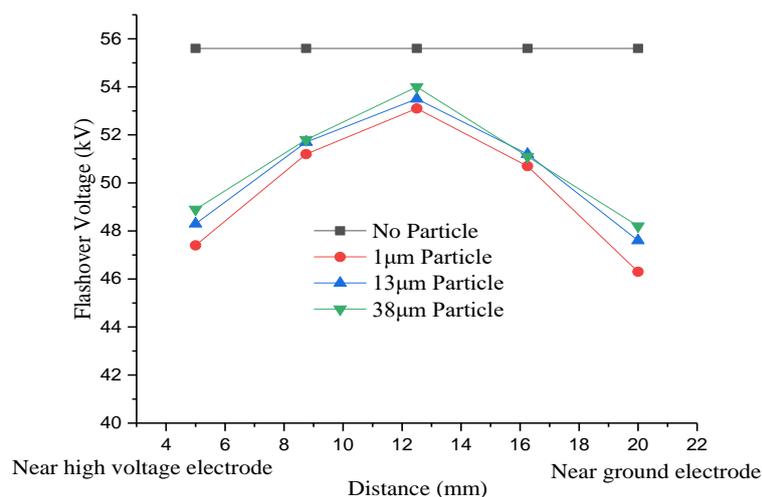
Three kinds of single layer particles were arranged in different positions on the board, with a parallel width of 10mm and a perpendicular width of 30mm. The flashover voltage of each distribution is shown in figure 7. It is obviously to see that the closer the particle was to the electrode, the more obvious the effect of the particle was on the insulation performance. The phenomenon can be explained that the electric field between the experiment electrodes is an uneven field, and led to the concentration of electric intensity at the position close to the electrode. The electric field were seriously distorted by particles. Besides, the particles near the electrode position were more likely to move under the impact of the electric field force, and the discharge path was easily formed during the movement.

Figure 7. Flashover voltage of different particle positions

- The closer the particle distribution to the electrode, the more obvious the effect on the insulation performance. When the particles were distributed in the middle of the electrodes, the flashover voltage was the highest, and it was about 10% higher than close to the electrodes.

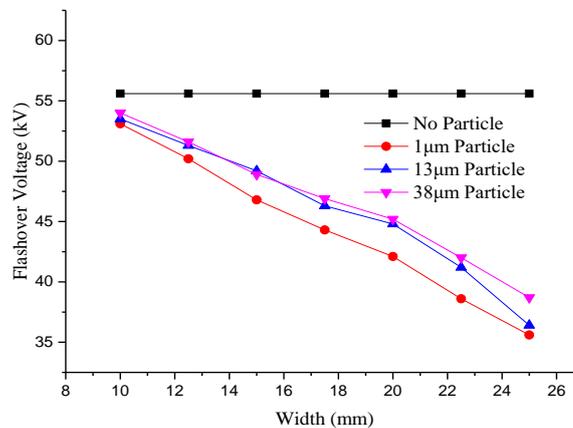
Three kinds of single layer particles were arranged in the center of the two electrodes, with a parallel width of 10-25mm and a perpendicular width of 30mm. The flashover voltage of each distribution is shown in figure 8. It is clearly to see that the wider the particle was, the more obvious the effect of the particle was on the insulation performance. It can be explained that the presence of particles reduced the insulation properties of the epoxy surface. The coverage of particles would

seriously impact the insulating property. Meanwhile, the charge of particles in the edge was consistently increasing with the particles' width, and these particles were more likely to move in the electric field.

Figure 8. Flashover voltage of different particle width

- The wider the particle distribution, the more obvious the effect on insulation performance. When the distribution area of the single layer particles exceeded 50% of the insulation distance, the flashover voltage would drop by about 25%.
