Study of the efficiency and durability of hydrophobization modifications of building elements

V Novak¹ and J Zach¹

¹Brno University of Technology, Faculty of Civil Engineering, Centre AdMaS, Purkyňova 139, 612 00 Brno, Czech Republic

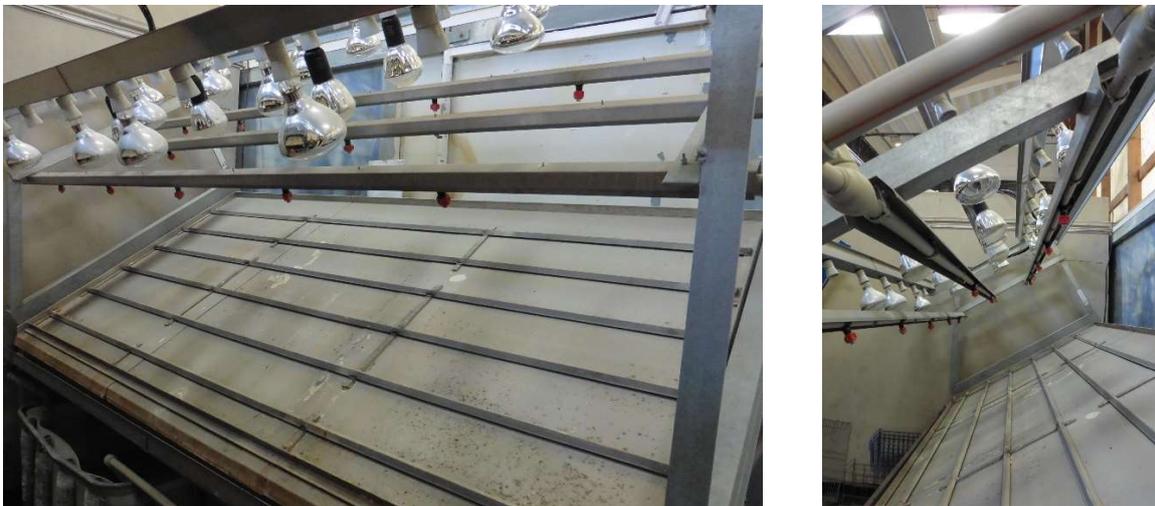
One simulation cycle consists of 170 minutes of water sprinkling using spraying jets that sprays about 103 litres of water per 1 m² of the effective area per hour. These 170 minutes of sprinkling is followed by a 10-minute pause. After the pause, the test sample is heated for 170 minutes using an IR lamp of about 1300 W per 1 m² with the addition of UV light of 250 W per 1 m². The temperature of the radiant area of the exposed material increases to about 60–70°C. This is again followed by a 10 minute pause. The procedure described above is repeated 17 times in succession. The samples are then left in water for 2 hours. After 2 hours of water saturation, the samples are placed in a climatic chamber at -20°C for 2 hours. This completes one simulation cycle of the durability test, which corresponds to the exposure of the samples to the outdoor environment under extreme conditions for a Central European locality for 1 year.

To create the necessary conditions, a device was used which is referred to as a „sprinkler“ (see figure 1). It is equipment of Research Institute for Building Materials. The degradation simulation was carried out as part of the collaboration between research institutions.

Figure 1. The device for simulation of load cycles.

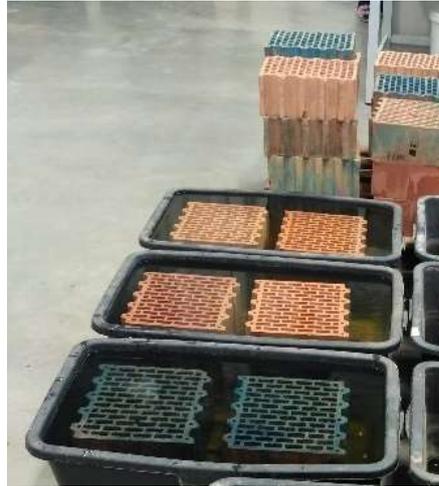
From each set of hydrophobized blocks, a sample was placed in a water bath for about 1 month (see figure 2). The water level was maintained above the upper surface of the blocks. Thus, the effectiveness of the hydrophobization protection on blocks was determined using the selected hydrophobization agents A and B. The efficacy was determined by monitoring the absorbance of the blocks over time. At the selected time intervals, the blocks were always drawn out of the water bath, for about 30 seconds the blocks were loosely placed on the pad for sufficient draining of surplus water from the surface of the block. Blocks were then weighed and put back into the water bath.

Figure 2. Placing of blocks in a water bath - determination of capillary absorption.

The capillary absorption (1) was calculated from the weight gain of the blocks over time (in selected periods) due to the water absorption into the pieces of block in relation to the masonry block surface.
