Typical defects analysis of metal parts of substation secondary components

D K Li^{1*}, J Wang¹, S X Liu², Z Hou², C Qiu³ and Y Xie¹

¹State Grid Hunan Electric Power Corporation Research Institute, Changsha, Hunan, 410007, China

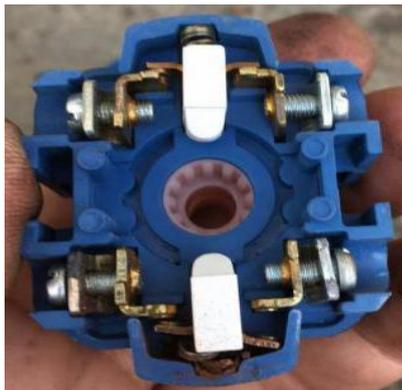
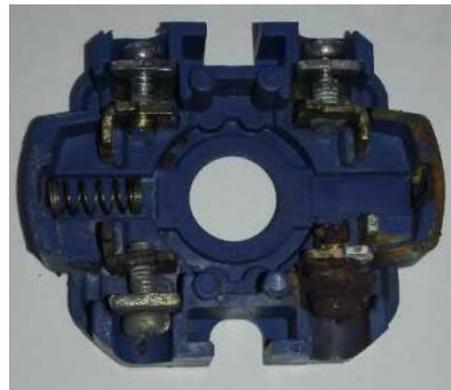
Figure 1. Defects of CA10 series far and near control switches

In the process of substation maintenance and operation, the failure of CA10 series switch of LW10B circuit breaker manufactured by a manufacturer has been found many times. The typical defects include damage, contact site rust and spring breakage, as shown in Figure 1, which can result in the opening and closing control failure of circuit breaker. For example, after disassembling the far and near control switch of a 500 kV circuit breaker in a substation, it is found that four of the eight rows of contacts are corroded and springs are broken, some of which are powdered. During overhaul of the 614 circuit breaker for a 220 kV transmission line in a 500 kV substation, the far and near control switch broke during operation.

Failure analysis of CA10 series switch of LW10B circuit breaker has been carried out. It was found that the metal materials for contacts, gaskets and compression springs are made of ordinary galvanized steel or 200 series stainless steel. These materials have poor corrosion resistance and are easy to rust and fracture in wet environment during long-term service^[2]. The test results show that the contact spring of CA10 series switch with serious rust is made of galvanized carbon steel and its metallographic structure is fibrous tempered sorbite, as shown in figure 2. However, under the same service conditions, contact springs made of 304 stainless steel are with good surface condition, and their metallographic structure is fibrous deformed austenite and carbide^[3], as shown in figure 3.

(2) In the design stage, material with excellent comprehensive properties such as aluminum alloy, nickel-plated brass and tin-plated copper should be preferred, while material with insufficient corrosion resistance such as galvanized steel, 200 series stainless steel and poor mechanical properties such as lead brass should be avoided.

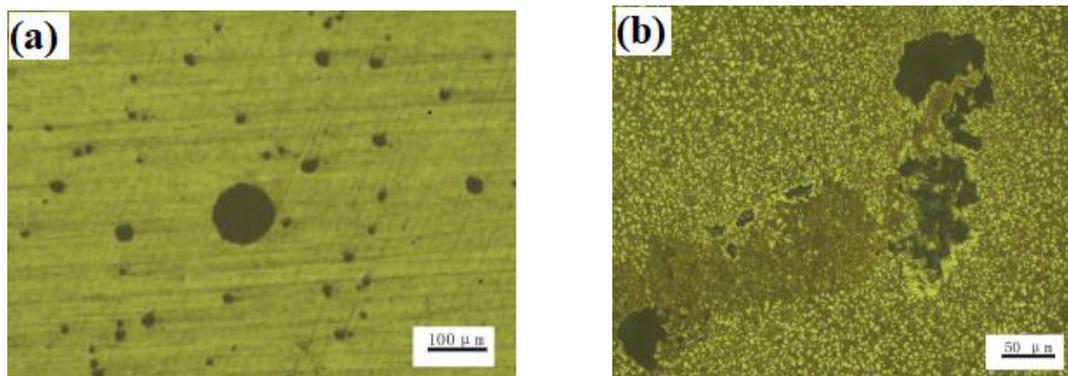
Figure 4. Microscope of the fracture fixed bolts and nuts (a) unetched after polishing (b) etched

The samples were further analyzed and the results are shown in figure 4. Metallographic pictures of the polished unetched samples are shown in figure 4(a). The black island in the figure is free element Pb. Metallographic structure after etching with FeCl₃ hydrochloric acid solution are shown in figure 4(b). The main constituent phases are equiaxed α phase and matrix β phase, and the obvious third phase element Pb is with black island shape^[4].

The solid solubility of Pb in copper-zinc alloy is very small, and it mainly exists at the grain boundary of solid solution. The hardness of the element Pb is very low, it has strong lubrication and friction reduction, and it can make the alloy have very high cutting performance. However, if the content of Pb in the alloy is too high, the distribution of Pb in the grain boundary will be continuous network, leading to the weakening of the grain boundary and even the island distribution of the precipitated Pb in the matrix, as shown in figure 4. All of these will lead to the decrease of mechanical properties and the increase of brittleness of the alloy, which will easily lead to fracture^[4]. Therefore,

the chemical composition of the alloy does not meet the requirements of the standard, especially the excessive lead content in the alloy is the direct cause of the breakage of the fixed bolts and nuts in the moving iron core of the circuit breaker opening coil.

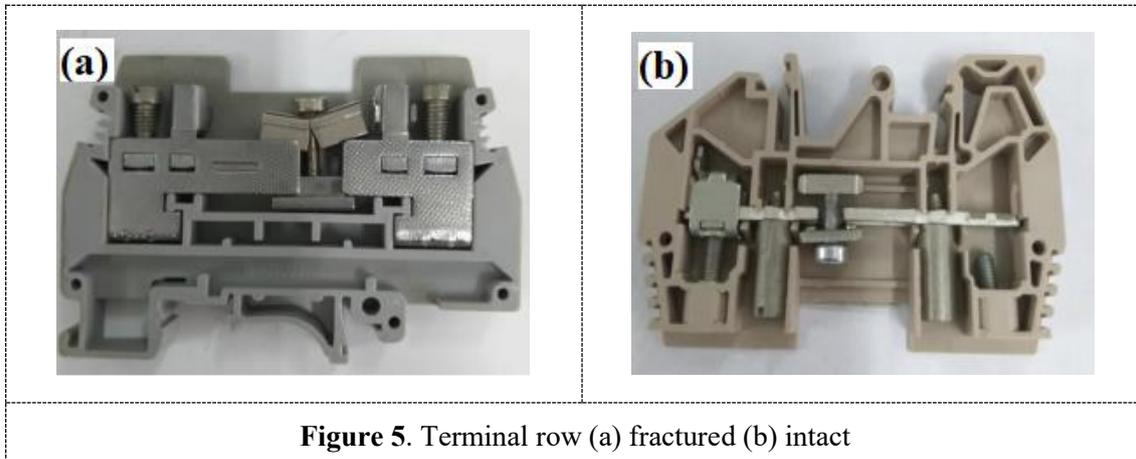
Figure 5. Terminal row (a) fractured (b) intact

During overhaul, it was found that there were a lot of fractures in one type of terminal row, as shown in figure 5(a), while other types of terminal row were intact under the same conditions, as shown in figure 5(b). Further analysis shows that the material of the broken terminal row is lead brass, and the lead content is far beyond the upper limit required by the standard, which will lead to brittleness of the terminal row. Thus, it is easy to cause cracking in the process of installation and screw hole processing.

Analysis shows that there is a tin plating layer on the surface of intact terminal row. The base alloy grade is ordinary H66 brass, and its composition is shown in Table 2. The H66 brass has high content of Cu, low content of Pb and impurities, and good plasticity. So it is more suitable for terminal row material than lead brass. In addition, we also found that the terminal rows made of aluminium alloy and tin plated copper have much better durability.

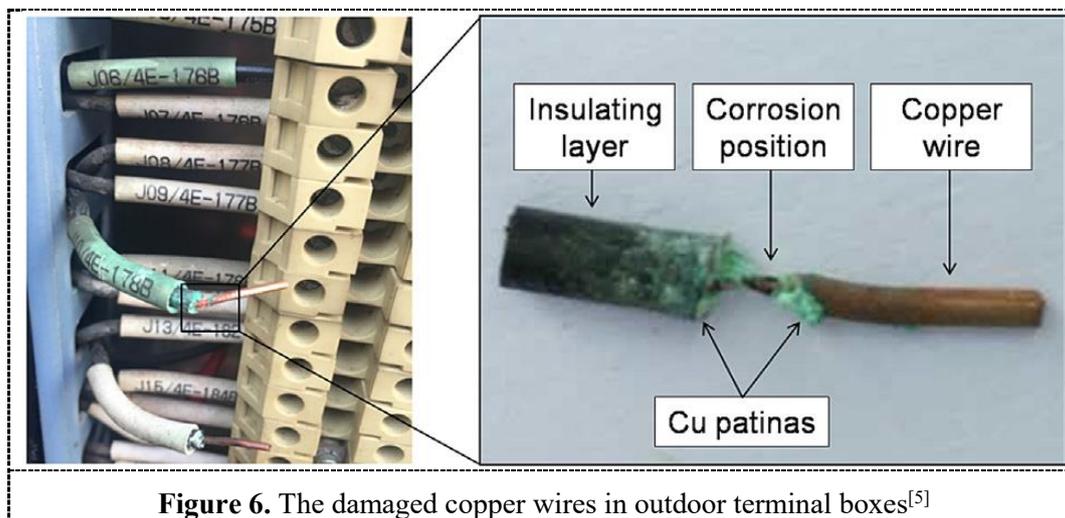
Figure 6. The damaged copper wires in outdoor terminal boxes^[5]

Terminal of the secondary cable core in terminal box of a substation is corroded, and the number barrel made of polyvinyl chloride is green. When unplugging the number barrel and unfastening the terminal, it is found that the cable core has been corroded seriously, and it almost falls off from the terminal row. The corrosion location of copper wire is just at the interface of insulating layer, but there is no obvious corrosion at a distance, as shown in figure 6. XRD and XPS analysis showed that the corrosion product of copper wire was $\text{Cu}_2\text{Cl}(\text{OH})_3$, which was a typical corrosion product of copper and copper alloy in marine atmospheric environment.

Further analysis shows that Cl^- can be dissolved from the number barrel and dominates the whole corrosion process. When the external humidity increases, thin liquid film is formed on the surface of copper wire, copper will react with oxygen in air to form Cu_2O film, and the corrosion rate decreases. In the meantime, a thin liquid film will be formed around the number barrel, and the chlorine elements

in it will dissolve in the form of chloride ions, which will increase the concentration of Cl^- in the surrounding environment. Then, Cl^- gradually invades into Cu_2O film and replaces O element in it to form soluble CuCl_2^- , which is further oxidized to soluble CuCl_2 under the action of oxygen. Whereafter, $\text{Cu}_2\text{Cl}(\text{OH})_3$ are formed by coordination reaction and redeposition process between Cu^{2+} , Cl^- and OH^- . The whole process can be expressed as follows:

From the above discussion, it can be seen that Cl^- dissolved from the number barrel and higher air humidity are the main environmental factors accelerating the corrosion process of copper conductors. In order to avoid the corrosion of copper conductors, it is suggested to replace the dehumidifier with independent control and evaluate the dehumidification effect regularly and the number barrel should be replaced with the material which does not dissolve the harmful ions such as Cl^- and SO_4^{2-} .
