## Study of the corrosion rate of the paths walls of aluminum heat exchangers in the ethylene glycol antifreezes environment under developed aeration of power fluid

To cite this article: A Petrov *et al* 2019 *IOP Conf. Ser.: Mater. Sci. Eng.* **589** 012031

A Petrov<sup>1,2</sup>, G Saatashvili<sup>1</sup>, A Averianov<sup>1</sup> and I Bilenko<sup>1</sup>

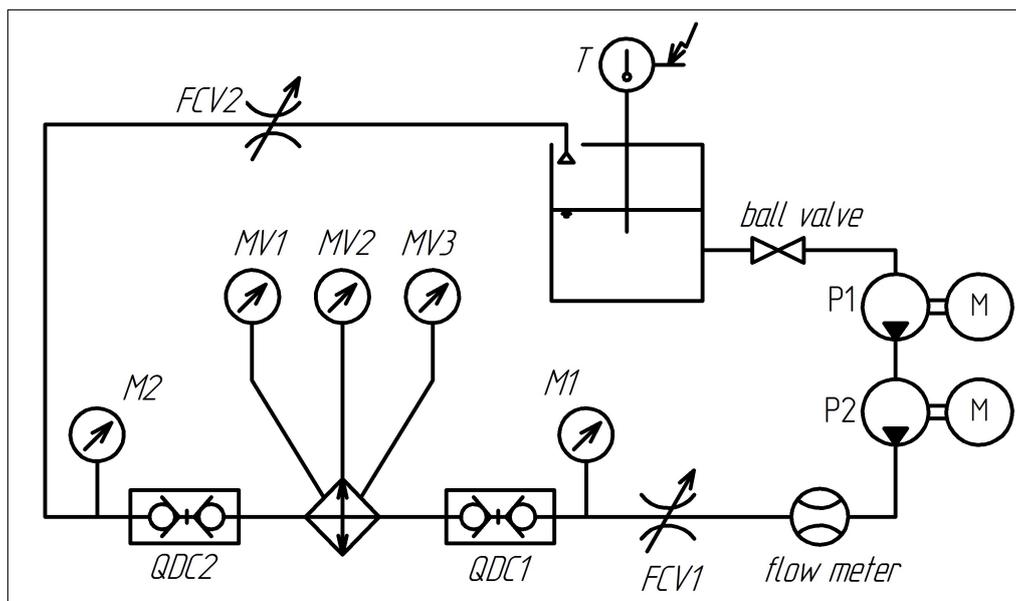
**Figure 1.**Diagram of the test bench

Heat exchangers were connected as one by one, as well two and two in series through quick disconnect coupling (QDC), similar to using in real system. The diagram of the test bench is shown in figure 1. To simulate the presence of bronze elements in the real system, inserts and fittings made from bronze without galvanic isolation (flexible pipe in a metal braid were used) between them and the heat exchangers were used in the test bench. The pressure at the inlet of the heat exchanger (before the QDC) was maintained within 3...4 bar, which corresponds to the pressure in the real system.

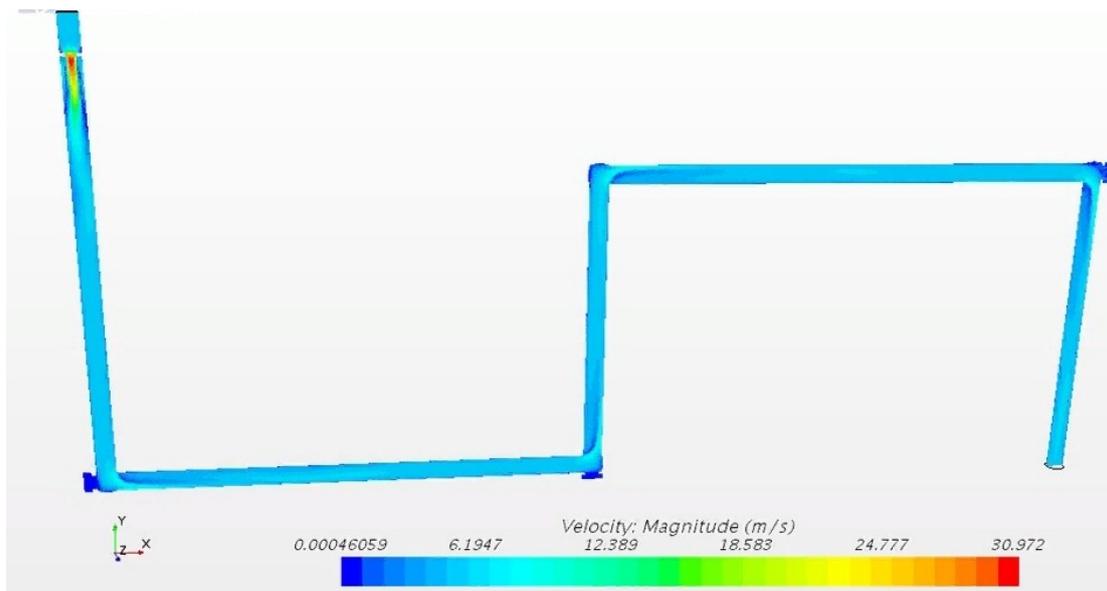
**Figure 2.** Velocity field distribution pattern in the heat exchanger paths at the flow rate 14 l/min

According to the hydrodynamic simulation results, the following conclusions can be drawn: the occurrence of steam cavitation in the heat exchanger paths is unlikely, because zones of pressure reduction equals to saturated vapor pressure were not detected (figures 2, 3). This pressure distribution pattern was also corroborated by measuring pressures in the holes (about 20 holes were made) along the heat exchanger paths.

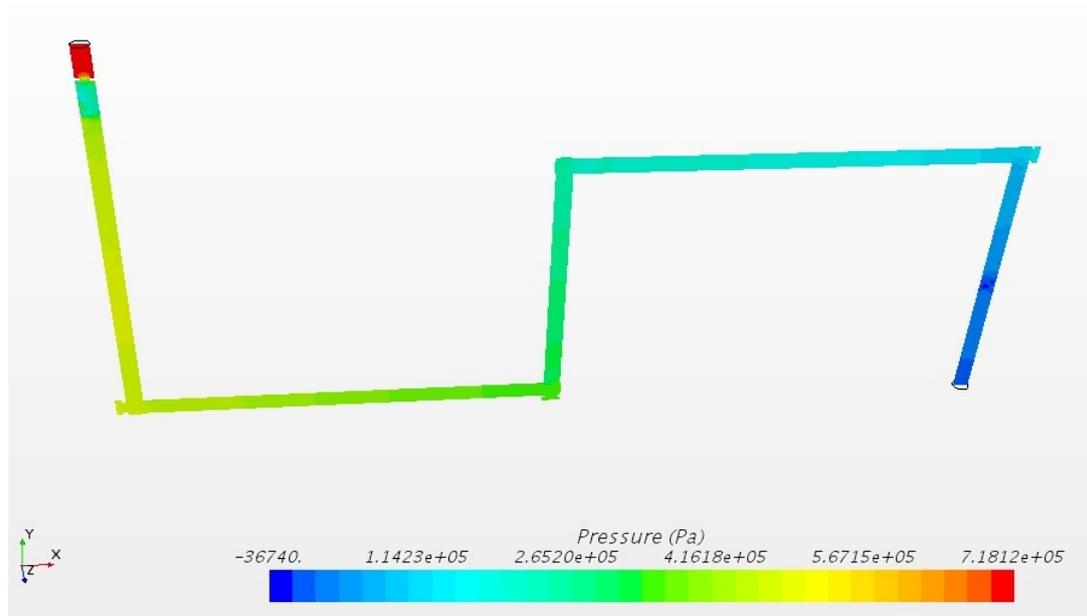
**Figure 3.** Pressure distribution pattern in the heat exchanger paths at the flow rate 14 l/min

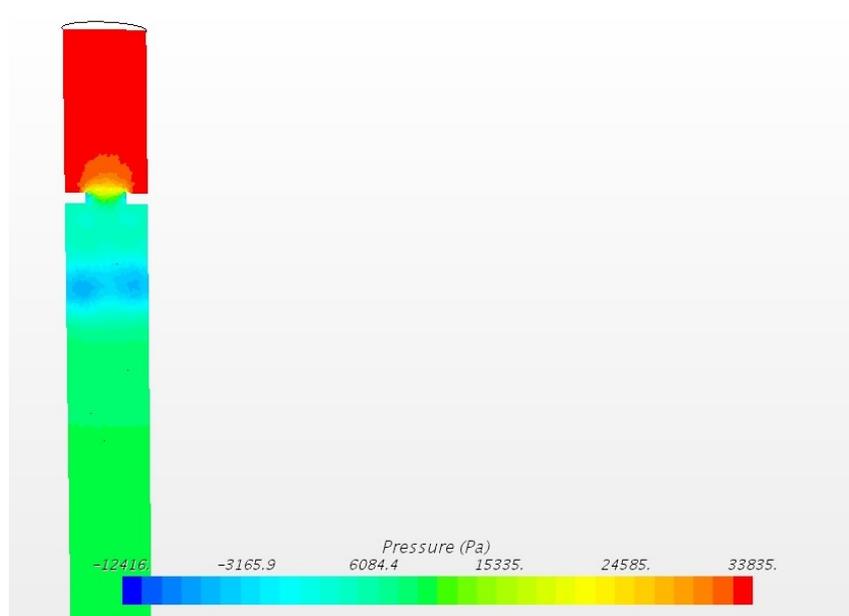
**Figure 4.** Pressure reduction zone after local flow narrowing in the heat exchanger inlet

There are no also anomaly high velocity zones, except of zone proximately after the QDC and particularly after flow deflection. However, the rapid decay of pressure after QDC, including the

laminar flow (figure 4), which causes a high probability of gas cavitation, i.e. release of dissolved gas, with a significant aeration of the fluid.

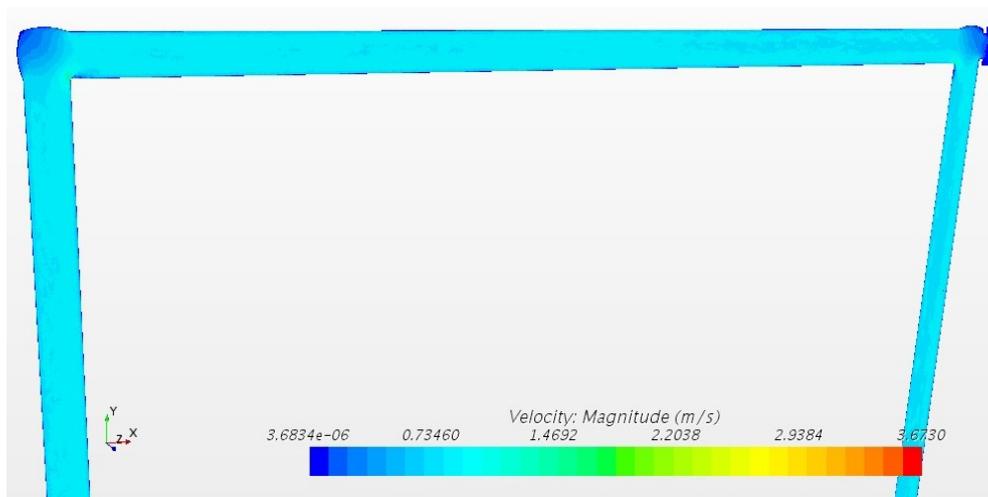
**Figure 5.** Local zones of velocity reduction

The presence of low flow velocity zones along path centerline of heat exchanger (figure 5), which combined with gas releases and low flow velocity in general can create a local high oxygen content zones in the upper medium paths zones at some distance of flow deflections. The hydraulic simulation of two-phase laminar flow (flow rate is 2 l/min) is shown in figure 6, a zones of high gas content in the upper path part are visible.

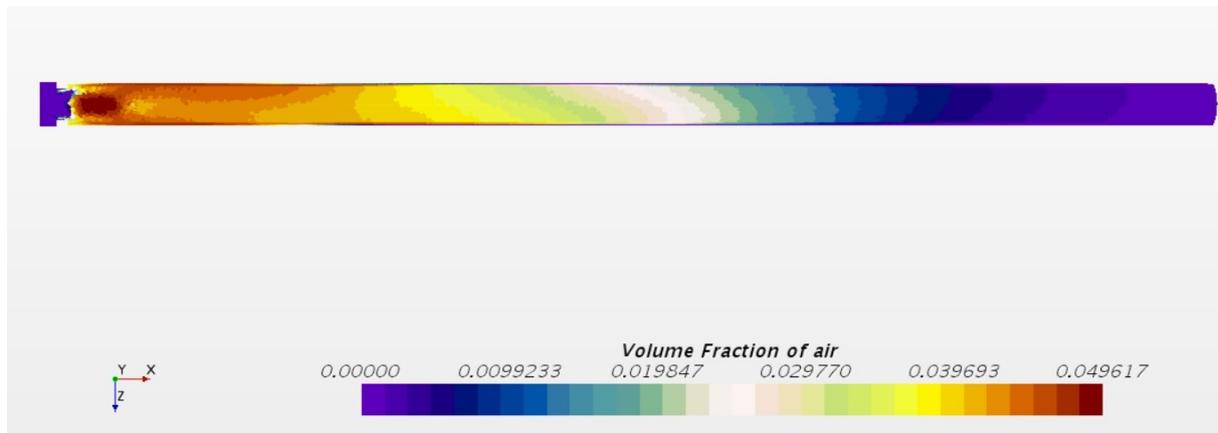
**Figure 6.** Two-phase laminar flow of fluid motion

It may be concluded that the presence of sharp narrowing and increase of flow, and flow deflection, which combined with high aeration level of fluid, cause intensive gas releases and laminar flow with low velocity results to movement of gas bubbles to upper part of path, causing a large amount of oxygen in wall layers.

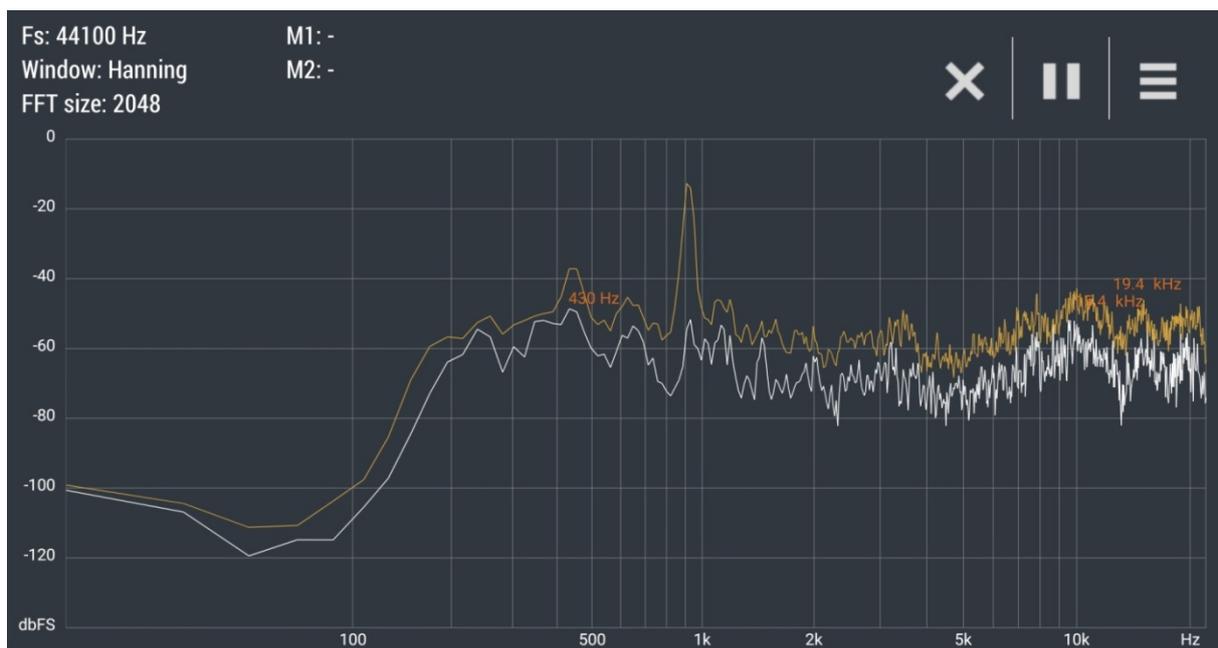
**Figure 7.** Noise levels measurement during the testing

The occurrence of intensive gas cavitation during the operating is confirmed by acoustic image of fluid flow in the heat exchanger [2]. The acoustic spectrum of the results of noise level measurement among the path (spectrum corresponds to zone after inlet part) is shown in figure 7. White shows the acoustic background in the room, orange - the noise in the path. Visible peak at frequency of about 1 kHz, arising due to the occurrence of steam cavitation. When the flow rate decreases, the peak amplitude decreases, but it does not disappear completely as long as there is a flow process.

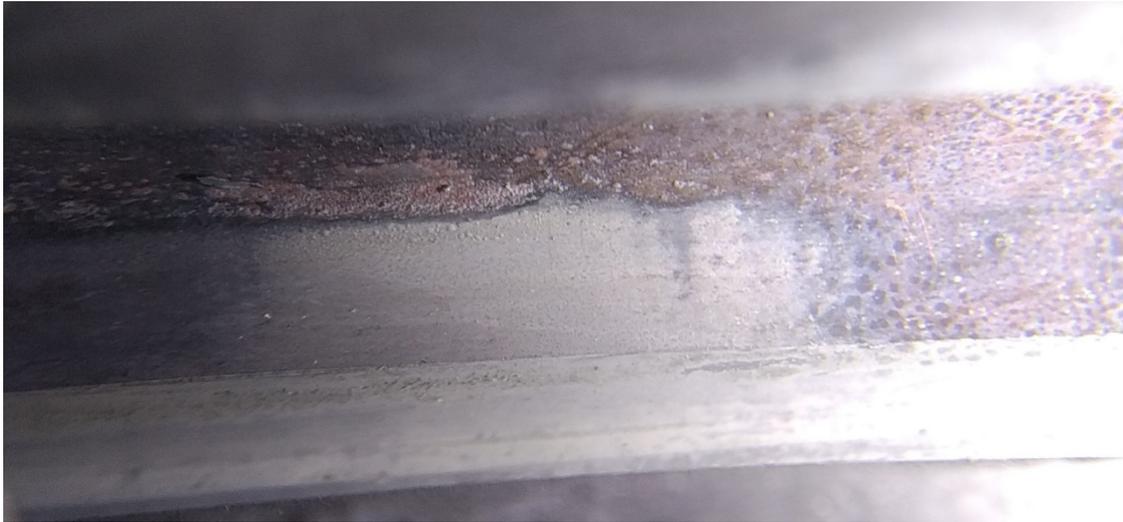
**Figure 8.**Corrosion of the path surface

After the testing, the study of paths surface was carried out by bore scope and milling for opening of some path parts. Among other things, was created the fluid precipitation in the reservoir, where numerous aluminum particles up to 0,1 mm in size were found out. Signs of corrosion in the opening path of heat exchanger made from D16T [aged-hardening duralumin] are shown in figures 8 and 9, the inner surface of the same path is shown in figure 10.

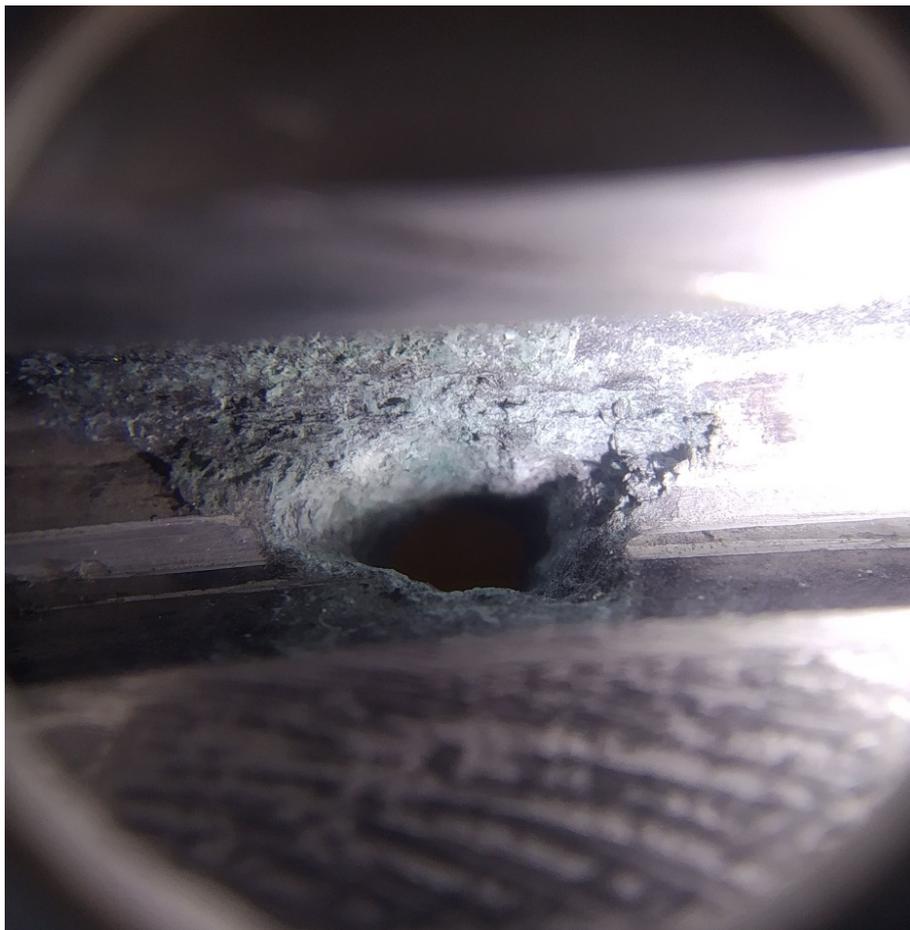
**Figure 9.** Open pitting corrosion on inside of heat exchanger path

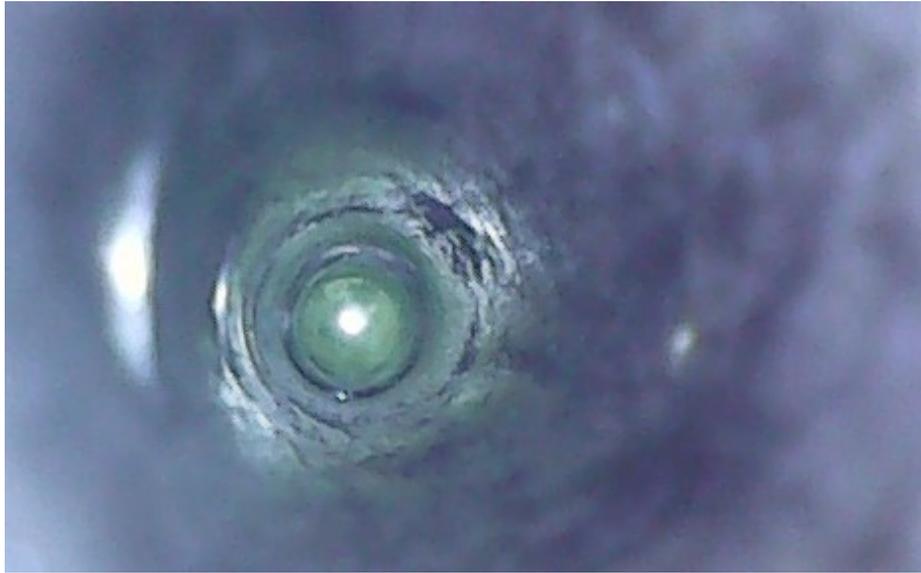
**Figure 10.** The path of heat exchanger made from D16T [aged-hardening duralumin], operating time is 130 hours, corrosion is visible

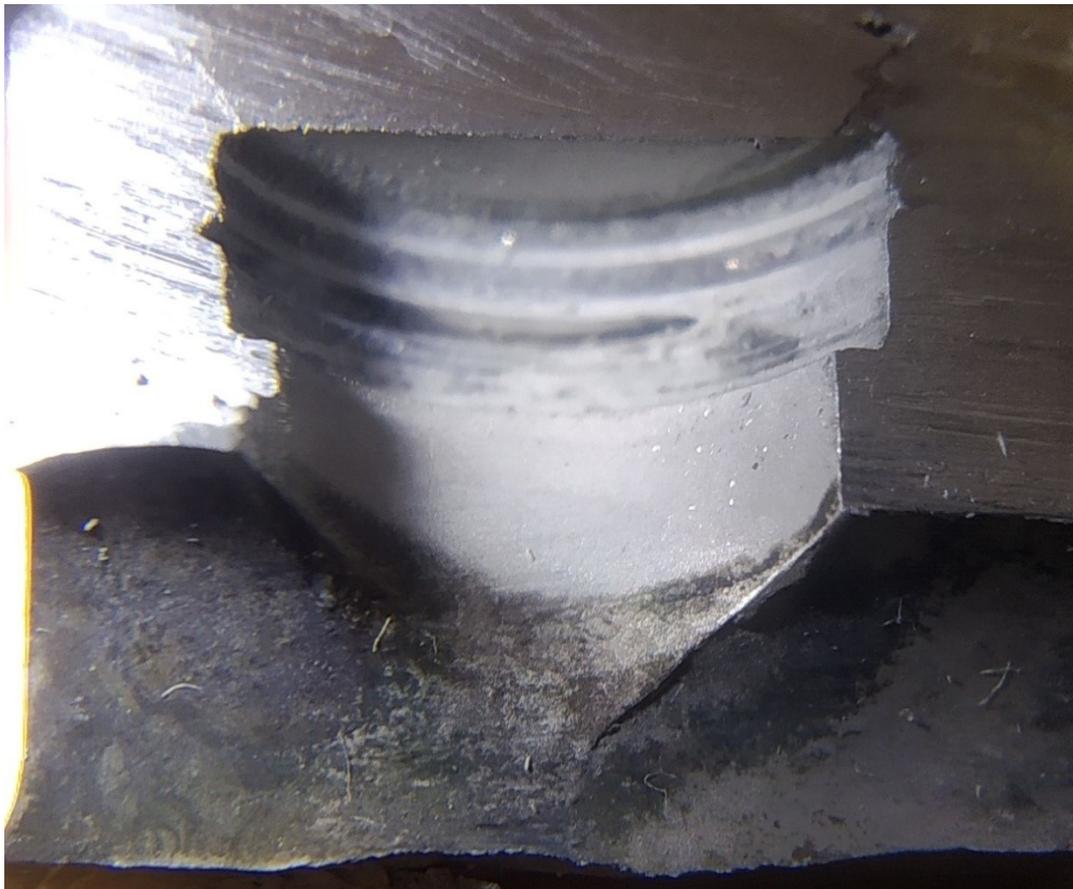
**Figure 11.**Corrosion zones in the path with and without spray coating

The effect of spray coating Sn-Bi on the corrosion developing is interesting. Zone of the path interface with and without spray coating that, perhaps, proves electrochemical type of corrosion [10,11].

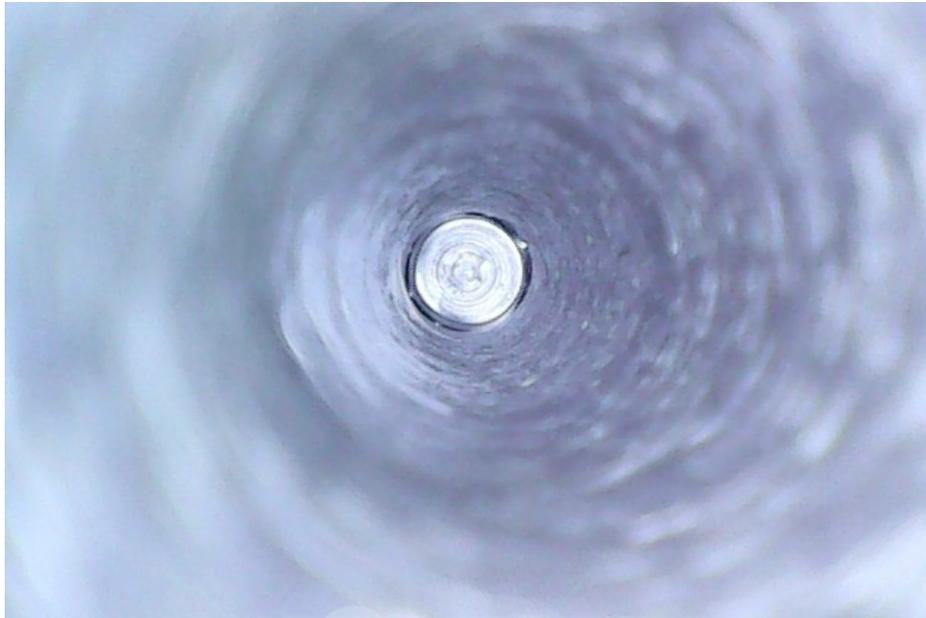
**Figure 12.** The path of heat exchanger made from AMg6 [93,5% Al, 5,5% Mg], operating time is 100 hours, there are no corrosion signs (there are signs of treatment)

The testing of heat exchanger made from AMg6 [93,5% Al, 5,5% Mg] has shown the absence of corrosion signs on the surface (figure 12):
