## Shear strength of FRP-Externally strengthened High Strength RC T-Beams

To cite this article: Basil Ibrahim *et al* 2019 *IOP Conf. Ser.: Mater. Sci. Eng.* **601** 012018

**Basil Ibrahim<sup>1\*</sup>, Moussa Leblouba<sup>1</sup>, Salah Al-Toubat<sup>1</sup> and Samer Barakat<sup>1</sup>**

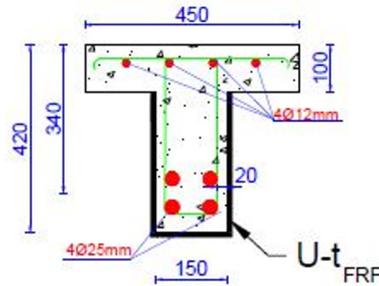
As shown in Table 1, the beams have a T-section with a web width of 150mm ( $b_w$ ), flange width of 450mm ( $b_f$ ), flange height of 100mm ( $h_f$ ), total height of 420mm ( $h$ ), effective depth of 340mm ( $d$ ), length of 3700mm and test span of 3300mm. The effective depth  $d_{frp}$  and the thickness  $t_{frp}$  of the CFRP are 240 mm and 0.166 mm/layer, respectively. All the 3 beams are designed to fail in shear. The longitudinal reinforcements consist of 4 25mm diameter bars as tensile reinforcements and 4 12mm diameter bars as compression reinforcements. Figure 1 shows the section details of the beams.

**Figure 1.** Beams section details.

All the three beams are large scale, HS RC T-beams without transverse reinforcement. The control specimen (Specimen 1) is virgin (i.e., without EB-CFRP). Specimen 2 is a beam that is strengthened with a layer of EB-CFRP strips in U-jacketing configuration placed at 90 mm from center to center. Specimen 3 similar to Specimen 2 except that the CFRP sheets are applied twice (double-layer). Table 1 summarizes the geometry and material properties of test specimens. Figure 1 shows the beams' section properties and Figure 2 illustrates the geometry of the beams and test setup.

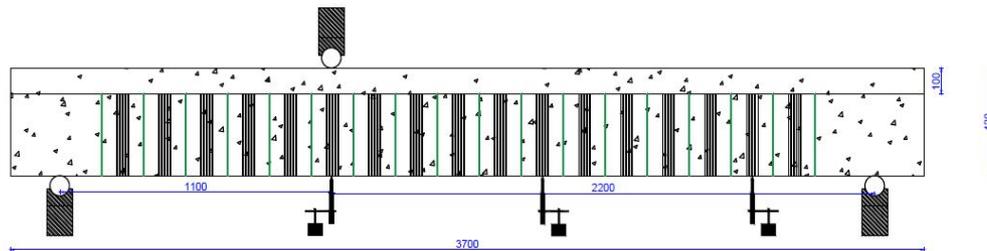
### 2.3 Test setup and instrumentation

**Figure 2.** Geometry of the beam and test setup.

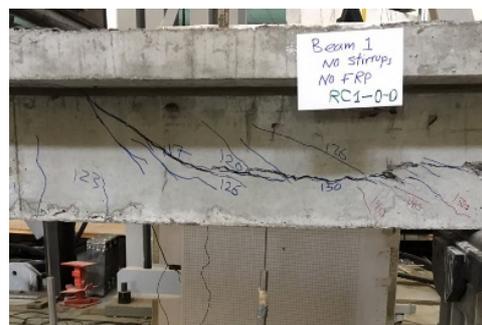
Specimen 1 failed due to shear as shown in Figure 3. After the appearance of flexural cracks in the tension zone of the beam at a load level of 70 kN, the shear cracks started to appear at a load level of 130 kN in the shear span from the point of loading until the support, and since there's no transverse reinforcement to control the shear cracks, the cracks widened until the sudden failure at a load level of 196 kN.

**Figure 3.** Control beam after failure.

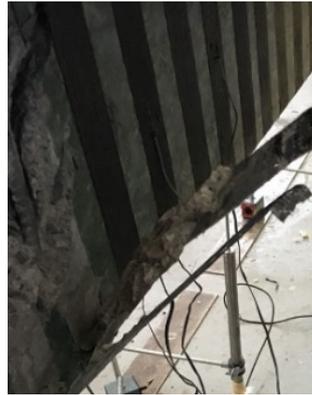
The behavior of this beam, as shown in Figure 4, was not much different from the control beam. In the beginning, shear cracks appeared, at a similar load level of 130 kN in the shear span after the formation of flexural cracks. The shear cracks started to get wider from the point of load application until the support level at a load of 170 kN. After the beam reached its ultimate load capacity of 220 kN, the main shear crack increased abruptly. The contribution of the CFRP strips in resisting the shear cracks started beyond the load capacity of the beam then dropped sharply. Subsequently, the CFRP strips started to debond from the concrete surface without reaching the rupture of the fibers.

**Figure 4.** Single layer beam after failure.

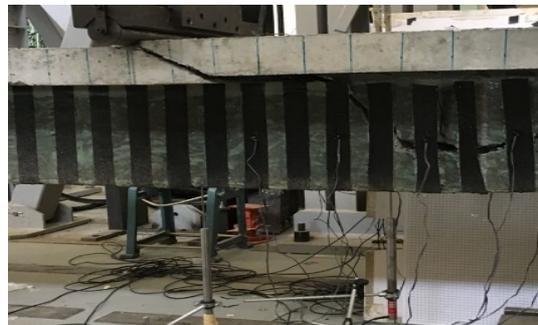
The performance of this beam was actually close to the behavior of the single layer. In the absence of the transverse steel reinforcement, adding another layer of CFRP strips was not effective as anticipated, which was mainly due to the debonding failure without rupture of the CFRP sheets (Figure 5).

**Figure 5.** Double layers beam after failure.

The observed debonding failure of the EB-CFRP in both, Specimen 2 and 3, suggests that the performance of the single-layer and double-layer specimens are no different, which means adding more layer was not effective in enhancing the shear behavior of the HS RC beam in the absence of transverse steel reinforcements.

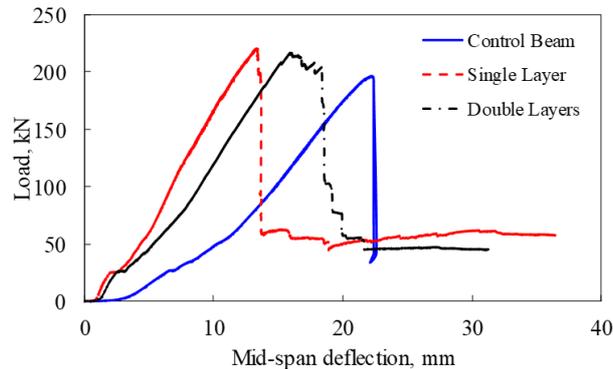
Figure 6 shows the load-mid-span deflection curves of the three beam specimens. Clearly, the CFRP had the effect of enhancing the post failure behavior of the strengthened beams. However, the CFRP layers had a negligible influence on the overall load-carrying capacity of Specimens 2 and 3; CFRP shear reinforcement increased the load capacity of the beams by around 20 kN only, shown in Table 2 below, which represents about 10% of the capacity of the control beam (i.e., Specimen 1). A noticeable effect of EB-CFRP was the residual strength which was about 23% of the ultimate load-capacity of the beams. The control beam failed without recording any residual strength.

**Figure 6.** Load-Deflection curve.
