Causes Analysis and Reinforcement Technology for 21st Horse Wall Cracks of Xi'an Ancient City Wall¹

Xuening FAN¹, Bo Liu², Xueding FAN³

Abstract. Xi'an ancient city wall is a national key cultural relics protection units and the most completely preserved ancient city wall building in China. In recent years, the increase of wall cracks has seriously affected the overall performance of the wall, which is in dire need of professional maintenance. Through monitoring the present situation of 21st horse wall cracks, the damage factors and failure mechanism is analyzed in detail. The reinforcement method of steel pipe cast-in-place pile and lime soil compaction pile is proposed based on the existing problems to prevent the expansion of the cracks and maximized preserve the original architecture cultural style, which has reference significance for the protection of ancient building.

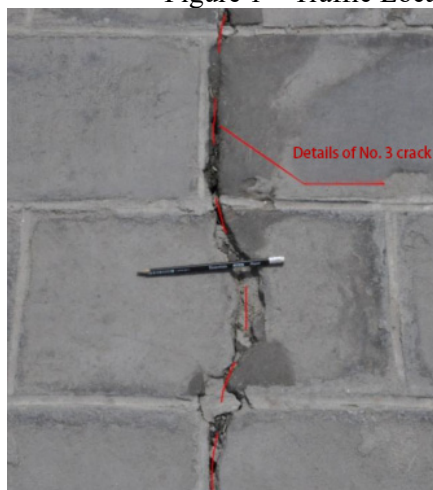
Figure 2 Local Picture of Crack III

The 21st horse wall section is located on the east side of the south gate of the city wall (the specific location is shown in figure 1). The surrounding terrain is relatively flat, belonging to the transition zone between the loess tableland and the alluvial plain in the Weihe Basin. The topographic unit belongs to the bench terrace II-2. The main external manifestation of the 21st horse wall's damage is the subsidence and cracks of the city wall's top plane, horse wall and wall of the city wall. The crack measurement, statistics and brief description are shown in Table 1. The specific cracks are shown in Figure 2 and Figure 3.

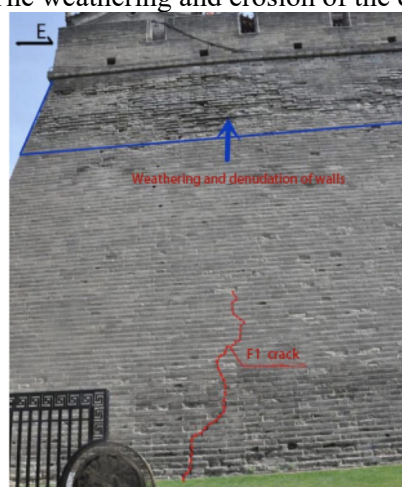
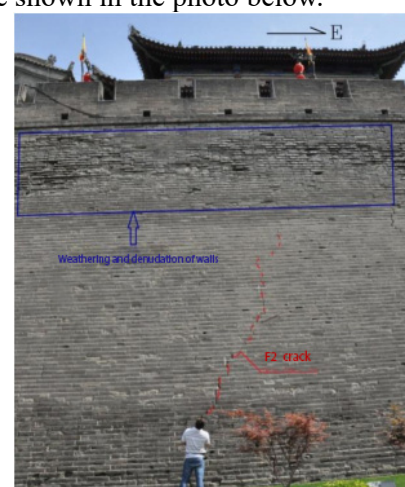
Figure4 F1Weathering and denudation of cracks & walls Figure5 F2Weathering and denudation of cracks & walls

The investigation also finds that from the height of the city wall's top plane down to the wall within 4m, the weathering and erosion of the city brick is serious, the brick sew was eroded, and the surface of the city brick was denuded and detached, forming a severely uneven wall surface, which is basically distributed in the entire 21st horse wall section, mainly caused by water seepage from top to bottom. The weathering and erosion of the city wall bricks are shown in the photo below.

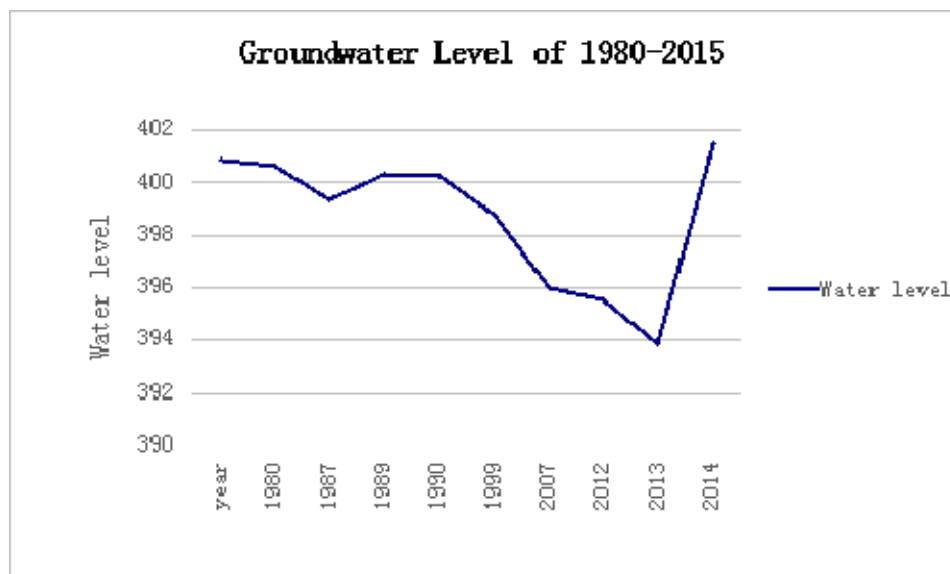
Figure 6 The Variation Trend for the Elevation of Groundwater Level from 1980 to 2015

Groundwater is exposed by drilling holes in the roots of the horse wall. The groundwater depth is between 7.10 and 8.70m and the corresponding groundwater level is 401.13 to 401.50m, but the measured water elevation of the moat in this area is 401.48m. It follows that the water level of the moat and the groundwater level of the horse wall are approximately the same. The variation trend for the elevation of groundwater level around 21st horse wall in the south gate of Xi'an city wall from 1980 to 2015 is shown in Figure 8. It can be seen from the figure that from the 1980s to the period of investigation (June 2015), the groundwater level of the 21st horse wall has a large variation, and the difference is up to 4-6 m. The reduce of groundwater level will increase the effective self-weight stress in the soil below the original groundwater level, resulting in a large area of additional subsidence of ground surface^[2]; The rise of the water level will increase the compressibility of the soil between the original groundwater level and the changed groundwater level, and for the viscous fill, it will decrease the strength of the soil and increase the earth pressure^[3]. Due to the long-term fluctuation of the groundwater level in which the wall is located, resulting in the uneven subsidence of the foundation^[4], which leads to the occurrence of cracks.

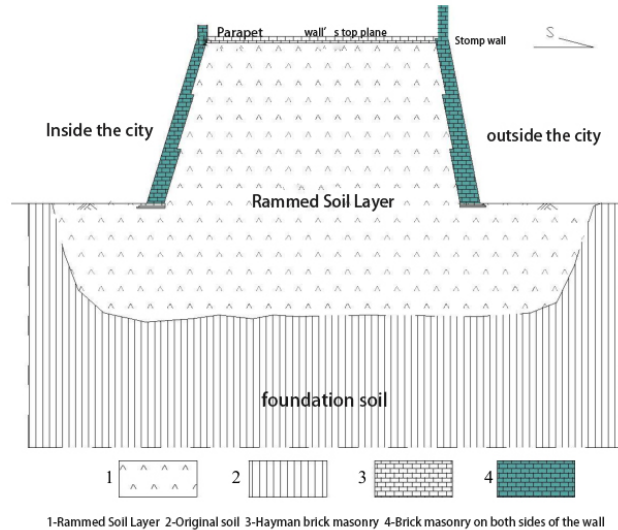
Figure 7 Structure Diagram of City Wall

According to the investigation for the condition of the wall and foundation of 21st horse wall, the city wall is divided into the four layers down from city wall's top plane, including the layer of city bricks①₁, the layer of lime soil cushion①₂, the layer of rammed soil①₃, and the layer of rammed soil ①₄, as shown in Figure 9. According to the statistical table of physical and mechanical properties of each layer, combined with the bearing capacity of each layer of soil, it can be found from situ test that the layer of rammed soil①₃ (about 0.8-7.0m depth) is collapsible loess with poor compactness, poor uniformity and low shear strength; the layer of rammed soil①₅ under the root of the city wall has a large water content, with poor miscellaneous fill, cluttered soil texture, large layer thickness variation and low shear strength; the layer of underlying loess②,③ under the foundation of the city wall are in the state of plastic to plastic-flow, with large water content, medium-to-high compressible soil, and low shear strength. It can be seen that the different soil texture has different moisture content, void ratio, hydraulic coefficient, compression modulus, etc.^[5]. Compared with the overall structure of the

city wall, it is a heterogeneous mass structure with large differences. Concentrated stress points will be formed at the junctions and variable cross-section of different materials^[6]. The occurrence of the cracks in the wall is inevitably under the effect of external load and its deformation.

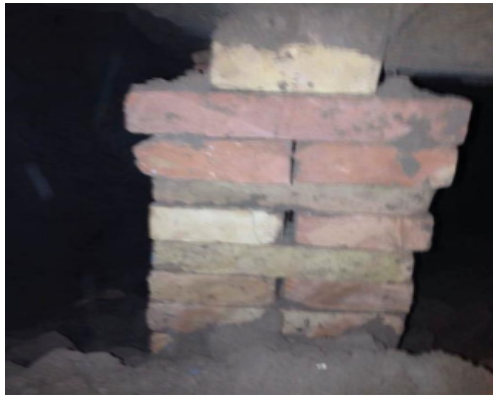
Figure 8 Air-raid Hole in the Sidewall of Exploration Well t2

During the excavation and exploration, many diseases such as holes and air-raid shelters were discovered. As shown in Figure 8, the exploration well t2 is located on the north side of the watchtower. During the excavation process, the air-raid hole is found at a depth of 7.3 m, and no hoop brick is found in the air-raid shelter.

Xi'an City Wall has experienced the wars of the Ming and Qing Dynasties, and also experienced the War of Resistance Against Japan and the War of Liberation, etc. Especially during the Cultural Revolution, people dig holes in the walls of the city to take earth and bricks and build civil defenses, leaving many holes and air-raid shelters. This has a great influence on the performance of the city wall. According to the pressure diffusion theorem of the ground building foundation, it can be known that the wall deformation and cracks will inevitably occur when the excavation depth exceeds a certain range^[9]. The existence of voids does not provide effective support for the upper building, so that deformation and cracks occur.

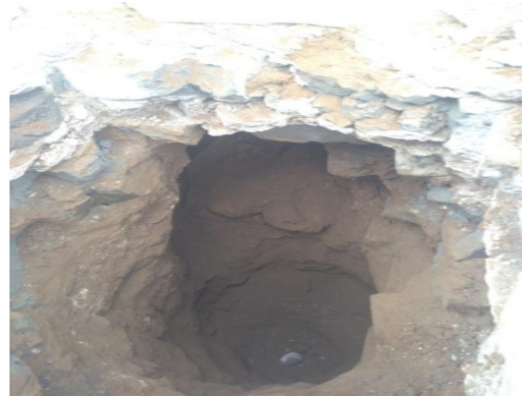
Figure 9 Hole in the Sidewall of Exploration Well t5

The exploration well t5 is located in the southeast corner of the entire 21st horse wall. During the excavation process, there is a hole at a depth of about 1 meter. There is loose collapsing soil in the hole, the hole is about 0.5m high and extends about 2m to the northwest. See Figure 9 for details.
