Prospective Studies for the Implementation of a Remote Access Earthquake Damage Detection System for High-Rise Buildings in Romania

To cite this article: Claudiu-Sorin Dragomir *et al* 2019 *IOP Conf. Ser.: Earth Environ. Sci.* **221** 012036

Claudiu-Sorin Dragomir ^{1,3}, Iolanda-Gabriela Craifaleanu ^{1,2}, Daniela Dobre ^{1,2}, Emil-Sever Georgescu ¹

¹ National Institute for Research and Development URBAN-INCERC, Bucharest, Romania

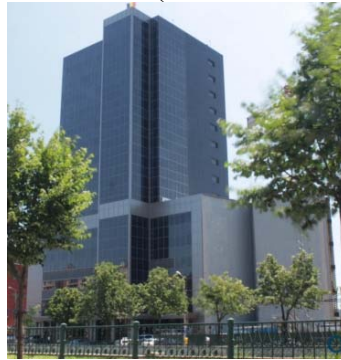
Figure 1. a) Office tower building

The Office tower building, from Bucharest, is situated on the Dambovită riverside and its height $H = 61$ m, figure 1a. A structural system with basement, ground floor, 15 levels and a technical floor, built in December 2008, which is one of the monitored buildings, figure 1b, figure 1c. In this case, the admissible values are distributed in a relatively large band of values and refer to an allowable level of vibration (17 ... 20 vibrars), the maximum instantaneous oscillation velocity of the soil (3 ... 25.4 mm/s), the maximum instantaneous oscillation velocity of the structure (8 ... 25.4 mm/s at ground level).

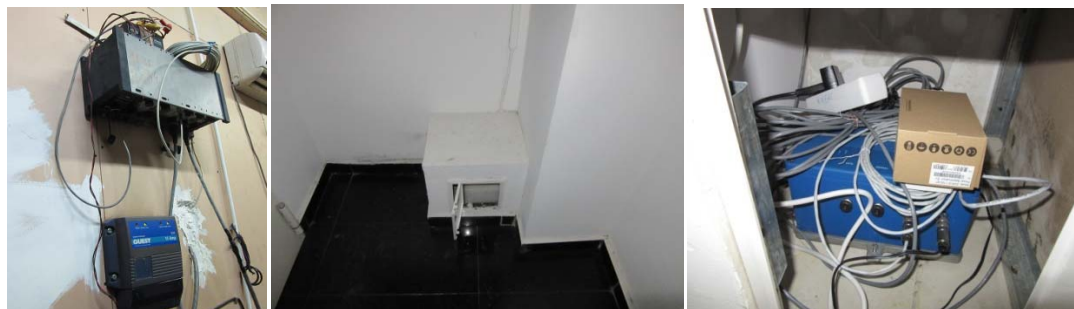
Figure 1.b) The GRANITE station installed with 3 sensors (at the top level, level 4 and basement) and a GMS18 GeoSIG station at the ground floor (which it will be removed further – figure 1.c)

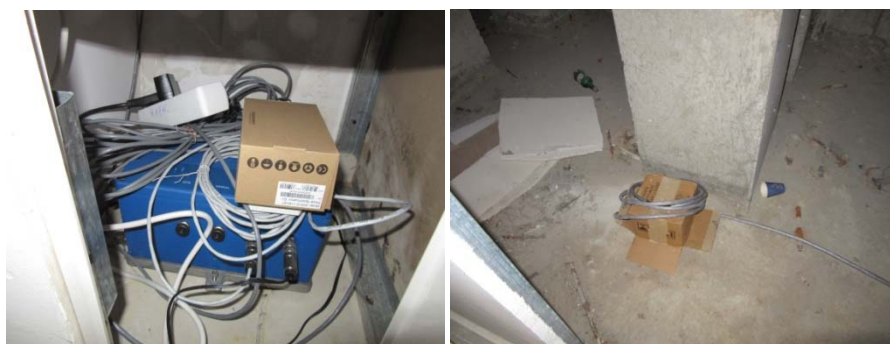
Figure 1.c) GMS18 GeoSIG station at the ground floor (left side) has been replaced with a triaxial sensor connected directly at the Granite multichannel station

Since February 2017, after this earthquake, the GMS18 GeoSIG station installed at the ground floor has been replaced with a triaxial sensor connected directly at the Granite multichannel station. From manual recordings for ambient vibrations, the maximum instantaneous values of the accelerations, velocities and displacements recorded with the three triaxial accelerometers on March 13, 2017, are shown in the following table and the graphical representations are attached, figure 6.

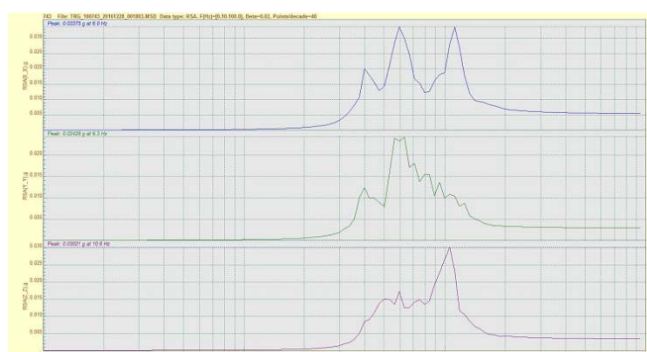
**Figure 4.** Acceleration Response Spectrum for X, Y and Z directions. Tripartite representation of acceleration, velocity and displacement spectra (channel 7)

- for the Vrancea seismic event of 28.12.2016, $M = 5.3$, records were made at this magnitude event, Table 3, and the response spectra in accelerations at ground floor and a tripartite representation of acceleration, velocity and displacement spectra are presented, figure 4.

Level	PGA (cm/s ²)	PGV (cm/s)	PGD (cm)
Ground floor – GMS18	5.31	0.13	0.004
Terrace-Granite	33.90	2.61	0.263
