Study on DC flashover characteristics of plastic sheds in small scale

Hui Liu ¹, Yang Zhang, Jinxia Yao, Ran Jia and Guoqing Ma

State Grid Shandong Electric Power Research Institute

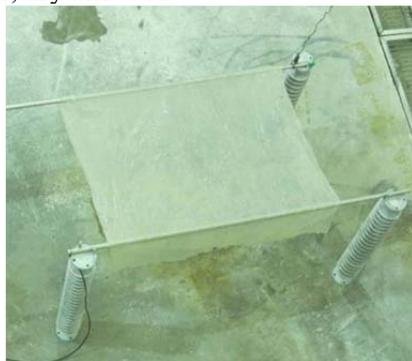
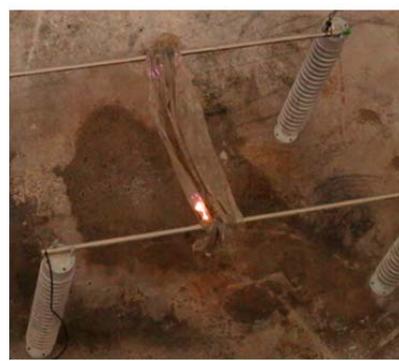
Figure 1. Plastic sheds in the experiment.

The DC electrode is two parallel steel pipes with a spacing of 1m. The plastic sheds is placed on the steel pipe(shown in Figure1). The width of the plastic sheds used in this article is 1.5m, and the length is equal to the pole distance.

(a) Tiled plastic sheds

(b) wrinkled plastic sheds

In the first step, tiled plastic shed at both ends of the electrode. The resistance of plastic shed was tested with a 2500V tramegger under the dry condition, and the result was infinity (supreme tramegger range). When a voltage of -70kV DC was applied, a noticeable corona was heard and no spark was seen.

A new sample was selected for experiment. The sample was first placed on both ends of the electrode and wetted with deionized water. The spray volume was 300mL. The wet plastic sheds was then tightened to make them wrinkled.

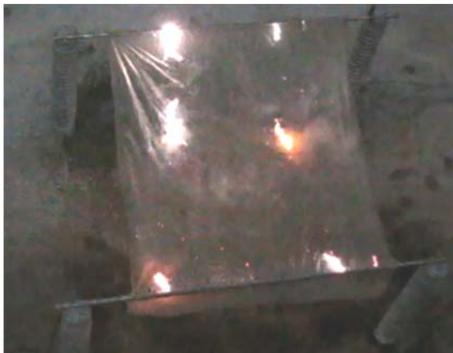
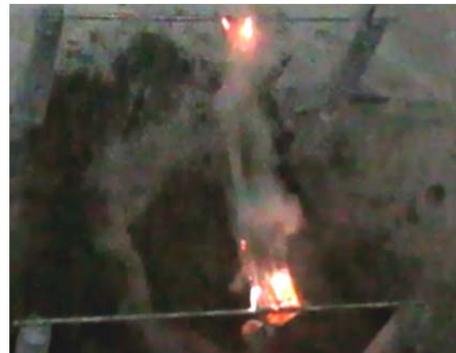
Figure 2. Plastic sheds flashover experiment with pole pitch of 1m.

During the experiment, the plastic shed near the poles first appears partial discharge, and the partial discharge develops to form a long partial arc. Finally the arc penetrates and flashover occurs.

The tiled plastic shed is extinguished after flashover, and there are less ablated holes. The wrinkled plastic shed continues to burn after flashover.

(a) Local arc of tiled plastic sheds

(b) Local arc of wrinkled plastic sheds

The average flashover voltage of tiled shed with 1m electrode distance is 121.8kV, and that of wrinkled shed with 1m electrode distance is 95.9kV.

For plastic shed with 1m electrode distance, the flashover voltage per meter of the wrinkled state is 21% lower than that of the tiled state. The wrinkled plastic shed is easier to flashover.

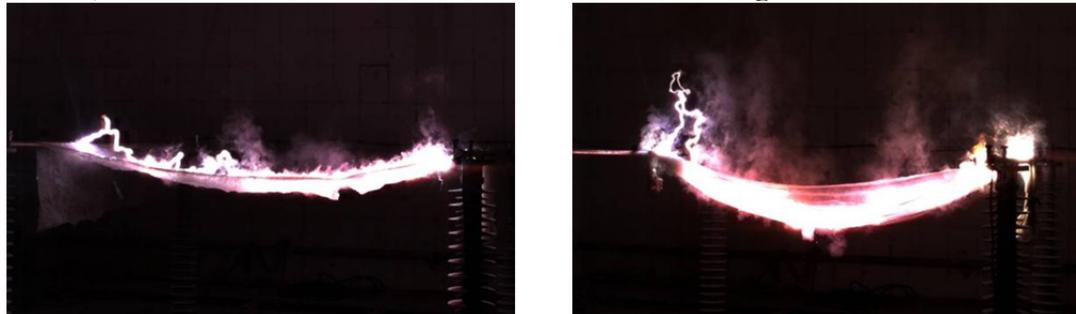
Figure 3. Plastic sheds flashover experiment with pole pitch of 2m.

For tiled plastic shed, it can be seen from Figure 3 (a) that during the experiment, the two electrodes first appeared partial discharge, then develop arc. The arc drifts away from the surface of

plastic shed. With the increase of voltage, the arc was connected, and finally formed a through discharge channel.

For wrinkled plastic shed, the flashover process was similar to the flat state as shown in Figure 3 (b), except that there was a slight arc at both ends of the electrode. Most of the arc channels were located inside the plastic cloth. As the arc was located inside the shed, the heat concentration was not easy to diffuse, and the shed continued to ablate after the arc was extinguished.

(a) Flashover of tiled plastic sheds

(b) Flashover of wrinkled plastic sheds

The average flashover voltage of the tiled plastic shed with a distance of 2m is 164kV, and the flashover voltage per meter is 82kV. The average flashover voltage of the wrinkled plastic shed with a distance of 2m is 139kV, and the flashover voltage per meter is 69.5kV.

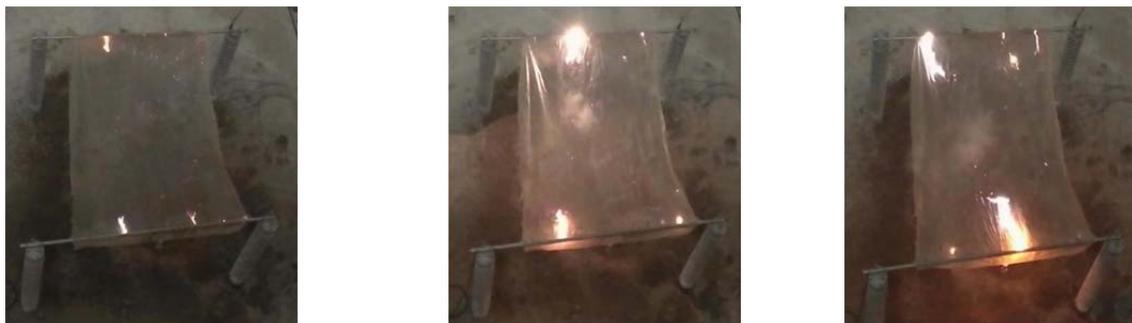
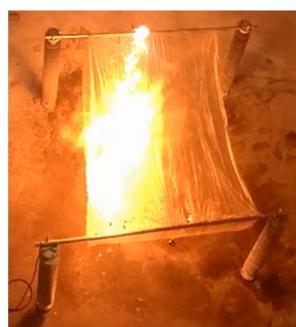
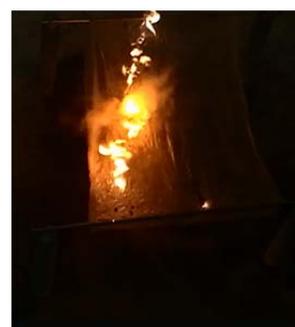
Figure 4. Plastic sheds flashover experiment with pole pitch of 2m (Top view).

(a) Partial discharge appearing

(b) Partial arcs forming

(c) Partial arc developing

(d) Flashover occurring

(e) Arcs extinction

The 2m plastic shed flashover experiment overlooking photo shows the whole process of DC flashover more intuitively.

In the first stage, as shown in Figure 4 (a), obvious partial discharge occurs and the partial discharge concentrates near the two electrodes.

In the second stage, as shown in Figure 4 (b), the number of partial discharge points increases and some intense partial discharges develop into small partial arcs.

In the third stage, as shown in Figure 4 (c), the local small arc develops and expands, and the arcs of the two electrodes develop simultaneously. The arc intensity (length, width, etc.) is similar. The arcs of the two electrodes gradually approach each other, and the arc distance decreases. It should be noted that for the strongest arc, the position of the arc is constantly changing with the formation of the dry zone, not fixed at a certain point, as can be seen from the comparison between Figure 4 (b) and Figure 4 (c).

In the fourth stage, as shown in Figure 4 (d), two electrodes arcs penetrate through, forming discharge channels and flashover. Corresponding to the previous stages, the final arc channel is not necessarily the location where partial discharge first occurs in the first stage, nor is it necessarily the location where the arc is most intense in the second or third stages.

In the fifth stage, as shown in Figure 4 (e), the arc goes away and the arc gradually dies out.
