Prior Seismic Performance Assessment for Building Community with High-Resolution Remote Sensing Images

To cite this article: Yongmei Zhai *et al* 2019 *IOP Conf. Ser.: Earth Environ. Sci.* **234** 012044

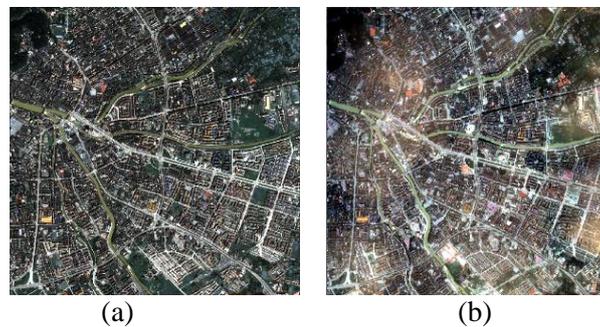
Figure 1. This is a Figure, it shows the remote sensing image of Dujiangyan area before and after the earthquake.

These high-resolution remote sensing images should be geometric registered and clipped before analysis.

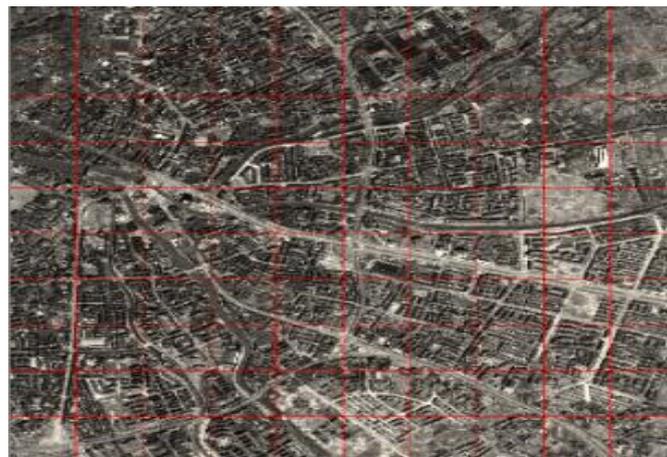
In order to improve the extraction accuracy, the original remote sensing images are further divided into 100 small sub-areas, and the buildings together with their shadows are extracted respectively in each sub-area. The schematic diagram of the partition is shown in Figure 2. The first part in the first row corresponds to sub-area 1, and the second part in the first row corresponds to sub-area 2, and so on.

Figure 2. This is a Figure, it shows the illustration of the partition diagram of the study area.

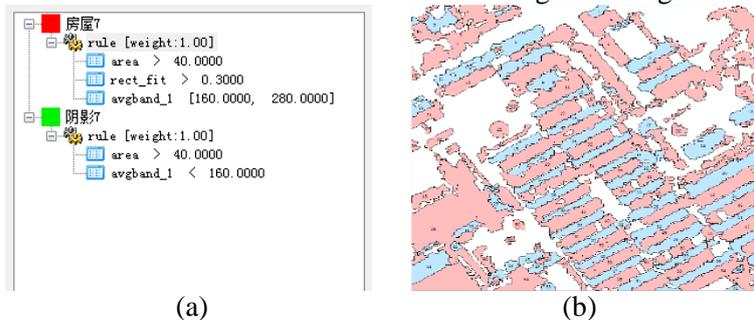
Figure 3. This is a Figure, it shows the classification rules and results of District 7.

The classification rules of different districts are different, it therefore, is necessary to classify object-oriented rules for different districts. Part of the district classification rules, corresponding attribute expression and the classification results was shown in Figure 3~ Figure 4.

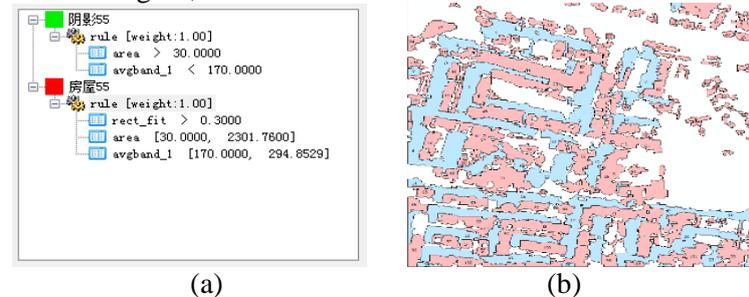
Figure 4. This is a Figure, it shows the classification rules and results of District 55.

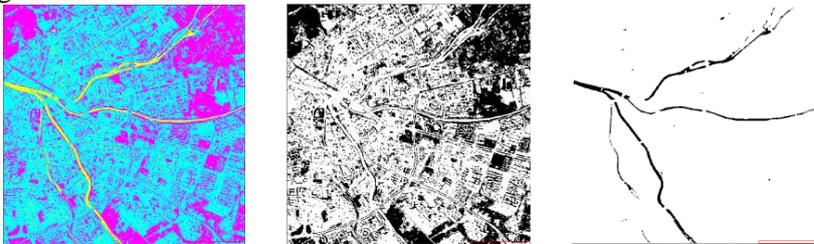
(a) The NDVI index image (b) Mask image of vegetation covered area (c) Mask image of rivers

Figure. 5. This is a Figure, it shows the process of building up the mask image of vegetation and rivers by using NDVI index image of Dujiangyan city.

A mask image of vegetation and rivers can be built up by using NDVI index, the process was shown in Figure 5.

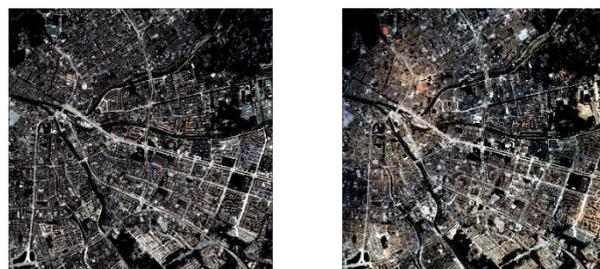
(a) Prior to the earthquake

(b) After the earthquake.

Figure.6. This is a Figure, it shows the image with the removal of the "non-building area" image prior to the earthquake and after the earthquake.

Thanks to the mask map applied to the remote sensing images obtained prior to and after the earthquake, distraction from non-priority areas can be removed such as vegetation covered area and river.(Figure 6.)

After the removal of the "non-building area", these first principal component images without noise are extracted by the principal component transformation technology, and it is enhanced linearly to highlight the image features. Finally, its results can be shown by the histogram explicitly.

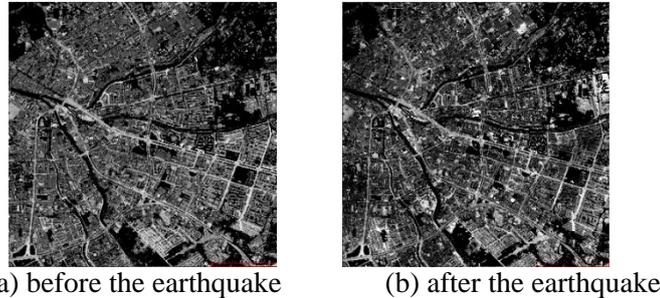
Figure.7. This is a Figure, it shows the image enhancement and gray matching before and after the earthquake.

After the image enhancement and gray matching, the grayscale of the images prior to and after the earthquake tend to be consistent, which indicates that the histogram matching is reliable. The matching image is shown in Figure 7.

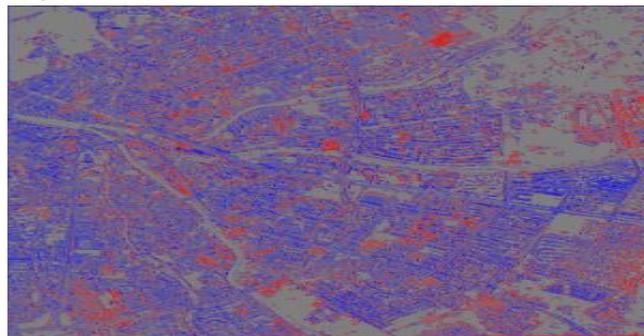
Figure.8. This is a Figure, it shows the result of differential method.

The improved differential method is used to calculate the image before and after earthquake, and the results are shown in Figure 8.

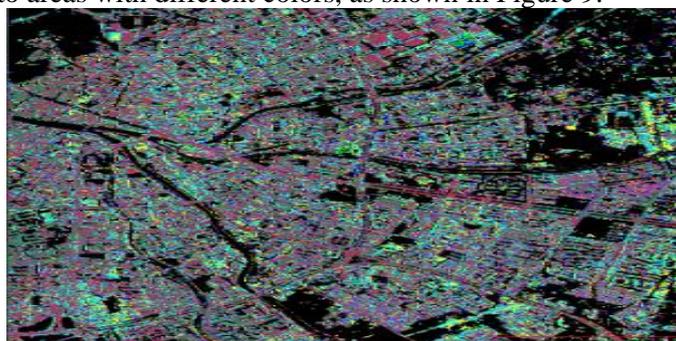
Figure.9. This is a Figure, it shows the thresholds-based division results by differential method.

Based on the selection of the 11 levels of the control thresholds, the result of differential method is divided by threshold into areas with different colors, as shown in Figure 9.

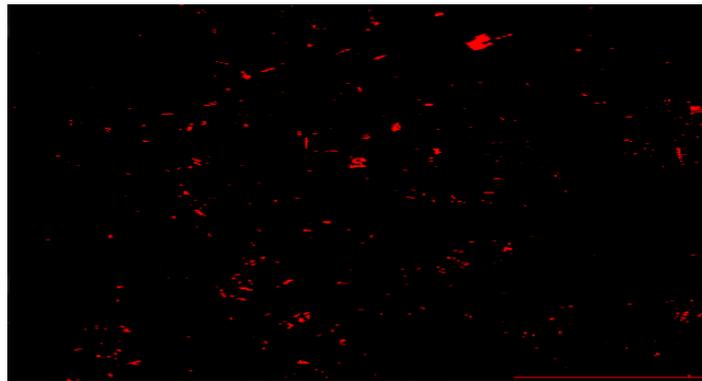
Figure.10. This is a Figure, it shows the extraction result of collapsed buildings.

Through visual interpretation, taking the threshold value 40% as the control range, the ratio of the difference greater than 40% is considered as the collapsed building in the earthquake. The classified image of collapsed buildings was extracted and then analyzed by Majority Element Algorithm, if the “set” pixel of certain threshold value range was extracted, the total area of collapsed buildings was calculated to be 86732.8m², as shown in Figure 10.

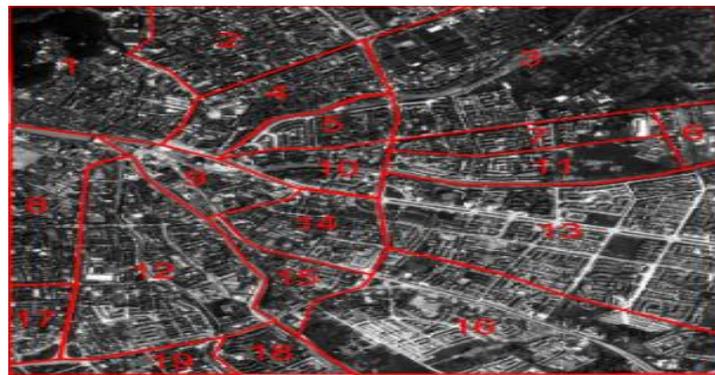
Figure.11. This is a Figure, it shows the division of the districts of Dujiangyan.

The blocks of Dujiangyan are divided into districts, as shown in Figure 11.

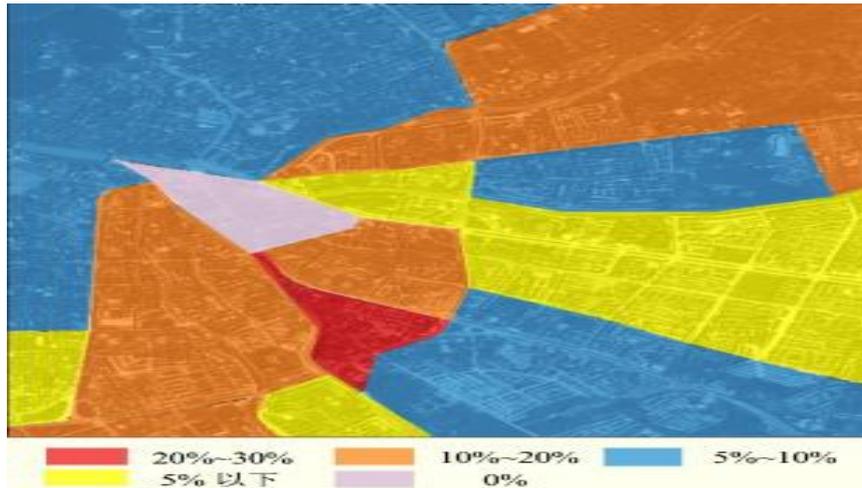
Figure.12. This is a Figure, it shows the colored graph of collapse rate.

The collapse rate of the buildings for post-earthquake assessment is displayed by the 2-D image, as shown in Figure 12.
