Classification of the technical condition of steel arch supports in dog headings with a long-term service life

G Dyduch

Silesian University of Technology, Faculty of Mining and Geology, 2 Akademicka Street, 44-100 Gliwice, Poland

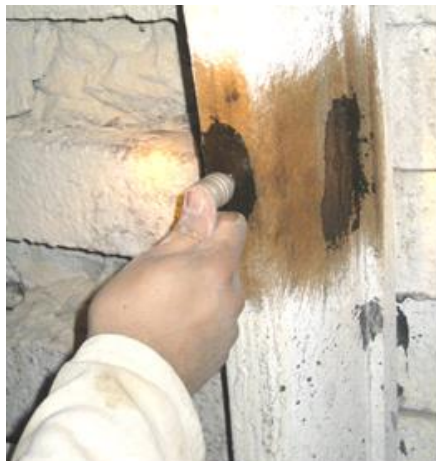
Figure 2. An example of thickness measurement of a section wall performed "in situ".

Determination of the degree of corrosion of individual elements of steel arch supports included a measurement of their thickness in the underground conditions. The tests were performed by ultrasonic echo method, with the use of SONO M610 ultrasonic thickness gauge by Metrison [1, 6, 7]

Measurements of individual arches were usually performed on both curves, usually in three places - at a distance of about 0.5 (so-called bottom measurement), about 1.25 m (so-called middle measurement) and about 2.0 m (so-called upper measurement) from the floor of the excavation (figure 1). Each time, the wall thickness of the right arm (RP), bottom (DN) and left arm (RL) was determined. (figure 2, figure 3).

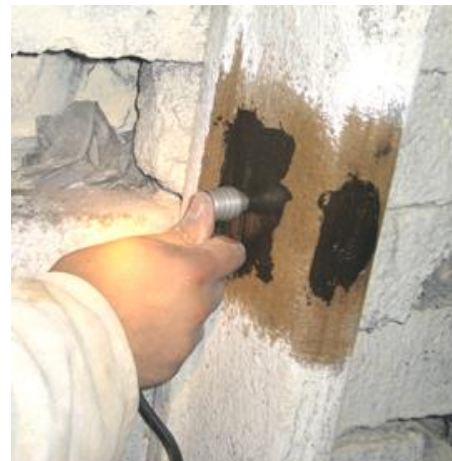
Figure 3. An example of thickness measurement of a section bottom performed "in situ".
