## Shear test of the rectangular beam on the new to old concrete interface based on Digital Image Correlation

To cite this article: Yu Liang *et al* 2019 *IOP Conf. Ser.: Earth Environ. Sci.* **267** 032058

Yu Liang<sup>1,2</sup>, Zhang Lei<sup>2\*</sup>, Lei Dong<sup>1</sup>, Chen bo<sup>3</sup>

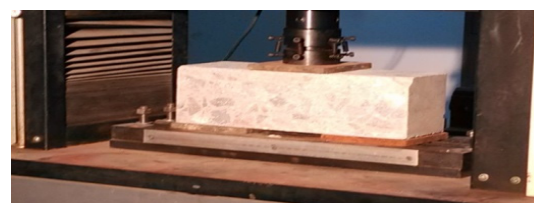
The test scheme was shown in Figure 2. Three steel plates were placed on the upper and lower parts of the specimen, respectively, for fixing, and the instrument pressure head exerts the same force on the specimen. In this paper, the Digital Image Correlation (DIC) was used to measure the strain field distribution at the meso-scale during the concrete shear failure process. The technology is a modern and optical method for non-contact and high-precision measurement of mechanical field deformation. Its principle can be summarized as follows: through image correlation matching, the speckle (random dot mark) image on the specimen surface is analyzed before and after the deformation to track the motion of these geometric points to get the deformation field. On the basis of this, the strain field is obtained by calculation. In order to get enough data, the time interval of digital image data acquisition was set to 10s and the image analysis was performed every 10s. The specific loading conditions of the test instrument were as follows:

(a) Force diagram of specimens

(b) Testing field diagram

Figure 2. Traditional rectangular beam shear test

Step1: The test entered the step2 when the displacement velocity was equal to 5mm/min or the loading was equal to 0.3kN.

Step2: The displacement velocity was controlled in 0.05mm/min, until the specimen was cracked.

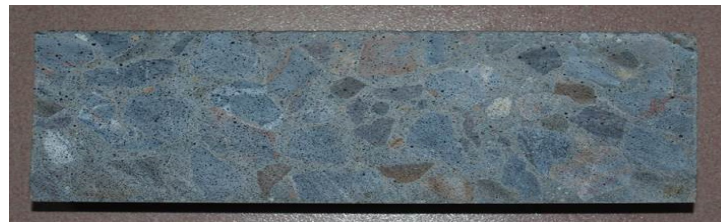
(1) Cut the surface of concrete specimen to be measured with depth of 1 cm to expose the interface and internal micro morphology of the aggregate layer.

(2) Clean the surface of the specimen to keep it smooth.

(3) Spray paint on specimen surface after it was cleaned up. Raise the spray can to make the specimen surface evenly painted and ensure that there are black paint spots all over the specimen surface so that the high-speed camera can perform data positioning and analysis more accurately.

Figure 5. Surfaces after cutting and spraying

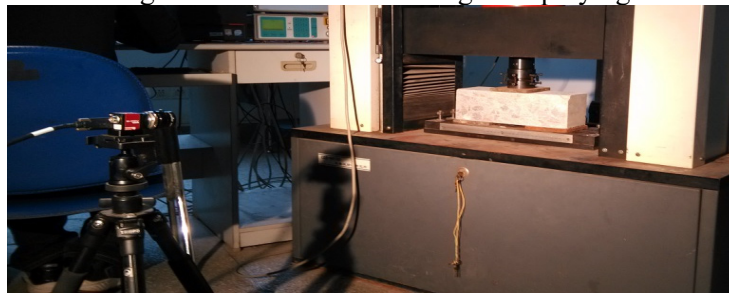
Due to special requirements of DIC for light source and surface roughness of the measured object, outer surface of the concrete edge should be removed before shearing test, so as to show the internal micro morphology as natural speckle field to be measured by DIC. The high resolution industrial CCD was used for surface image acquisition. Specific operation is as follows:

Figure 6. Test instrument of DIC
