Safety Performance Assessment Strategies of P91 Steel Based on Leeb Hardness

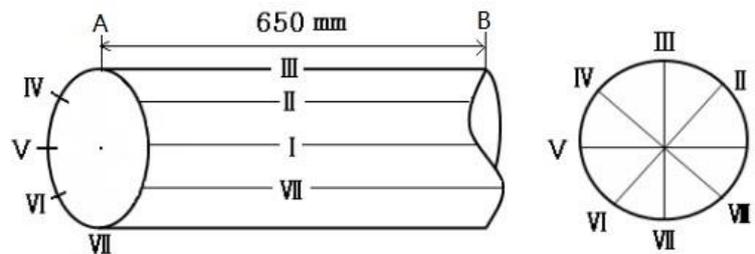
Figure 1. Schematic diagram of hardness testing position.

The pipe segment is divided into eight equal parts along the radial direction from the outer surface, and the bisectors are marked from I to VIII, as shown in figure 1. The surface hardness at different locations is measured by Leeb hardness tester after grinding, as shown in table 1. The pipe is cut along lines II and VI to measure the hardness at different positions in the axial section. The results are shown in table 2. It can be seen from the tables that the minimum hardness of the section is 112 HBHLD, and the hardness distribution along the thickness direction is uniform on the axial section, while the hardness of the inner surface is slightly higher than that of the outer surface.

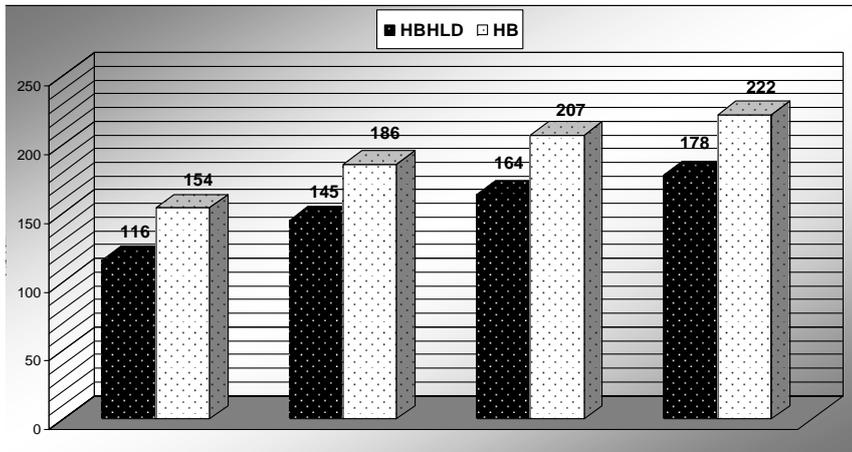
Figure 2. Comparison between HBHLD and HB.

For P91 steel, the experimental results show that the hardness HBHLD measured by portable Leeb hardness tester is about 40 lower in value than the hardness HB measured by desktop Brinell hardness tester, as shown in figure 2.

P91 is a high-alloy steel, so it is necessary to find out the corresponding relationship between HBHLD hardness converted by Leeb hardness and Brinell hardness in order to accurately measure the true hardness of P91 steel. For P91 steel, experimental results show that the HBHLD hardness measured by portable Leeb hardness tester is about 40 lower than that measured by desktop Brinell hardness tester, as shown in figure 2. Considering that the measurement results of Leeb hardness are influenced by the surface state of materials and the direction of testing, it is reasonable that HBHLD is 35 lower in value than HB. That is 145 HBHLD is equivalent to 180 HB, 125 HBHLD is equivalent to 160 HB.

When testing the hardness of P91 steel with portable Leeb hardness tester, the deviation between the Brinell hardness converted from Leeb hardness (in HBHLD) and the hardness measured by desktop Brinell hardness tester (in HB) must be fully taken into account. That is, the former is about 40 less than the latter in value.

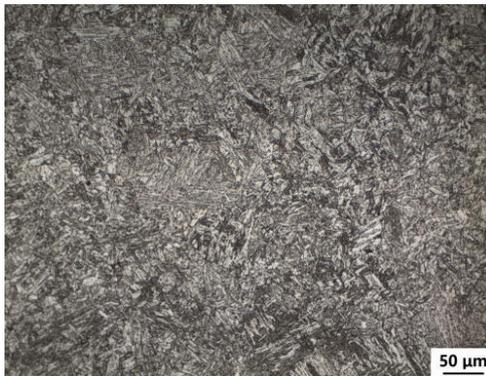
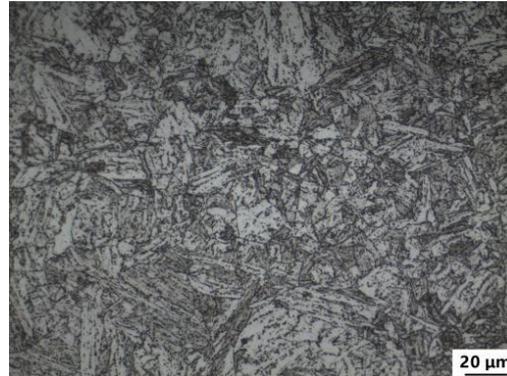
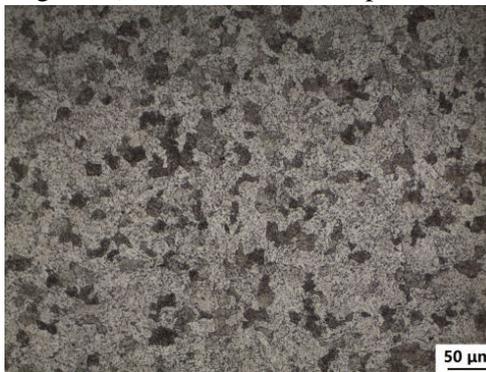
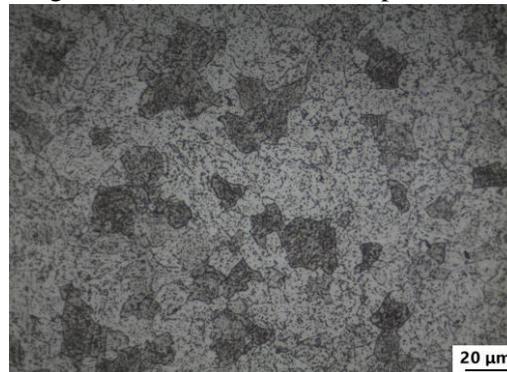
Metallographic photographs of 178 HBHLD and 116 HBHLD samples at different magnification are shown in figure 3. It can be seen from that the sample with 178 HBHLD hardness has typical tempered martensite structure. Grain boundary of the original austenite is visible. The grain size of the austenite is about 30 micron. There are several black and white slabs in the original austenite grain, and the fine structure of the slab is obvious. However, the metallographic structure of 116 HBHLD sample has almost no tempered martensite morphology. Its structure is identified as tempered sorbite after careful analysis.

Figure 3(a). 178 HBHLD sample $\times 200$

Figure 3(b). 178 HBHLD sample $\times 500$

Figure 3(c). 116 HBHLD sample $\times 200$

Figure 3(d). 116 HBHLD sample $\times 500$

For P91 steel, reasonable heat treatment process is the key to ensure its best strength and toughness. If the tempering temperature and time are not properly controlled, the high temperature recovery can be completed, which means the overtempering has occurred. Thus, the size of sub-crystalline block grows up, martensite lath merges and widens, dislocation density decreases greatly, carbide particles precipitate and grow along grain boundary and lath boundary, and even a large number of massive ferrite appears, which will lead to abnormal microstructures of P91 steel, and sharp decrease in hardness, mechanical properties and creep strength^[1,4]. The microstructures of 116 HBHLD samples have almost no the typical morphology of tempered martensite, as shown in figure 3. The precipitated phase particles have obviously matured, as shown in figure 4. So their room temperature strength is much lower than the standard requirements, as shown in table 4. Some studies have shown that the room temperature mechanical properties of P91 steel with 180 HB hardness can meet the requirements of the standard at the lower limit, and the high temperature properties also decrease greatly compared with that of 223HB, while the durability of 100,000 hours is equivalent to the recommended values of the standard. However, the mechanical properties of P91 steel with 160 HB hardness have been

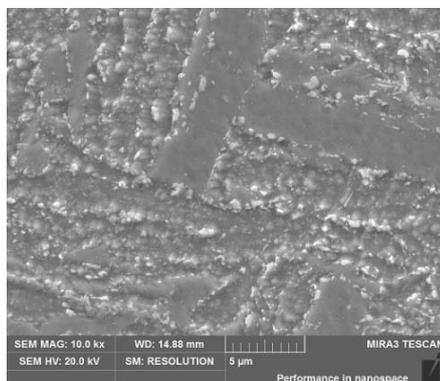
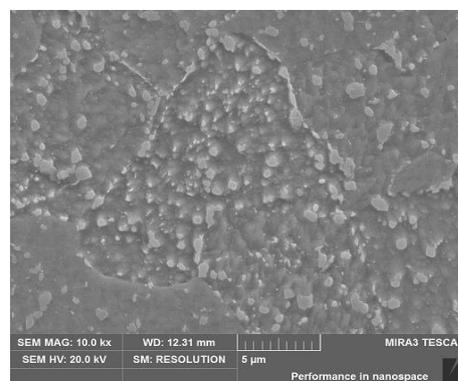
Figure 4(a). 178 HBHLD sample

Figure 4(b). 116 HBHLD sample

The scanning electron microscopic photographs of 178 HBHLD and 116 HBHLD samples are shown in figure 4. It can be seen from the figure that the average diameter of precipitated phase particles in 178 HBHLD samples is about 0.2 micron, while that in 116 HBHLD samples is about 0.5 micron. The precipitated phase has obviously coarsened in the 116 HBHLD samples.
