## Technical inspection of high strength bolts in hydropower plant: nondestructive examination

Wenbo Li<sup>1</sup>, Lanlan Liu<sup>2</sup>, Yusen Wang<sup>3</sup>, Junjun Chen<sup>1</sup>, Yi Xie<sup>1</sup>, Jiarui Hu<sup>1</sup>,  
Lipeng Sun<sup>1</sup>, Yi Long<sup>1</sup>

<sup>1</sup>State grid hunan electric power company limited research institute, Changsha, Hunan, 41007, China

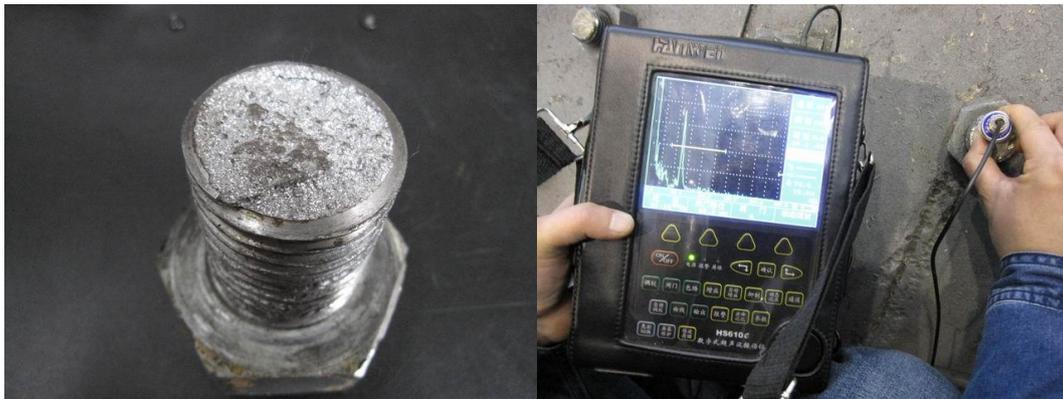
During UT inspection of bolts, it was found that there was crack reflection echo at 74mm of the upper thread buckle of rotor magnetic yoke tightening bolt #96, and the bottom wave was completely covered. The bolt was completely broken during pulling out of the tightening screw. It was observed from the section that the crack originated at the root of the thread and extended to the 1/2 radius (Figure 3).

Figure 3. The tension bolt of rotor magnetic yoke is broken.

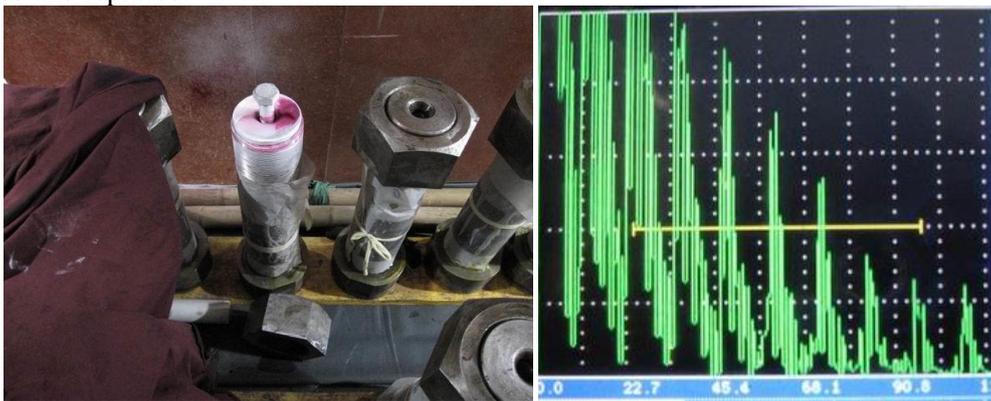
The connecting bolt of generator shaft is used to connect the large shaft of generator with the lower broken shaft. It was found that the coupling bolts of the generator were found to have excessive defects (stratification) during UT inspection, as shown in Figure 4, which was determined to be unqualified and replaced.

Figure 4. Stratified defect of generator coupling bolt.

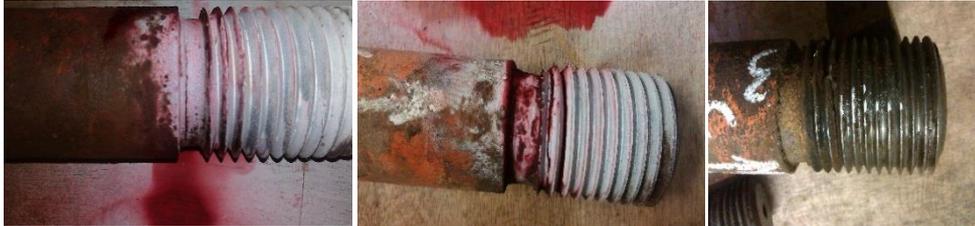
The bolt of top cover setting ring will be closed on the setting ring, which is the bolt with the highest bearing stress in the hydrogenerator set. The direct cause of the accident in the flooded workshop of the Sayang hydropower plant in Russia was that the bolt of the top cover setting ring fell off or broke, which led to the damage of the unit and the serious accident in the flooded workshop. During the maintenance of a unit, all the bolts of the top cover sitting ring of the unit were penetrated 56 bolts in total. It was found to have cracks at the root of the thread (Figure 6) through penetrating. The cracks were all distributed at the stress concentration at the root of the thread.

Figure 6. Penetration detection of hold-down bolts with cover setting ring.
