## Girder crack of concrete single pylon cable-stayed bridge

**Abstract.** Taking the reinforcement and maintenance project of a concrete cable-stayed bridge as the background, aiming at the stress cracks on the web of the box girder of the main bridge after several years of operation, starting from the actual situation of design and construction, the integral calculation model of the bridge is established by Midas Civil and the local analysis and calculation model of the main girder is established by the general finite element software. Four kinds of analysis and calculation models are analyzed. Finally, it is shown that the web cracks of the bridge are caused by the cable tension when the bridge is cantilevered. On this basis, the concrete and feasible bonded steel plate method is proposed to repair and strengthen the cracks, which is of certain reference significance for the reinforcement and maintenance of the same type of bridge cracks in the future.

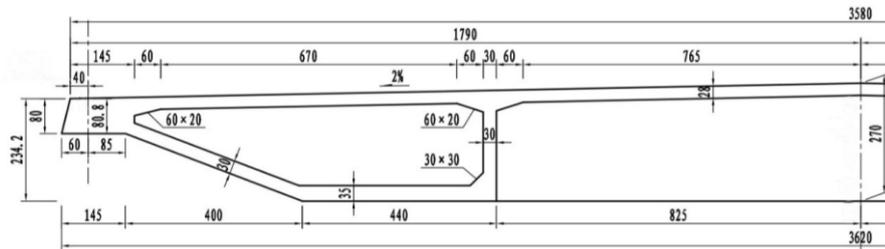
Figure 1. Half-size of the main bridge box girder.(Unit: cm)

The main girder is a prestressing concrete separated box girder with 35.8m top width, 36.2m top air nozzle width, 2% cross slope, 2.342-2.7m beam height and 3.2m tower root beam height. The thickness of single box roof is 28 cm, the width of bottom plate is 4.4 m, the thickness of bottom plate is 35 cm, the root of tower is increased to 65 cm, the inclined web thickness is 30 cm, the root of tower is increased to 60 cm, the web thickness is 30 cm, and the root of tower is increased to 60 cm. The distance between the boxes is 16.5m.

Cross beam: along the bridge, according to the distance between the cables, a cross beam is set between the ribs of the main beam. The width of the common cross beam is 0.4m, the width of the cross beam at the connection of the tower and the beam is 6.0m, and the width of the cross beam at the end of the main span is 1.6m. The width of common cross beam in cast-in-situ section of side span is 1.2m, that of auxiliary pier top cross beam is 1.2m and that of side span end cross beam is 3.5m. The crossbeams are all pre-stressed concrete structures.

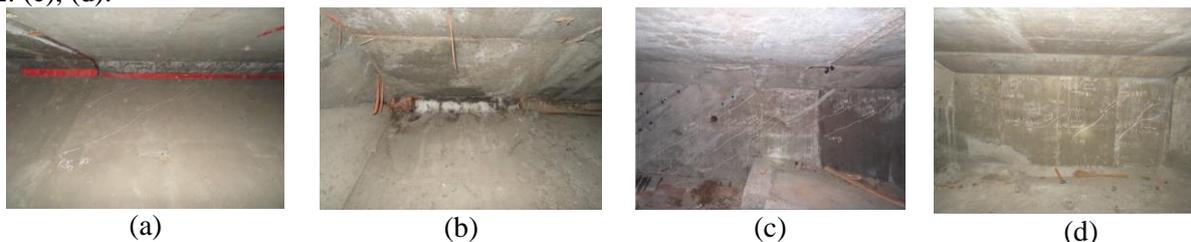
Figure 2. Typical crack diagram of the box girder web.

There are generally stress cracks in the inside of the inclined web, mainly shear cracks in the inclined web, but all cracks have not crossed the construction cracks after checking. Only a few cracks have been found in the outside of the web due to the coating layer. There are 62 cracks in the inclined web. There are seepage paste in individual cracks. The typical crack pictures are shown in Figure 2. (a), (b).

There are local stress cracks in the straight web, but the cracks are relatively concentrated and mainly shear cracks, a total of 46 cracks in the straight web. Typical fracture photographs are shown in Figure 2. (c), (d).

(2) Local high stress zones appear in the webs of the bridge after cable tension under cantilever condition during construction stage, which exceed or approach the standard value of tensile strength of concrete. If the strength of concrete does not meet the requirements during tension, cracks may occur inside and outside the inclined webs or straight webs, and cracks may extend to the roof.

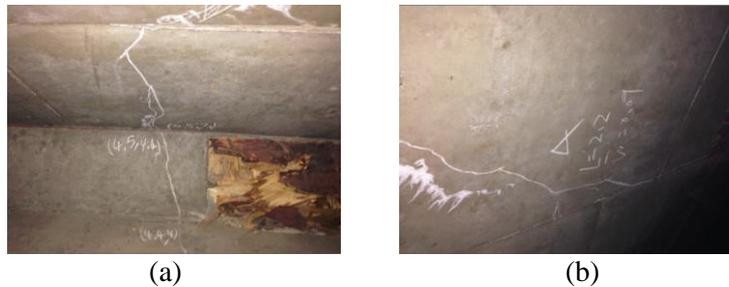
Figure 3. Typical crack diagram at the bottom of the box girder roof.

There are 62 cracks on the bottom of the roof, and most of them are connected with the cracks on the inclined web. Most of them have the phenomenon of seepage and paste. There are 62 cracks on the bottom of the roof, and serious corrosion of bars is found. Typical fracture photographs are shown in Figure 3.(a), (b).

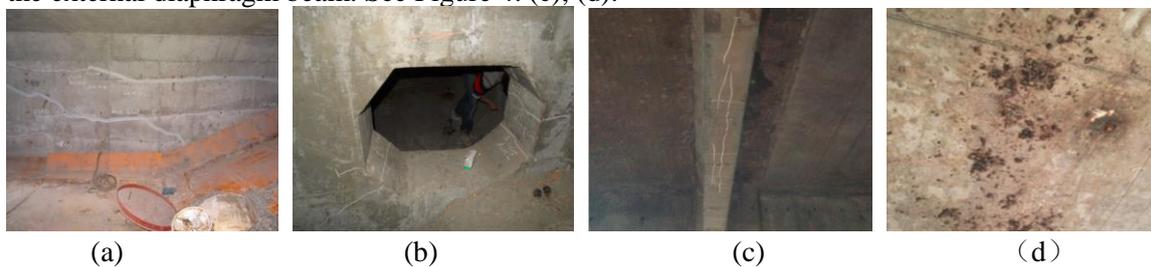
Figure 4. Typical crack diagram of the box girder diaphragm.

**3.3.1. Inner diaphragm of box girder.** There are 8 transverse cracks in the diaphragm beam at the pylon position. There are 74 vertical cracks in the conventional diaphragm beam part of the manhole position along the intersection of the section. Typical cracks are shown in Figure 4. (a), (b).

**3.3.2. Outer diaphragm of box girder.** The external diaphragm beam is a pre-stressed concrete structure. There are 16 transverse and longitudinal stress cracks at the bottom of individual external diaphragm beams, and there are local pockmarks, inclusion garbage, water seepage and whitening at the bottom of the external diaphragm beam. See Figure 4. (c), (d).

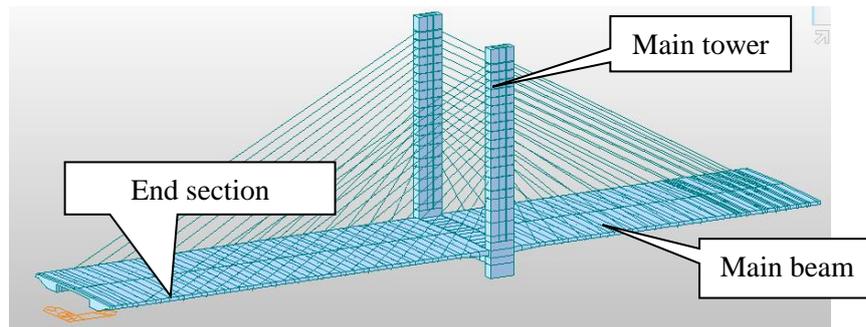
Figure 5. model of the rod system.

The finite element model is established by Midas finite element program, in which the girder element is used for the main girder and the main tower, and the cable element is simulated by truss element. There are 377 beam elements and 60 truss elements. The model diagram is shown in the Figure 5.

The load is taken from the design load, and the coefficient of increase of dead load is taken into account. The selection of cable force in construction stage and construction conditions are carried out according to the completed drawings.

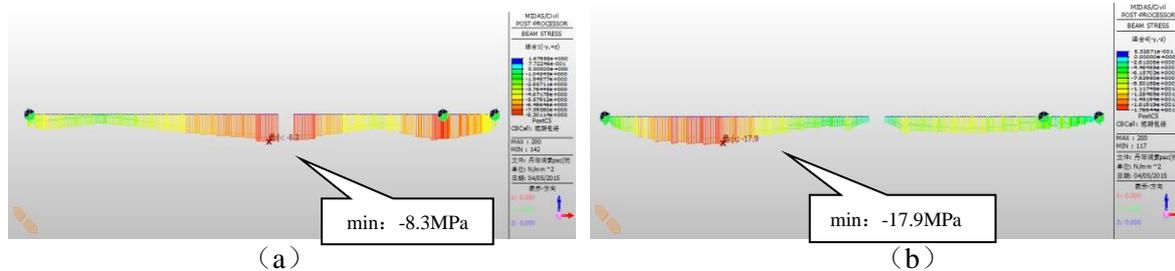
Figure 6. Short-term stress envelope diagram (unit: MPa)

Through calculation, the upper and lower edge stresses of the superstructure under short-term envelope condition are shown in Figure 6.

From the stress envelope of upper and lower edges, it can be seen that there is no tension stress in the box girder in use stage, the whole section is in compression state, and the maximum compressive stress is 17.9 MPa, that is to say, normal use meets the requirements of the code.

(1) When the bridge is analyzed as a whole under the original design condition, there is no tension stress in the box girder in the normal service stage, and the whole section is in the compression state, which meets the requirements of the code.

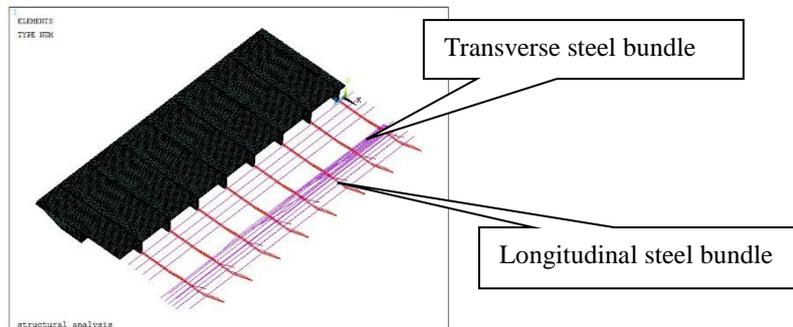
Figure 7. Schematic diagram of the mixed model unit

4.2.1. Modeling. The model is established by large-scale general finite element software. Solid45 element is used for solid element and Link8 element is used for strand. Eight blocks of main span are selected for analysis. The truncation position of blocks is loaded according to the measured internal force, and the anchorage zone of blocks is loaded according to the actual cable force. The model diagram is shown in Figure 7.

4.2.2. *Analysis.* According to the typical stage of bridge construction and use, the analysis is divided into four working conditions: cantilever casting condition, completed bridge condition, live load single working condition and constant live load overlapping working condition.
