Assessing shoreline response to three submerged breakwaters at Kerteh Bay, Terengganu, Malaysia using Landsat imagery

Abstract. As part of a project to determine the exact structural and environmental parameters governing the mode and magnitude of salient formation behind a submerged breakwater, a remote sensing technique is being adopted to assess the extent of erosion/accretion at Kerteh Bay, Terengganu, Malaysia. Multi-temporal Landsat satellite images of coarse resolution for the years of 1994, 2000, 2006, 2009 and 2012 were acquired for this purpose. The images were subsets divided into smaller areas of interest and classified using supervised classification of support vector machine. The classified image is then vectorized to extract shoreline based on waterline in each of the subset rasters images. Tidal correction were adopted to correct the waterline/shoreline to the mean sea level (MSL) datum. Comparison of corrected shorelines was carried to obtain the extent of erosion/accretion at the Kerteh Bay, Terengganu, Malaysia. It was observed that substantial accretion was observed between the years 1994-2006 at the upper part of the study area, the part between northern part

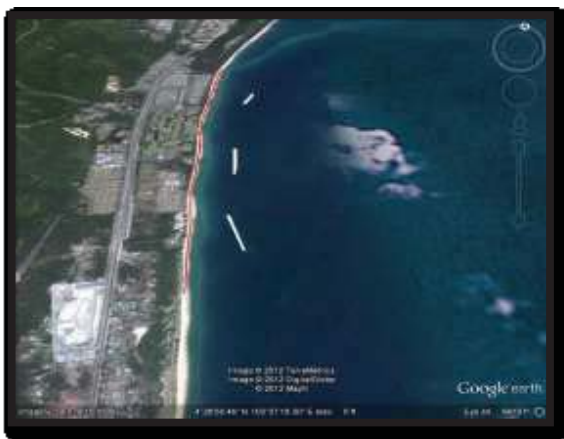
Figures 1: Survey path.

Total station method of survey has been in place for quite a while. It is method of survey that involves the use of total station equipment to perform survey. In this field work, it was used to carry out beach profile survey, among the parameters that total station measures are angles, both vertical and horizontal angle and also distances, both slopes distances and horizontal distances. These parameters were adopted to compute the elevation at each point on each profile line. Figure 1 show the survey path followed with respect the SBWs installed, total of 2.6 kilometres was survey.

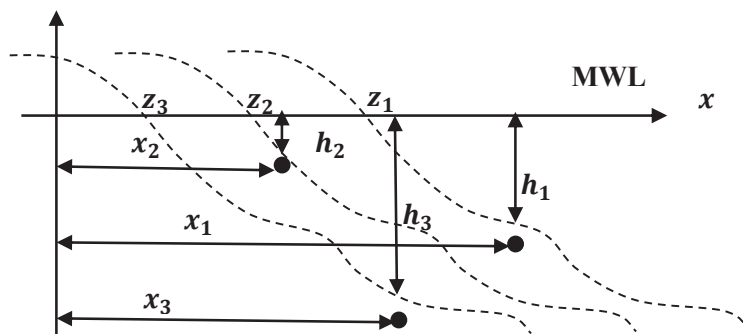
level (MSL) is based on the concept of one-line model for shoreline evolution and called one-line shift method (OSM). It is assumed that beach moves offshore or onshore with one bottom profiles. Fig 3 shows three beach profiles at three different times: t_i ($i = 1, 2, 3$). At time t_i , the waterline is located at x_i , away from the origin of the transformed coordinates, the corresponding water depth is h_i above or below MSL. When the sea surface is at MSL, the MSL-datum-based shoreline is located at z_i away from the origin. Figure 3 illustrates an example of a beach profile moving from the right to the left.

Figure 3: Beach profiles at three different times and symbolic notation.

If the extracted waterline from satellites images at time t_2 and t_3 are located at x_2 and x_3 , respectively, $x_3 > x_2$. Extracted waterline without consideration of tidal effect imply that the beach moves from left to the right. This inference conflicts with assumption for Figure 3 shifting the extracted waterlines to the MSL-datum-based shoreline position is necessary to accurately estimate the beach movement.

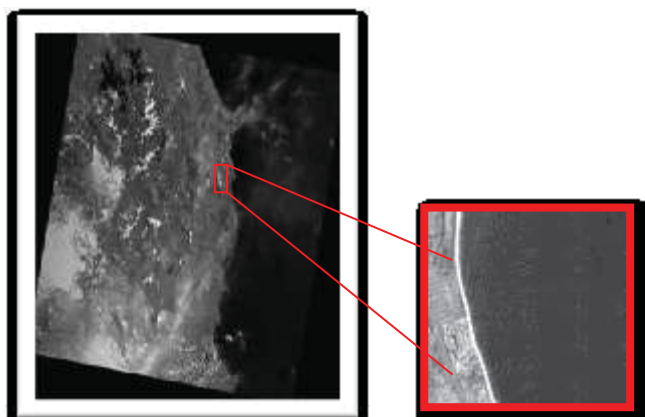
Figure 4: Showing sub-setting of unprocessed image.

As stated in Section 2, Landsat multi-temporal images of the study area with 15 m spatial resolution were acquired. These images are 15 m resolution of panchromatic form. Figure 4 shows the unprocessed image. Three images each were acquired for the years 1994, 2000, 2004, 2009 and 2012. The three images in a year were required for the purpose of correcting tides for each year. Using the OSM method of tidal correction it is required to use images of a particular area taken at most six months apart, this will ensure the images used for the tidal correction are taken at a time when there is no or negligible change in bottom slope.

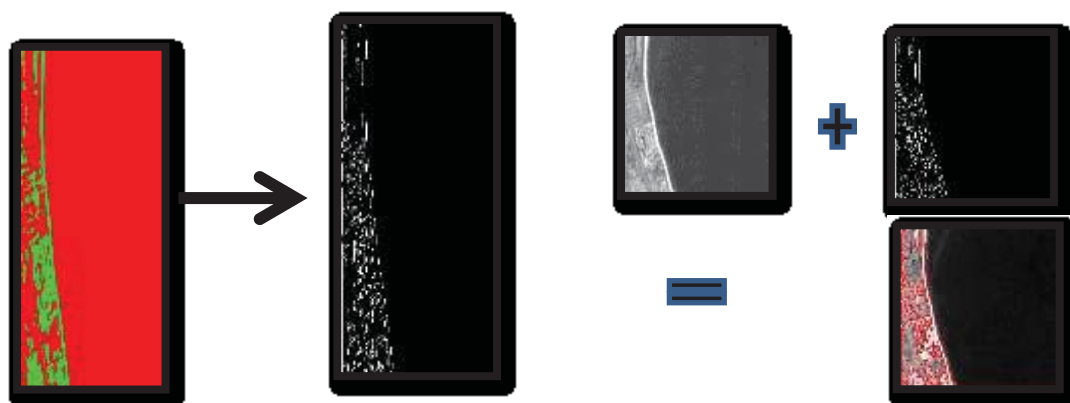
Figure 5: Vectorization of classified images and overlay of vector on raster image.

After the application of tidal correction using the OSM method, changes were evaluated using the overlaying method. This was performed in the ENVI 4.9 software. The graphic representation of this process is as shown in Figure 5.

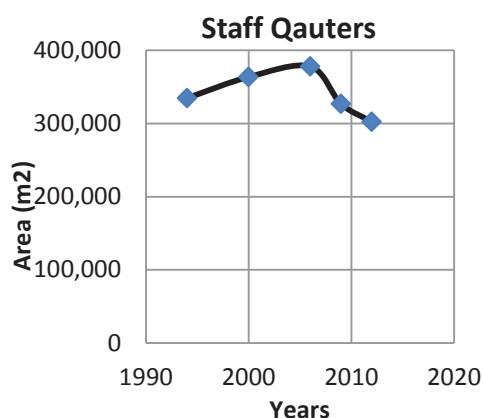
Figure 5: Showing erosion at the staff quarters.

It was found that accretion occurred at the Staff Quarters, which is the northern part of the study area between the years 1994-2000, the area affected by accretion can be about 28,800 m² of area. Between 2000-2006, there was also accretion at the same area but lesser intense than that of 1994-2000. The area affected was about 14,400 m². In the year 2009-2012 erosion of magnitude 51,075 m² were observed.

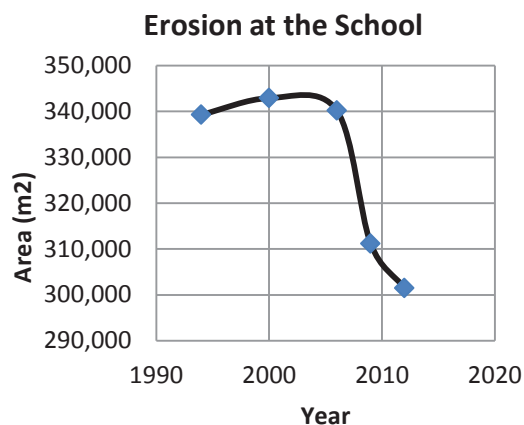
Figure 6: Showing erosion at the school.

In the school area, accretion was also noted between the years 1994-2000 covering an area of 3600 22 m² and unlike the other two areas (staff quarters and golf course) less erosion occurred between 2000-2006 covering an area of 2700 m². However, erosion during the years 2006-2009 and 2009-2012 were at higher rate with values of 29025 m² and 9675 m² respectively.

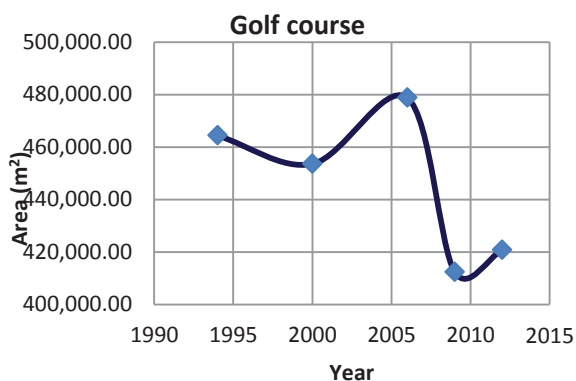
Figure 7: Showing erosion at the Golf course.

For Golf course area, between 1994-2000, lesser accretion was noted as compared to the Staff quarters area. The accretion covered an area about 10,800 m². At the Golf course area, accretion occurred between the years 2000-2006, covering an area 25,200 m². Excessive erosion occurred between 2006-2009 in this area. The magnitude of the erosion is about 66375 m². In the subsequent years 2009-2012 erosion of about 8235m² occurred.

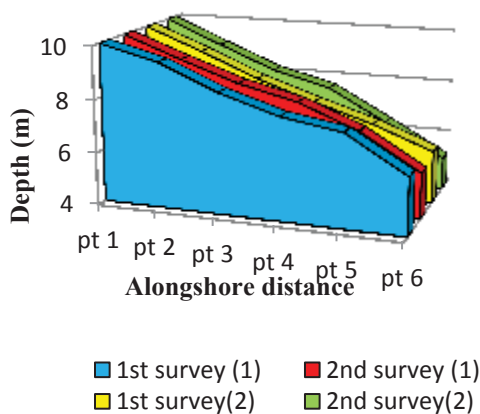
Figure 8: Plots of survey line 1 & 2 for 1st and 2nd survey

While Figures 8 and 9 shows plots of surveys line towards the southern part of the study area, Figure 10 shows plots of survey somewhere in between the southern part (school) and the northern part (staff quarters).

northern part of the study area and Figure 8 and 9 shows plots of profiles 1, 2, 3 and 4, which represent profile lines at the southern part of the study area. The erosion rate in the area between the northern part and the southern parts can be considered as moderate. More erosion was found in the northern part as compared to the southern part as depicted in Figure 10.

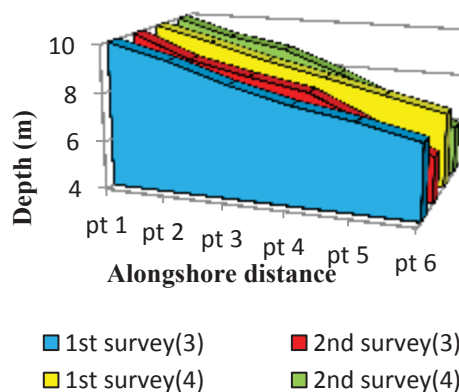
Figure 9: Plots of survey line 3 & 4 for 1st and 2nd survey

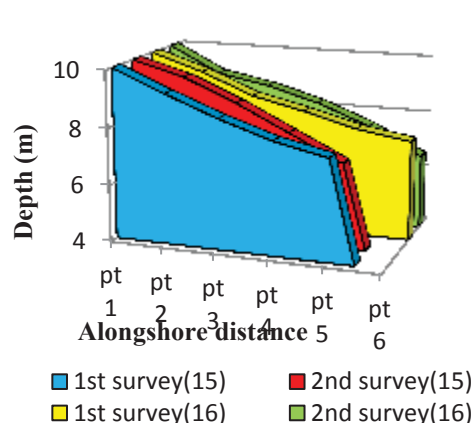
Figure 10: Plots of survey line 15 & 16 for 1st and 2nd survey

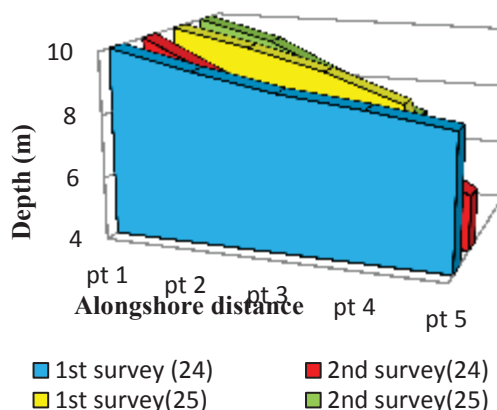
Figure 11: Plots of survey line 22 & 23 for 1st and 2nd survey

The second field trip revealed an alarming erosion rate that had occurred between the period of the first and second visit. Visual observation of the site reveals more erosion occurred at the northern part of the study area as compared to the southern part of the study area. Figures 11 and 12 indicate that more serious erosion occurred at the northern part as compared to the southern part. Figures 11 and 12 are plots of the profile lines 22, 23, 24 and 25, which represent survey lines at the

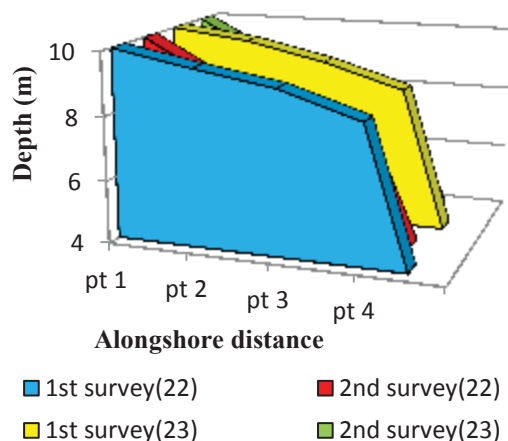
Figure 12: Plots of survey line 24 & 25 for 1st and 2nd survey

Figure 12 show plots representing line 22, 23, 24 and 25, these are the survey lines at the northern part of the study area, taken just in front of the staff quarters in the study area. To complement the graphical plots of the two surveys carried out on the study area, pictures were taken during the two surveys. A close look of the pictures amplifies the results obtainable from the plots of the surveys. Figures 13, shows pictures of the study area during the first survey and Figure 14 shows pictures of the study area during the second survey.
