## Reclamation of mosquito breeding sites using Landsat-8 remote sensing data: A case study of Birnin Kebbi, Nigeria

Danboyi Joseph Amusuk, Mazlan Hashim<sup>1</sup>, Amin Beiranvand Pour

Geoscience and Digital Earth Centre (Geo-DEC), Universiti Teknologi Malaysia

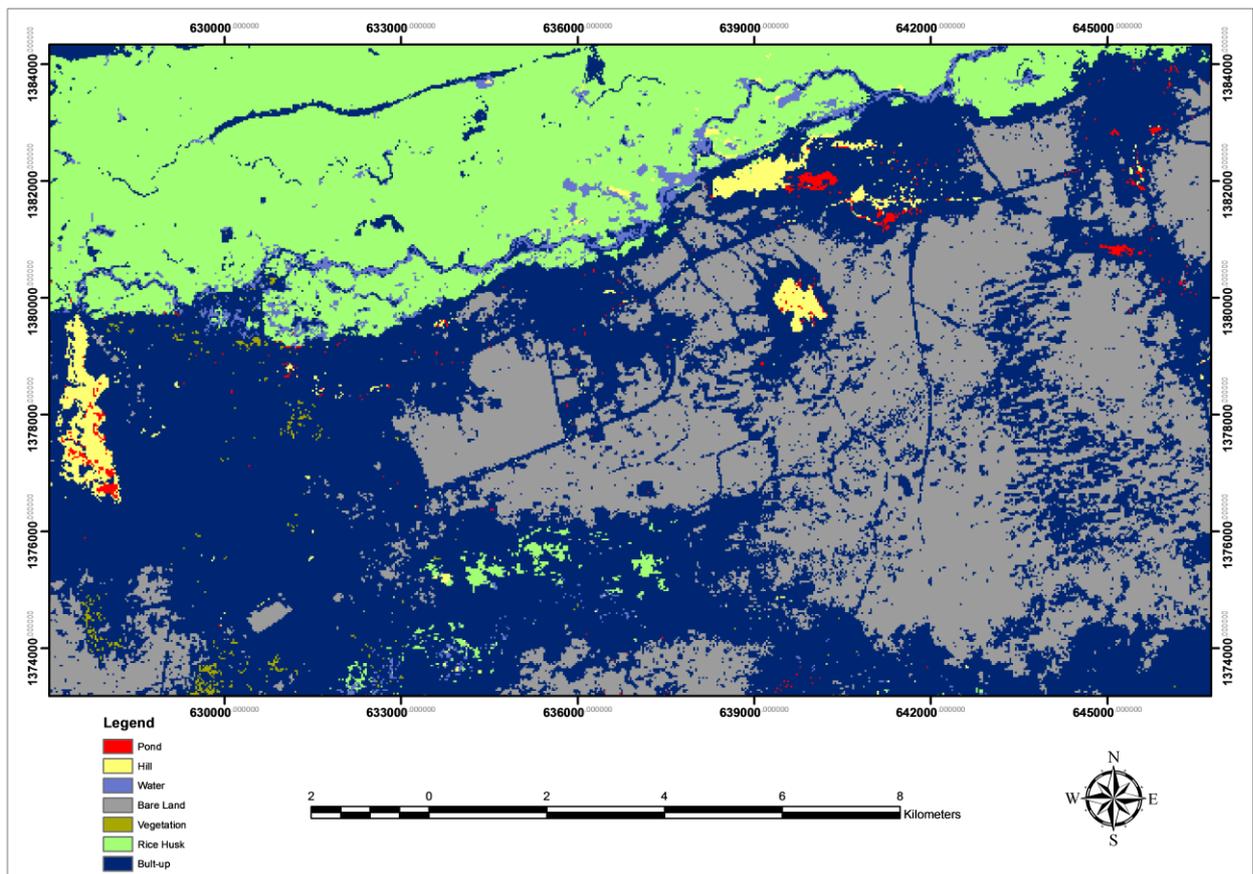
Figure 2 shows supervised classified image map for Birnin Kebbi city derived from Landsat-8. Variety of different information was extracted for the study area. Derelict ponds are appeared as red color in north-east, center and western segment of the scene. Most of the derelict ponds are located in residential (build up) areas. However, some of them are associated with hilly areas that appeared as yellow color. Several small derelict ponds were detected in residential area as red pixel especially western part of the image map. Rice husk appears light green color in the north part of the image. Residential (build up) region manifested as dark blue and bare land as gray pixels, which are distributed in central and southern segments of the image. Water body and river are depicted in light mauve hue.

**Figure 2.** Supervised classified image map of Birnin Kebbi city derived from Landsat 8 data.

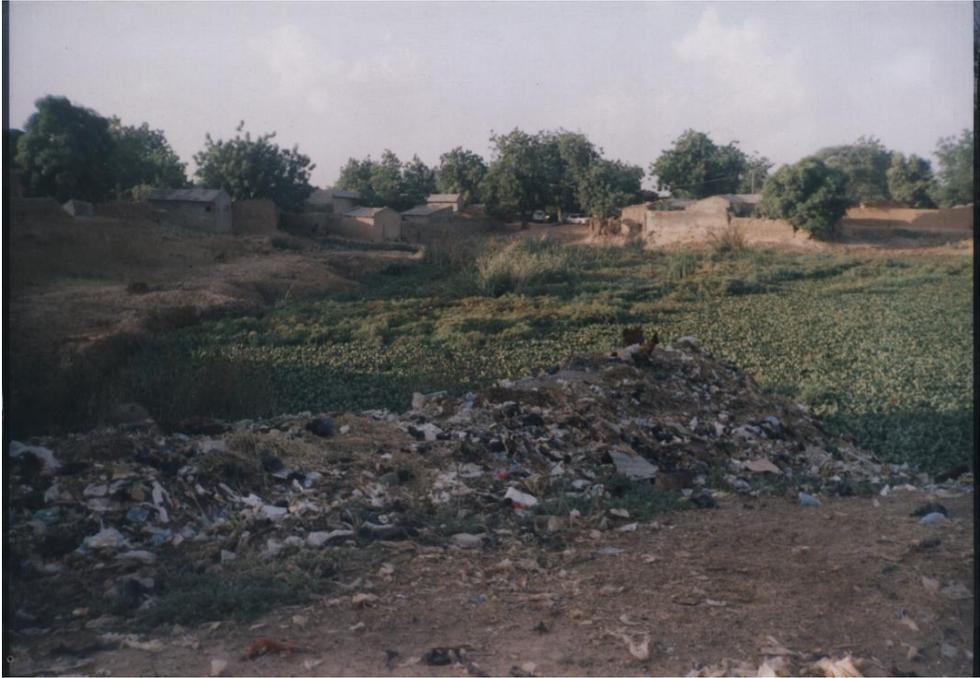
Figure 3 and 4 show derelict ponds, which they filled with vegetation and solid waste dumped, which are suitable place for mosquito habitats. These ponds fill with water during rainy seasons bringing to people high cases of plasmodium falciparum within periods of time. Malaria and Typhoid cases during rainy seasons bloom in residential region around the derelict ponds in Birnin Kebbi city every year [5]. Figure 5 shows the affected population by the Malaria and Typhoid during rainy seasons in 2006 to 2014, which led to death in some cases.

Figure 3: A pond covered by water Lilly.

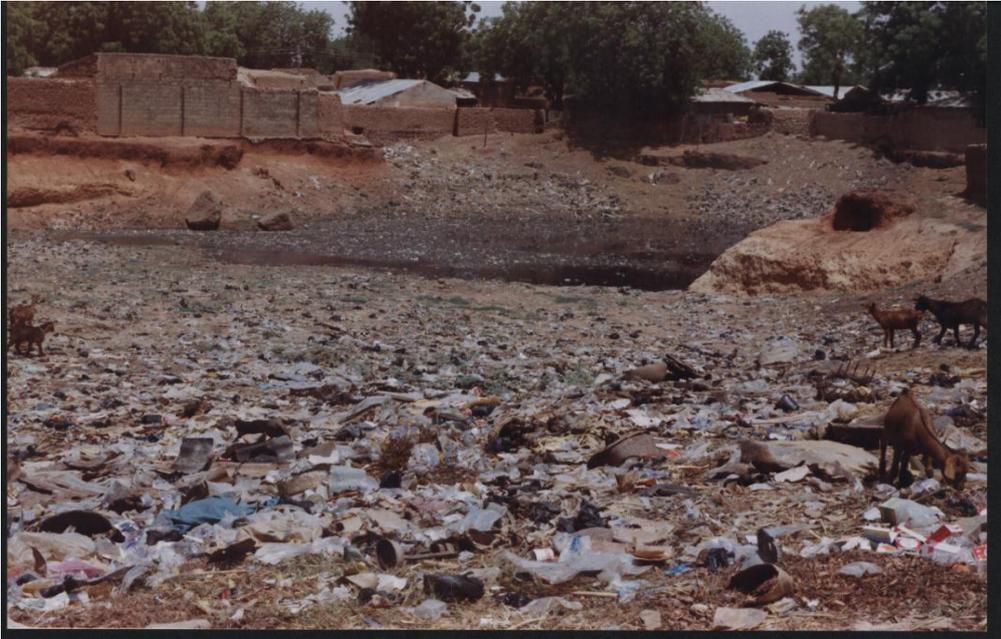
Figure 4. Solid waste dumped in one of the ponds.

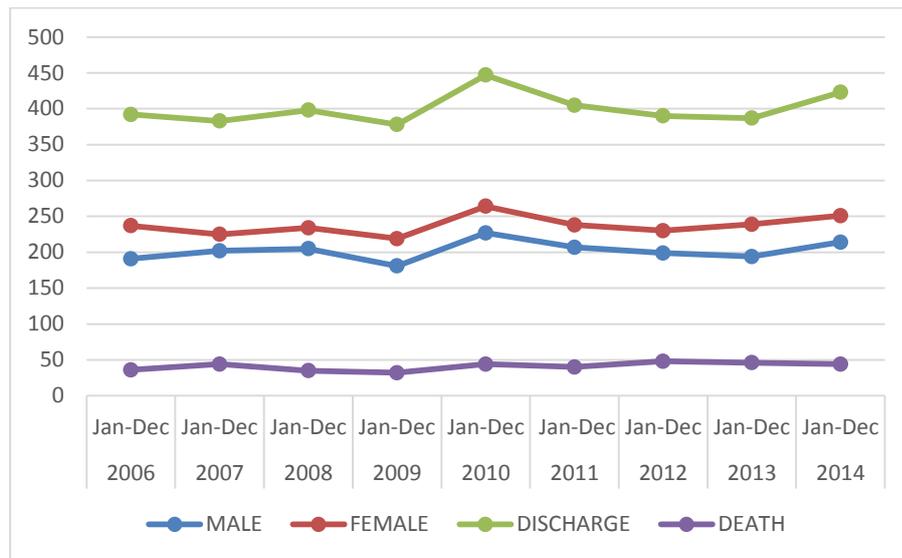
**Figure 5.** Malaria and Typhoid cases during rainy seasons in 2006 to 2014 for Birnin Kebbi city.

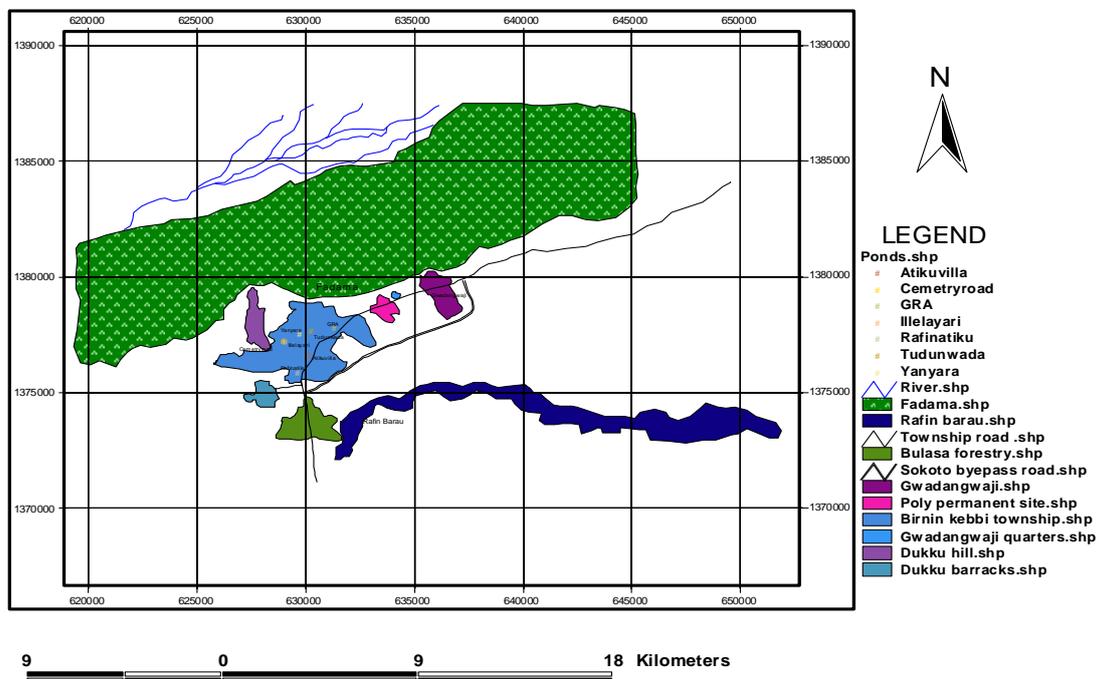
Land used map has been produced for Birnin Kebbi city using Landsat-8 and GIS techniques (Figure 6). Most of derelict ponds with different sizes and shapes are depicted on the map.

**Figure 6.** Land used map of Birnin Kebbi city.

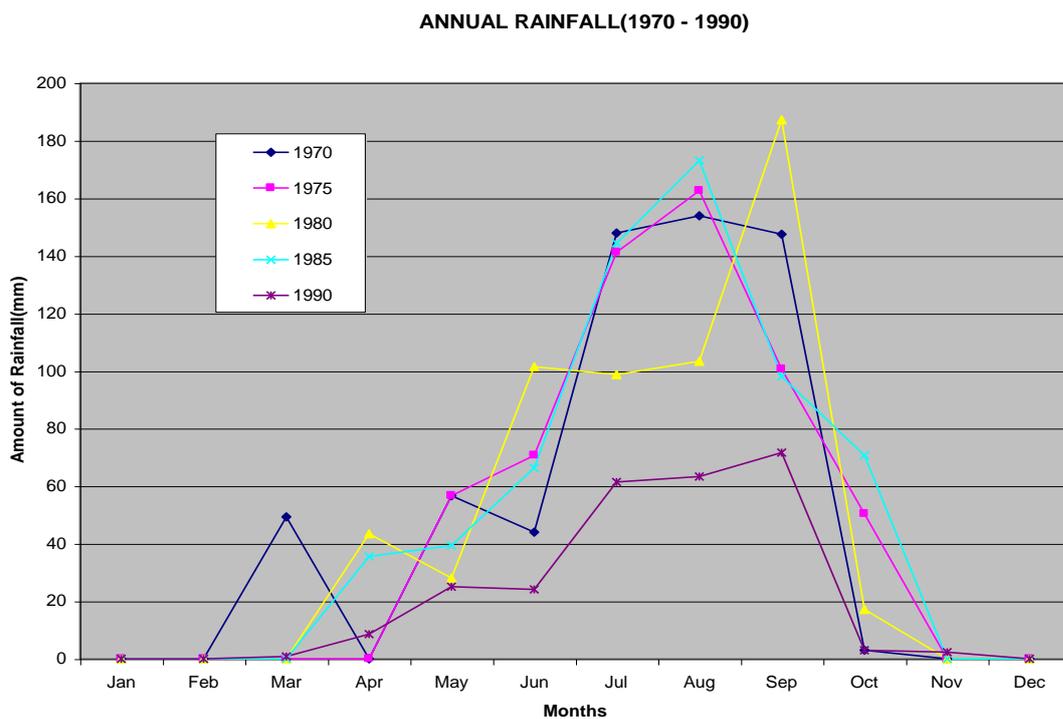
Figure 7. Annual Rainfall variability during 1970 to 1990 for Birnin Kebbi region.

Although, there is no climatic recording stations in Birnin Kebbi, but the town falls within the Theison polygon whose recording stations is situated at Sokoto. The average maximum temperature ranges between 30<sup>0</sup>c and 41<sup>0</sup>c, while the average minimum ranges between 15<sup>0</sup>c and 26<sup>0</sup>c. Average rainfall is 740mm annually, and spreads over a rainy season of about 120 days (Figure 7). A larger water deficit occurs due to a high potential of evaporation level during the hot season. At these periods, the ponds get filled up with from rain to overflow. The absence of drains to discharge the water away makes some of the derelict ponds to contain water all of the year. These places are suitable for mosquito breeding, which is a continuous exercise throughout the year.
