Problems Related to the Siting of the Laboratory Building for Civil Engineering Department at the University of Warmia and Mazury in Olsztyn, Poland

Abstract. This paper deals with the conditions underlying and the problems arising from the siting of a building with specialist laboratories in a developed part of the university campus in Olsztyn, Poland. The topography of the terrain and the need to house civil engineering laboratories in the planned building had an immense impact on the shape of the building and consequently on its foundations, whose dimensions responded to the ground conditions and the specification of various loads they would have to support, including the equipment for the laboratories. The siting of a building as a step in the construction process entails several problems, which are first taken into consideration at the stage of making preliminary concept plans and are subsequently verified while working on the final construction plan. The required information included geotechnical documentation, survey of the ground conditions and the data regarding the predicted loads on the building, necessary to select the right type of foundations. All these problems grow

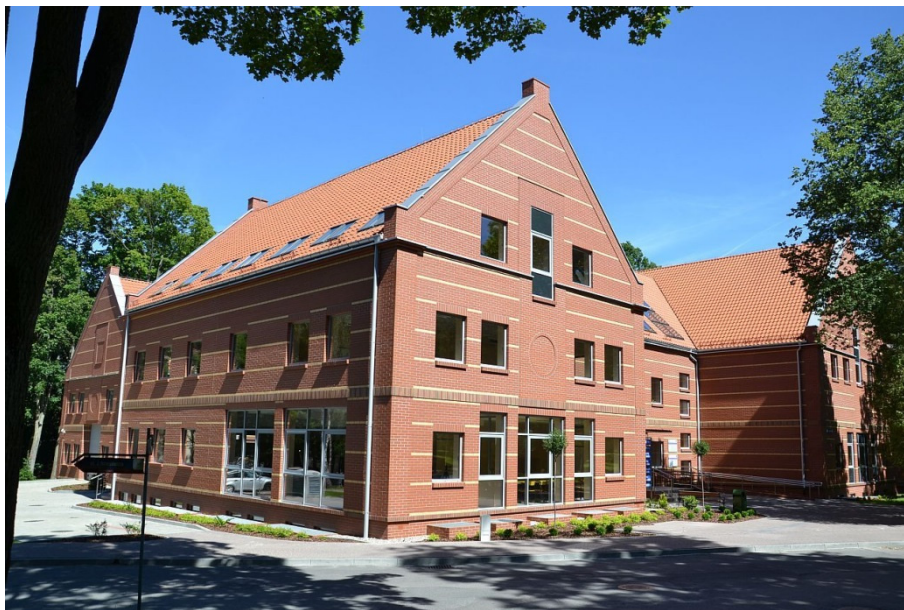
Figure 2. The laboratory building of the Department of Civil Engineering, the UWM in Olsztyn

The principal problems in designing a new laboratory building arose from the conditions set by the Heritage Officer, and revolved around the question of how to adapt the functions of the building to the specific character of civil engineering as a course of studies (laboratories for testing construction solutions) while creating an architectural form that would be harmonious with the historic buildings in this part of the campus [4], Figure 2.

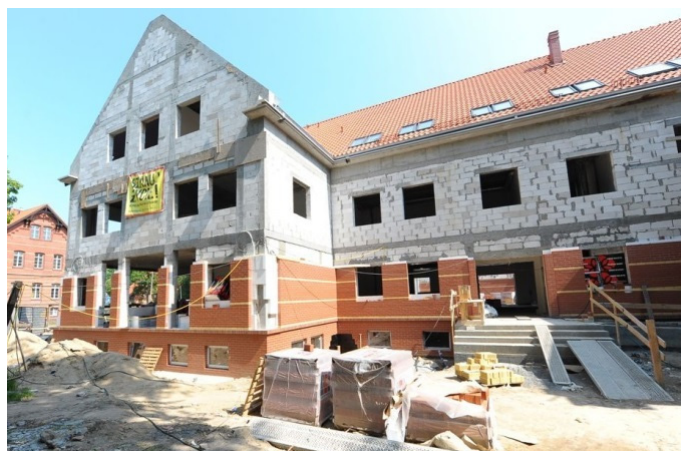
Figure 4. The laboratory building of the Department of Civil Engineering, the UWM in Olsztyn – works on the frontage

adapted, including its siting and adequately designed foundations. Having to satisfy all the above conditions while adhering to the guidelines arising from the functional programme, proposed technologies and heritage conservation requirements meant that producing a plan for the building and performing the construction works constituted a great challenge (Figure 4).
