# Strategic rehabilitation of the earthquake affected micro-hydropower plants in Nepal

**Abstract.** Most people in the rural areas of Nepal rely on Micro-hydro Power Plants (MHPs) for their energy sources. With around four decade experiences in design and development of MHPs, Nepalese techno-entrepreneurs have gained wider reputation in the South Asian region and the beyond. However with the lack of competences in developing Francis turbines, majority of the MHPs are equipped with either Pelton or Cross Flow turbine, even though Francis units are suitable. With the devastating earthquake of a 7.6 magnitude that struck in the Gorkha district on Saturday, 25 April 2015, about 76 km northwest of the capital city Kathmandu, and the aftershocks followed claimed more than 8000 lives. It did not leave hydropower plants either. Many big plants have been affected and hundreds of MHPs were damaged, needing short to long term rehabilitation. The preliminary assessment of the 61 affected MHPs in the 6 earthquake affected districts shows more than 50% sites are suitable for Francis turbine. Hence the strategic rehabilitation plan has been developed in the present paper for the affected plants

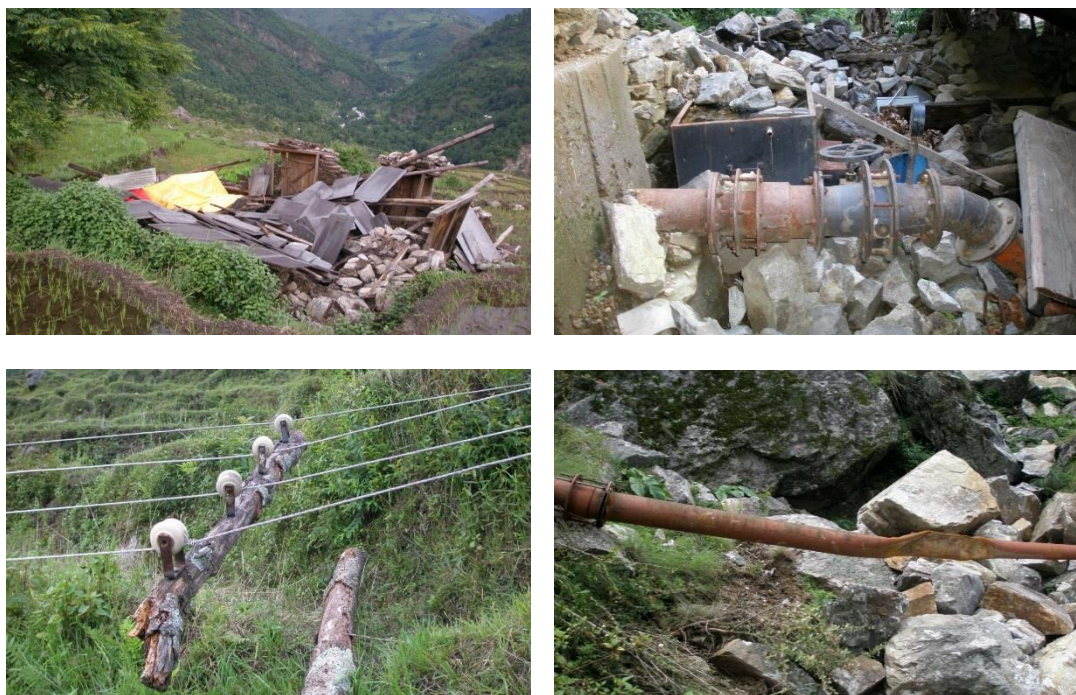
**Figure 6.** Micro-hydro plant damaged by the earthquake in Dolkha district in Nepal

Figure 6 shows a MHP completely damaged during the earthquake of 25<sup>th</sup> April, 2015. The penstock pipe has been burst due to the falling stones, the power house was completely destroyed, and the distribution line poles were broken. The rehabilitation of damaged MHPs needs strategic planning so that the power house runs in an optimal condition.
