The measured study of natural weathering performance of reflective thermal insulation coating in hot-summer and warm-winter region

Abstract. In order to study the attenuation performance of solar direct reflectance of reflective thermal insulation coating under natural weathering, we conducted a measured study on five coatings with the built natural weathering platform. After the 18-month natural weathering experiments, the color of coating templets turn undertint or black with coating layer pulverized and fallen off, some of the templets starting to crack, fall off and go mouldy. Meanwhile, the reflectance ratio of reflective thermal insulation coating decreased significantly after 3 to 6 months, the degree of attenuation of the five templets is 2% to 28%. After 18 months' exposure to the blazing sun, the most significant degree of attenuation reached 46%. The solar direct reflectance of coating templet of the same brand remained high as before after natural weathering with an initial high solar direct reflectance

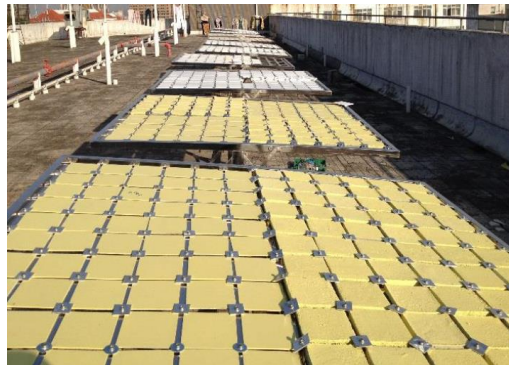
Figure.1 Exposure Test

Templets were marked exposure test fence and insulated on the roof (as shown in Figure 2). And same kind of coating were marked in same exposure test fence designed to prevent mix-ups. Exposure test fences distance parapet above 1.5 m.

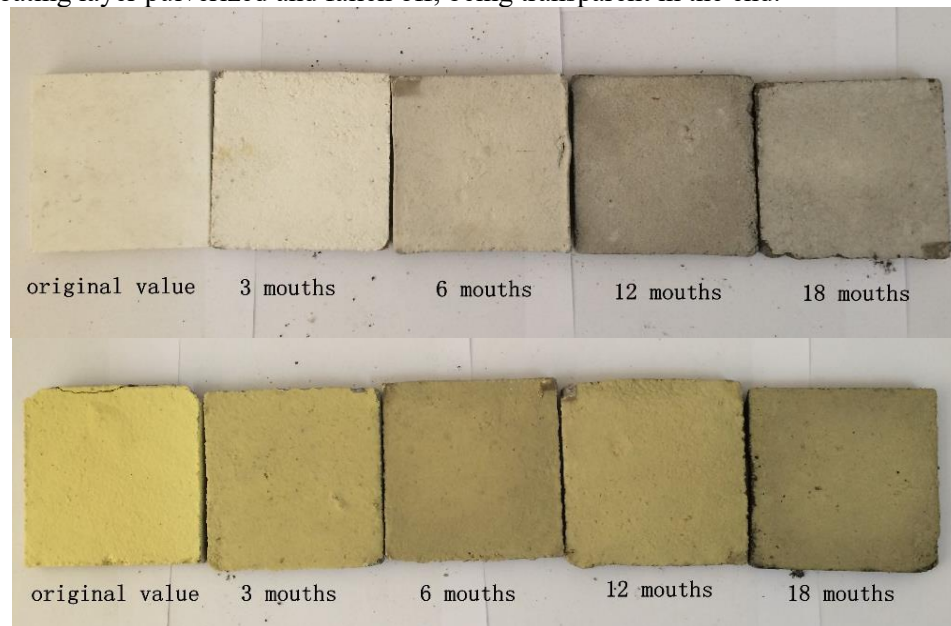
Figure.2 Contrast between aged templets and new templets

According to the Figure.3, the colors of the coatings vary from each other after 18-month's exposure to the blazing sun, compared with the templets without exposure to the blazing sun. As a result of solar radiation, wind, rain and atmospheric gas pollutants, the color of coating templets turn undertint or black, with the coating layer pulverized and fallen off, being transparent in the end.

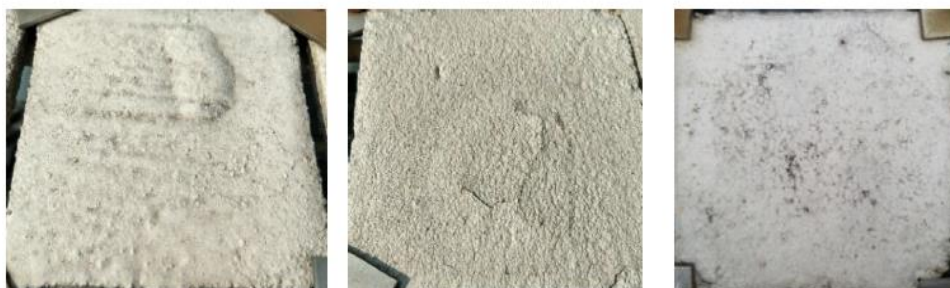
Figure.3 The common characteristics of coating templets after natural weathering

The Figure.4 shows the appearance of templets after natural weathering. Due to the high temperature in summer in Xiamen, templets, which are affected by the climate stress, blistered, cracked and dropped off. Furthermore, the humidity is high in hot-summer and warm-winter region throughout the year, which makes it easier for templets to grow mold or breed microorganisms. Therefore, when applying the reflective thermal insulation coating in this region, not only should the coatings possess a fair property of anti-physical change, but also the properties of damp-proof and stain resistant.

a) blister

b) crack

c) grow mold

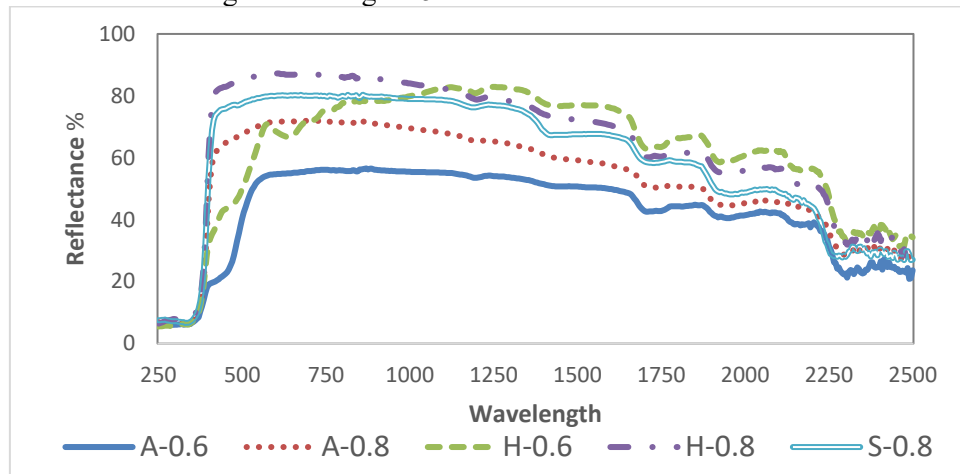
3.2.1 The Determination of the Initial Value of Solar Direct Reflectance. We measured the initial value of solar direct reflectance within the wavelength coverage of 250 to 2500nm of the coating templates using spectrophotometer before exposure to the blazing sun, the initial value curve of solar direct reflectance of the five coatings shows Figure.5.

Figure.4 The comparison of the initial value curve of solar direct reflectance of each coating Based on the computational formula of reflectance, we calculated the solar direct reflectance for the whole wave band, the results of five coatings are summarized in Table 3.

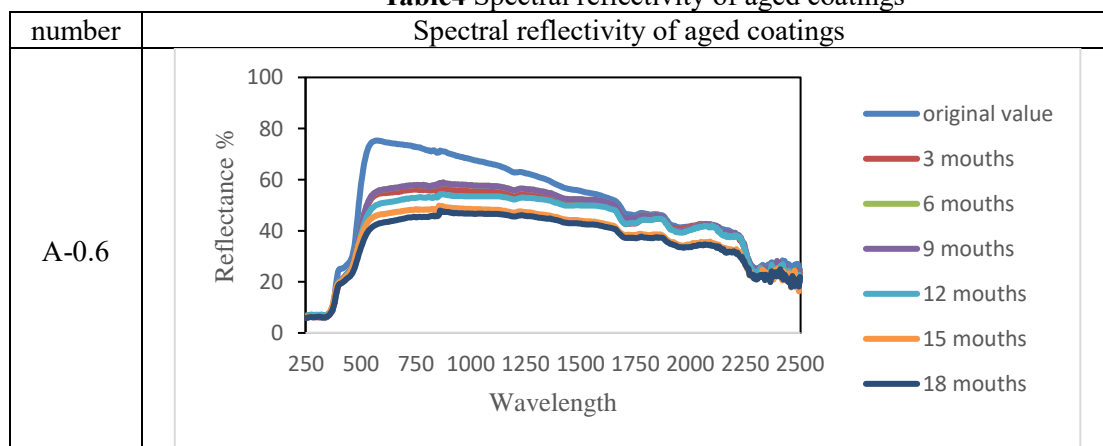
Table4 Spectral reflectivity of aged coatings

3.2.2 The Attenuation Law of Natural Weathering. We measured the solar direct reflectance of coating templates with different exposure time using spectrophotometer, the natural weathering spectrum reflectance ratio of coatings within 250nm to 2500nm wave band are showed in Table 4.

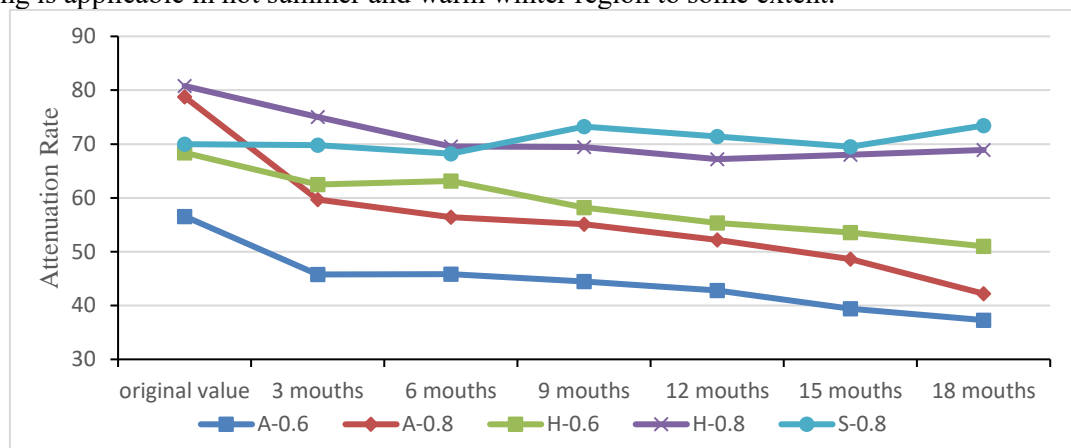
Figure 5 Attenuation diagram of five kinds of reflective thermal insulation coating

By analyzing the Figure 6, we found that the solar direct reflectance of the majority of the coating templets decreased significantly after 3-6 month's exposure. The decline of the solar direct reflectance

of A-0.6, A-0.8, H-0.6, H-0.8 and S-0.8 is 19%、28%、8%、7%、2% respectively.

After 18-month's exposure to the blazing sun, the solar direct reflectance of the five coating templets became constant. Compared with the initial value of the solar direct reflectance, the attenuation trend of A-0.6 and A-0.8 is the high, which is 34% and 46% respectively; the attenuation trend of H-0.6 and H-0.8 is in the middle, which is 25% and 15% respectively; S-0.8 attenuate little. In which, after 12 to 18 months' of exposure to the blazing sun, the attenuation trend of templet A-0.6, A-0.8 and H-0.6 slowed downed overall, the solar direct reflectance of templet S-0.8 and H-0.8 tended to rise slightly. The reason for the rise can be that the rain wash in the summer makes the impurity in the surface of templet decrease. In this way, the accuracy of measured solar direct reflectance increased with less disturbance.

In addition, the solar direct reflectance of templet A-0.8 with a high initial value remained higher than that of A-0.6 as before. Same for the comparison of H-0.6 and H-0.8. Therefore, the solar direct reflectance of coating templet of the same brand remained high as before after natural weathering with an initial high solar direct reflectance.
