Conservation of Semarang chinatown traditional settlement as physical characteristics of chinatown district

Abstract. Historical environment must be conserved due to their contribution toward cultural, social, economic and aesthetic values. They transfer the emotion, thought and backgrounds of social live to modern societies. As one of oldest settlements, Semarang Chinatown gives great influence toward Semarang City and has endless historical values. Old Chinese settlement is very thick with Chinese culture. It becomes the primary source of physical characteristics in this historical environment. However, physical and visual problems come along with the rapid economic growth in Semarang Chinatown. The old buildings that still remains in Semarang Chinatown are in deficient condition and losing their shapes. Moreover, modernization and economic growth influence the change building facade. Several old buildings were replaced with new buildings that tend not to adopt Chinese Architecture style. Consequently, it changes the value of the buildings and the value of the historical environment.

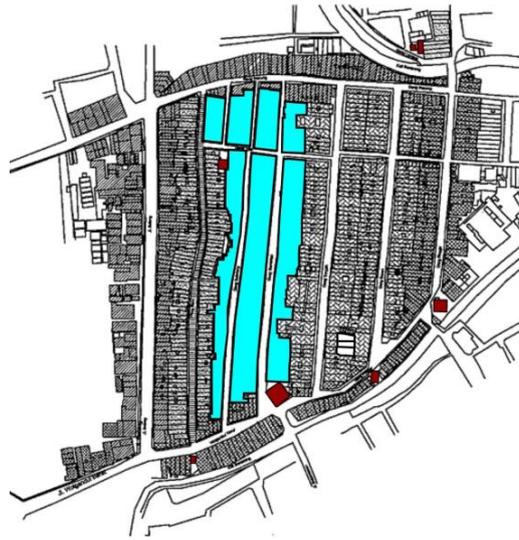
Figure 2 Traditional Residence Location in Semarang Chinatown (Source: Author analysis, 2017)

On the early stage, the buildings on these alleys belonged to the Chinese residents. Nowadays those areas are mostly developed into a commercial district. Only in Gang Tengah, Gang Cilik, and Gang Gambiran can we identify some traditional Chinese residential buildings, as seen on Figure 2 and Figure 3.

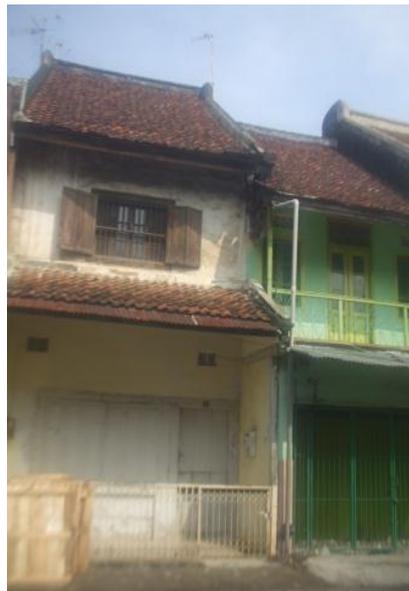
Figure 3 The Traditional Housing Facades in Semarang Chinatown

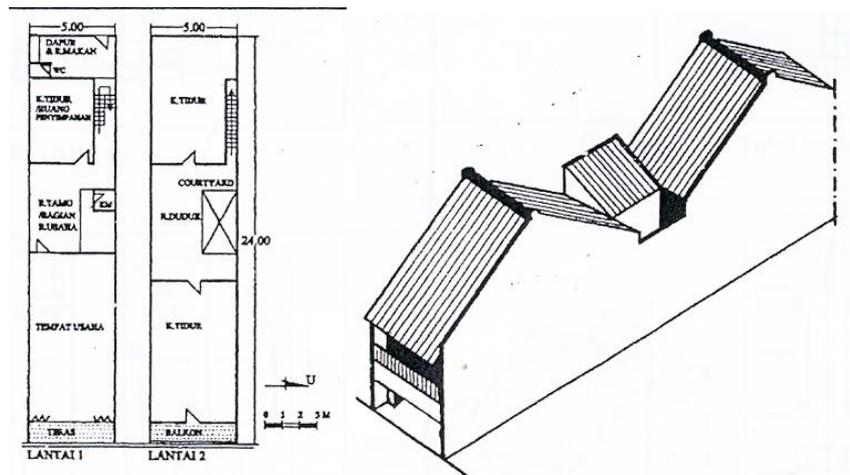
Figure 4 Illustration of a house used for business (Source: Reference [7])

- The houses with multiple uses for business. They are two-storey houses where the first floor is utilized as the business place (store) and the second floor is for living place, as seen in Figure 4.
- The purely residential houses, as seen on Figure 5 and Figure 6. The typical characteristics of the houses are: (1) Two-three storey row house in log array, and (2) Most of them were initially built in big sizes and later were turned into smaller houses

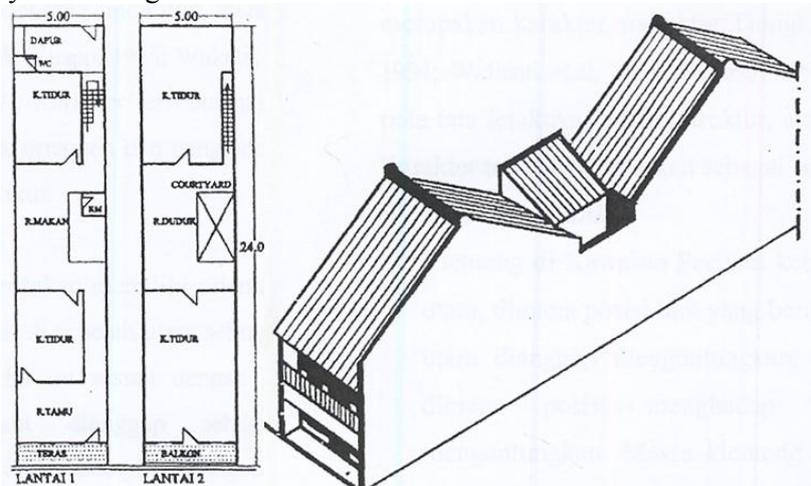
Figure 5 Illustration of pure residential house (Source: Reference [7])

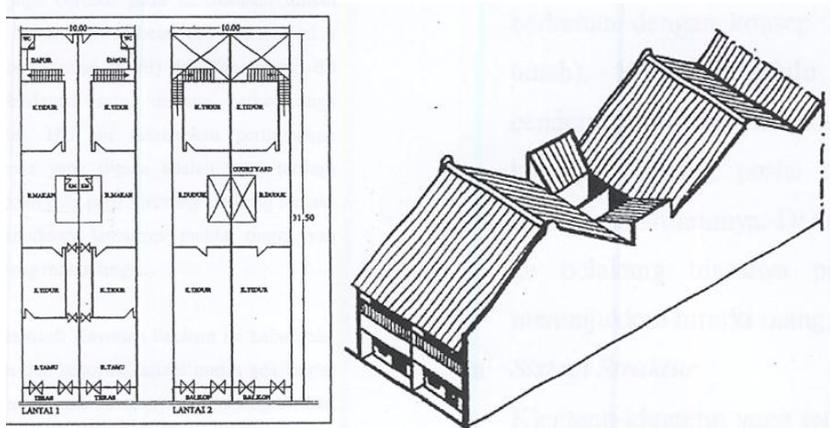
Figure 6 Illustration of Attached House Consisting of Different Units (Source: Reference [7])

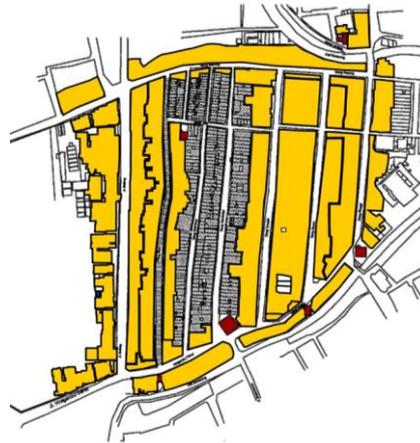
Figure 7 Location of buildings with different style

A couple of sub-districts such as Gang Warung, Gang Pinggir, and Gang Besen have been changed with modern architecture, totally different from the typical Chinese Architecture within the area, as shown on the Figure 7, Figure 8 and Figure 9. This replacement varies from minor replacement to total conversion. There were adjustments on some cases where the owner combined the old elements with the new ones.

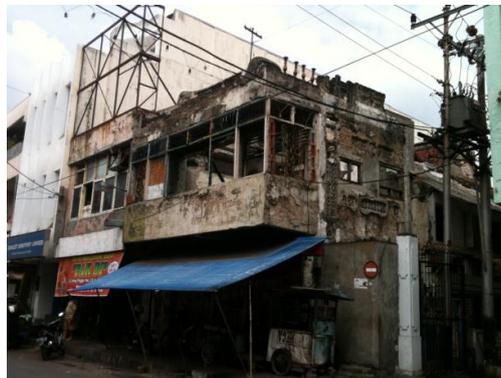
Figure 8 Deterioration of the buildings

Most of the façade changes on Chinatown were done by replacing the old-classic Chinese styles into modern and simplified ones, due to financial problems, lack of craftsmanship, and alternative materials availability.

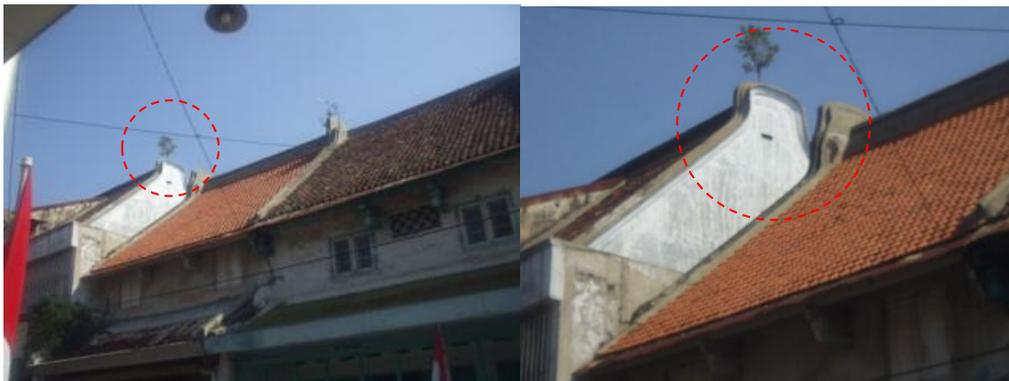
Figure 10 Typical *Konde* Roof

Traditional Chinese houses use a folded roof, with a unique curve on their two edges. The people of Semarang called this kind of roof edges as Konde roof. As heritage buildings, the existence of these old buildings has become the physical characteristic of Semarang Chinatown district. One of the images of the district was established by the presence of the group of residential buildings with highly Chinese Architecture values. Therefore, the changing of the building façade will create a problem in the future. Although there are four buildings in the middle of the Semarang Chinatown already listed as Heritage Conservation Buildings, it still is insufficient to maintain the whole characteristic of the Chinatown District.
