# Shoreline change after 12 years of tsunami in Banda Aceh, Indonesia: a multi-resolution, multi-temporal satellite data and GIS approach

**Abstract.** The Indian Ocean Tsunami event on the 26 December 2004 has caused severe damage of some shorelines in Banda Aceh City, Indonesia. Tracing back the impact can be seen using remote sensing data combined with GIS. The approach is incorporated with image processing to analyze the extent of shoreline changes with multi-temporal data after 12 years of tsunami. This study demonstrates multi-resolution and multi-temporal satellite images of QuickBird and IKONOS to demarcate the shoreline of Banda Aceh shoreline from before and after tsunami. The research has demonstrated a significant change to the shoreline in the form of abrasion between 2004 and 2005 from few meters to hundred meters' change. The change between 2004 and 2011 has not returned to the previous stage of shoreline before the tsunami, considered post tsunami impact. The abrasion occurs between 18.3 to 194.93 meters. Further, the change in 2009-2011 shows slowly change of shoreline of Banda Aceh, considered without impact of tsunami e.g. abrasion caused by ocean waves that ero

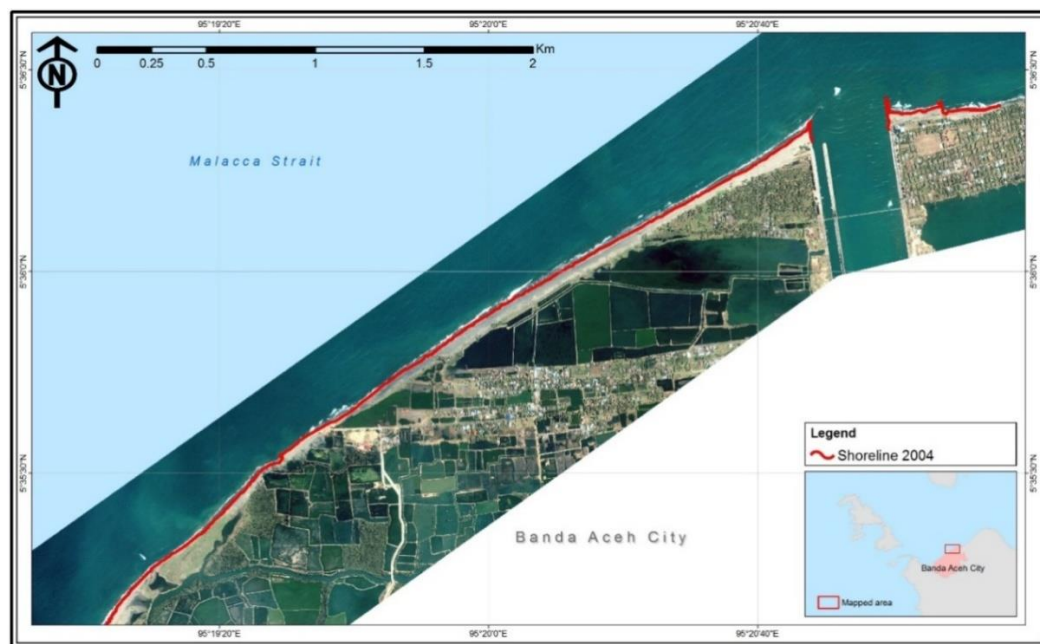
The shoreline of Syiah Kuala sub-district before tsunami was undamaged, as shown in figure 2. It clearly indicates the shoreline of Banda Aceh before tsunami. The red line on the map indicates the shoreline of Syiah Kuala which was undamaged. While, the dotted line on the map indicates the shoreline and part of rives canal which toward to the sea.

**Figure 2.** Shoreline map of Syiah Kuala Sub-district, Banda Aceh before tsunami in 2004

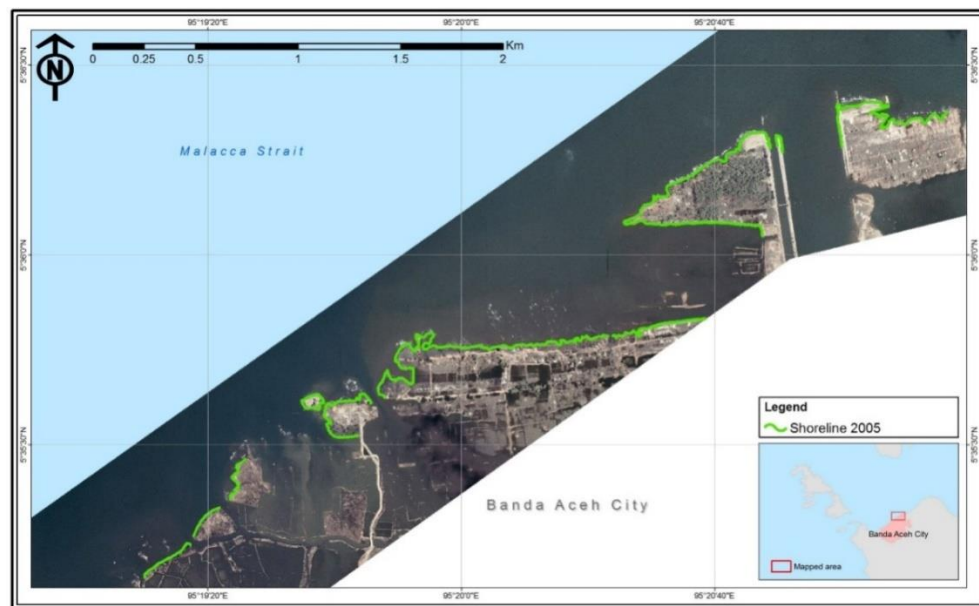
The shoreline of Syiah Kuala after tsunami in 2004 was severe damaged where it suffered high enough coastal erosion so that the level of sea water was so big enough to immerse the land area along the shoreline of Banda Aceh. For more detail, the impact of tsunami on shoreline of Syiah Kuala sub district can be traced back as described in figure 3.

**Figure 3.** Syiah Kuala-sub-district map showing shoreline change for January 2005

After tsunami, the shoreline of Syiah Kuala sub district changed in certain areas, as noted with the disconnected green line in Figure 3. This change is caused by the sea flooding the land has diminished some part of the shoreline. The long term effects of tsunami on the shorelines could vary to be due to the natural erosion and the flood. However, tracing back the damage can be retrieved again as long as the image data are available.

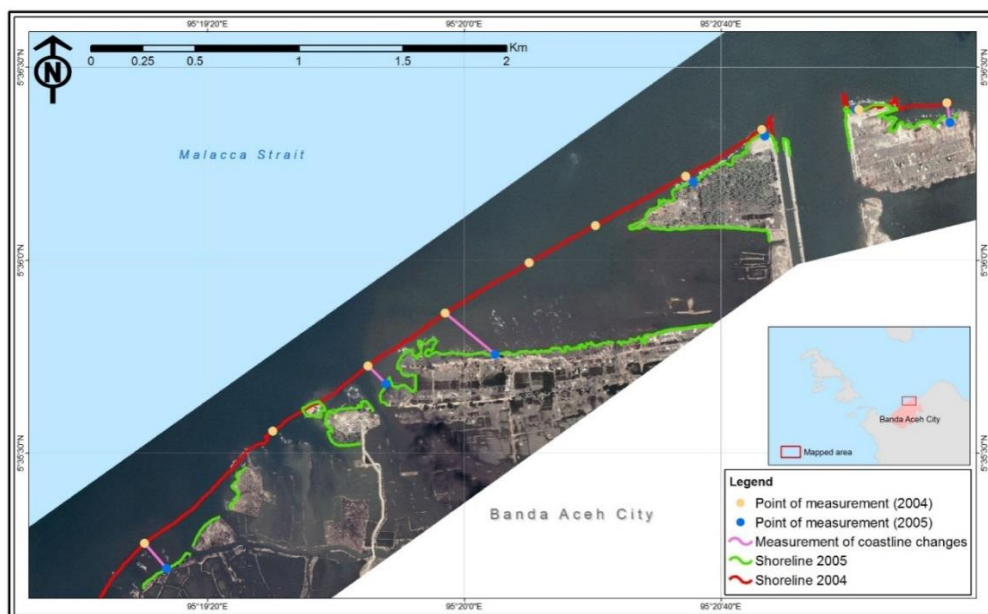
The result analysis of the shoreline of Syiah Kuala area before and after tsunami based on overlaid result of image using GIS tool for 2004 and 2005 shows various changes (figure 4). Figure 4 illustrates the changes of Syiah Kuala shoreline between 2004 and 2005.

**Figure 4.** Map of the Syiah Kuala shoreline changes between 2004 and 2005, note: redline represent previous shoreline

The changes of shoreline at Banda Aceh between 2004 and 2005 were totally worst in which shoreline on 2005 had been disappeared caused by tsunami. On 2004 to 2005 the shoreline along Syiah Kuala had been seriously damaged (abrasion) started from the lowest level that were 12.15 meter to 309.92 meter. In certain area, the shoreline was also totally wrecked and this made flood flow into pond of residents near the area. To see the rate of shoreline changes after tsunami at Syiah Kuala subdistrict, it was conducted an analysis between 2004 and 2009 (figure 5). Figure 5 shows several changes of shoreline at Syiah Kuala with different wide of coastal owing to both abrasion and accretion. Between 2004 and 2005, we checked for nine dots as points for GPS points recorded to see the changes with the lowest (55.1 meter) and the highest (178.77 meters) changes.
