The Impact of Physical and Chemical Properties to Form a Slip Surface in Pyroclastic Breccia in Pawinihan Landslide, Banjarnegara

I Permanajati^{1,4,*}, Z Zakaria², M S D Hadian², H Z Anwar³ and R Setijadi⁴

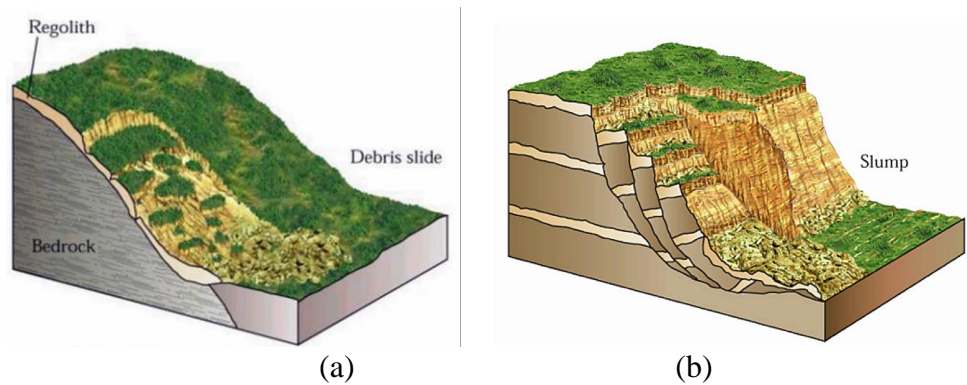
Figure 1. Sliding surface of translational (a) and rotational (b) [1].

Sliding surface is a plane at the ground level as the lower limit of the material moving before the landslide [1]. Then the sliding surface weak, the masses of soil and rock occurred a shift in intensive process that is accompanied by grinding, drag, erosion, and destruction of grain (grain crushing). The shape of sliding surface divided into two types, rotational and translational [1]. Here's a picture of both the sliding surface (Figure 1).

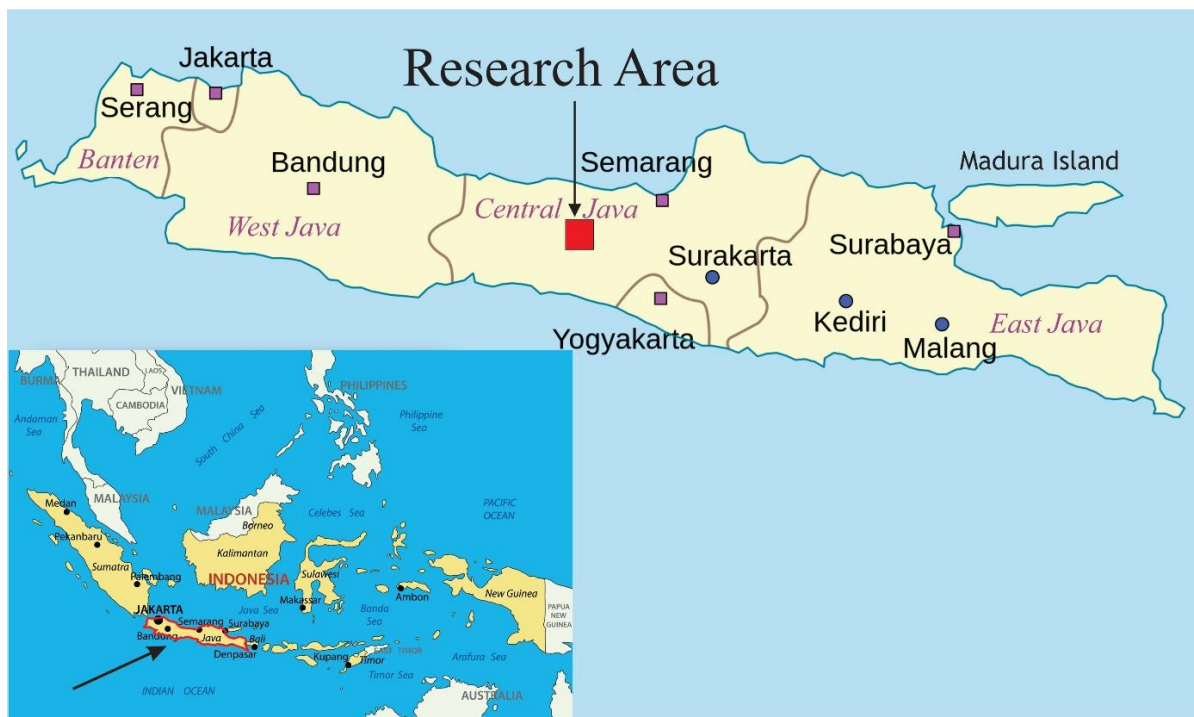
Figure 2. Geological map of research area [7].

research location is the area of Mount Pawinihan, Banjarnegara. According to Condon et al. (1996) rocks in the study area is composed of pyroclastic breccias and has a slope of 30° - 45° [7] (Figure 2).

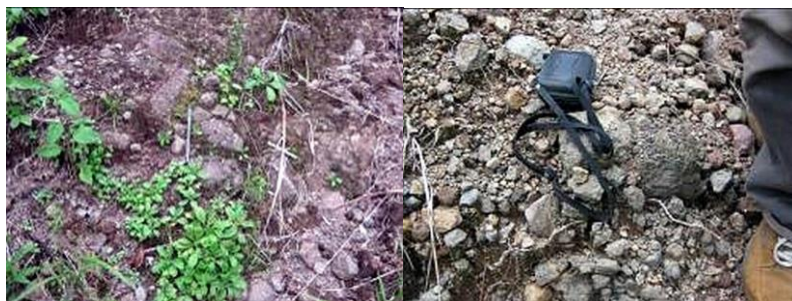
**Figure 3.** Position of sliding surface in zone 3.

In area of Pawinihan landslide, sliding surface found in weathered layer based on field observations and petrographic. Based on field observations, characteristics of megascopic is a brown color and the composition of rocks with soil (F = 50% M = 30%) + soil = 20% fragments are still visible with the gray-brown color, condition matrix mostly rotted, texture breccia still seen clearly indicate a breccia lithology, fragments measuring 5 cm - 10 cm and the condition rather soft, can be scratched with a hammer. Visible oxidation, hydrolysis, and an intense hydration has been running with the increasingly brown discoloration and development of land as a result of the weathering process, the microstructure can still be observed from grains fragments, probably due process of disintegration (Figure 3).

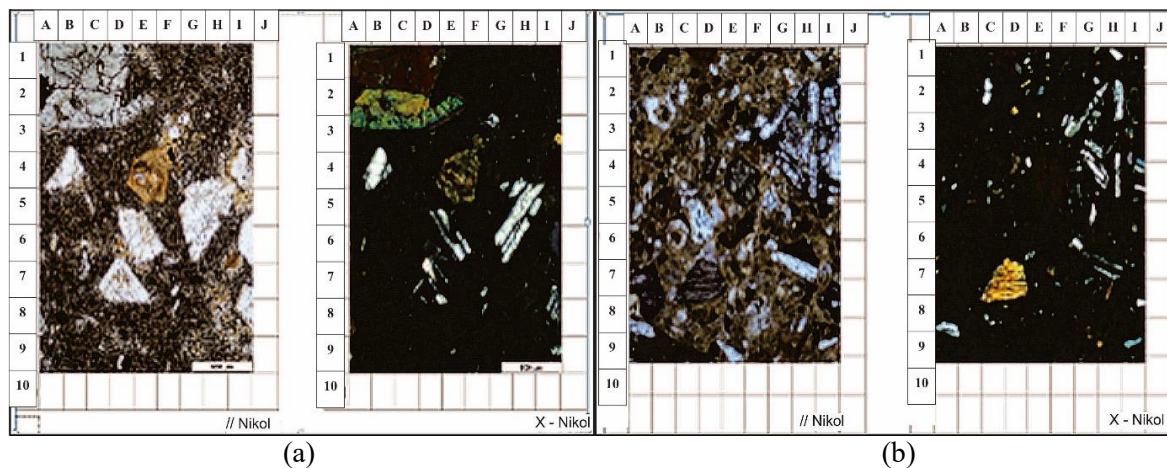
Figure 4. Petrographic of fragment and matrix of sliding surface.

Based on petrographic analysis of the fragments and the matrix contained in the zone of sliding surface, rock fragments in sliding surface zone is andesite oxidized (7%) altered by phenocrysts form plagioclase (20%), k-feldspar (5%) and pyroxene (10%) which is embedded in a mass basis in the form microlit plagioclase (10%) and the mass of glass (25%), cuts the rock is transformed into mineral opaque (8%) and clay minerals (7%), chlorite (5%) encountered cavity of (3%) (Figure 4.a).

Then the composition of the rocks matrix in the zone sliding plane is breccias volcanic brown rock, compiled by the granular fragments of rock (25%), plagioclase (10%), pyroxene (5%), k-feldspar (3%), carbon (2%), iron oxide (10%) are embedded in a matrix form of glass volcanics (10%) and material pyroclastic (15%) sized tuff rough, incision rock is transformed into clay minerals (7%), mineral opaque (5%) and chlorite (3%), common cavity of (5%) (Figure 4.b). Then based on XRF analysis consists of oxide mayor SiO₂ 52.3% Al₂O₃ 31.6%, Fe₂O₃ 12.1%, TiO₂ 1.61%, MgO 0.903%, K₂O 0.702%, CaO 0.278%, MnO 0.248%, P₂O₅ 0.169 %, BaO 0.0329%, ZnO 0.0164%.

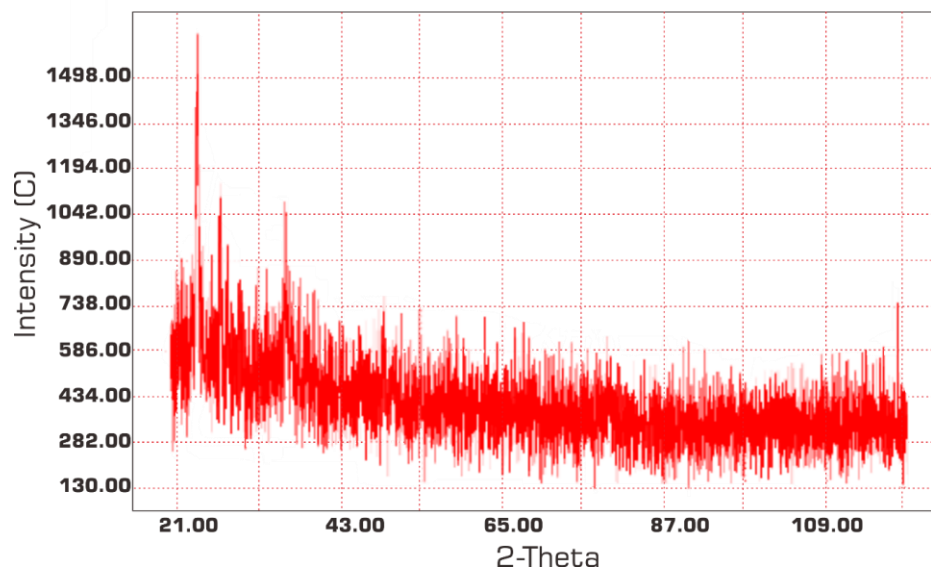
Figure 5. XRD analysis in sliding surface.

Then from the XRD analysis results obtained mineral kaolinite, maghemite, halosit, cristobalite and montmorillonite (Figure 5). SEM analysis with 2500x magnification shows the texture of clay minerals smectite and illite group. Smectite seemed a form pieces in between the grains, whereas illite looks like fine fibers form between granules. There are grains of quartz covered by clay minerals in the center of the photo with dimensions of approximately 30 x 30 μ m. Porosity is a bad primer on samples with a variation of pore size between 1-10 μ m with a fairly evenly spread. Secondary porosity may be a cracks in between the grains and the relationship between pore too bad (Figure 6).

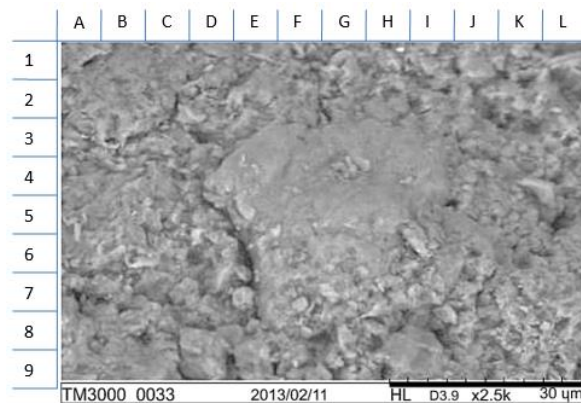
Figure 6. SEM photo in the sliding surface of Pawinihan landslide.

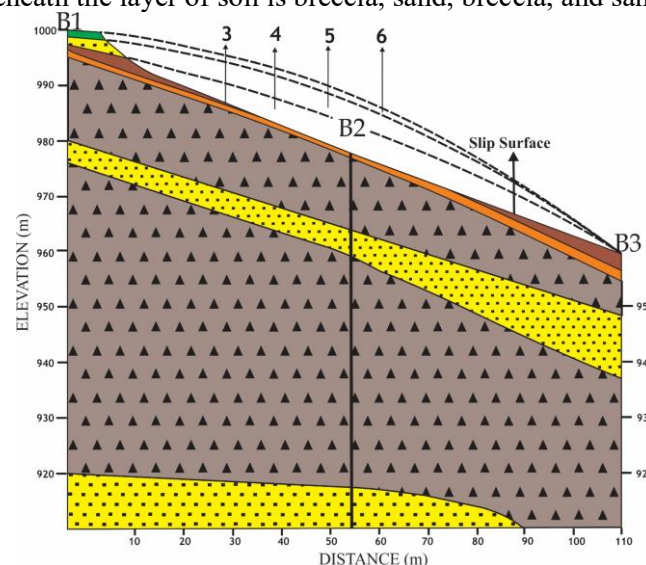
Figure 7. Correlation in the point B1-B2-B3 with test pit in track of landslide.

Correlation geo-electric with field mapping and test pit can be seen in Figure 7. The results of geo-electric measurements and elevation measurements with GPS obtained the lowest point sliding surface as high as 949 m above sea level and the highest point of landslides is 999 m above sea level, measured slope angle is 35°. Based on geo-electrical data at point B1 obtained soil layers at depths of 0-375 m with resistivity from 297.27 to 52.20 Ohm M, meanwhile on the point B2 obtained soil layer at a depth of 0 to 1.98 with resistivity 867.54 to 3775, 76 Ohm M. Point B3 has a soil layer at a depth of 0 to 3.9 m with resistivity from 0.60 to 59.32 Ohm M. When correlated with a layer of soil based on trials in the top of the landslide, obtained a depth of strong weathered layers as deep as 0-4 m. So it is interpreted that the soil layers included in the weathered zone with a high residual soil that is visually dominated by land than a rock. So, beneath the layer of soil is breccia, sand, breccia, and sand again.

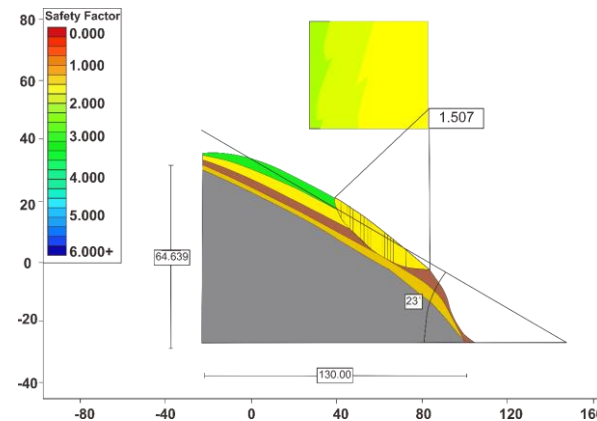
Figure 8. Section of Pawinihan landslide with simulation before landslide.

Here are the results of simulations that have been carried out with a slide program version 6 for a conditions before the landslide (Figure 8) and then the data based on the simulation results by taking FK = 1.5 (Figure 8) obtained deployment sliding plane cut zones 6, 5, 4 and stopping in the zone 3 in accordance with the real conditions (Figure 9) but position of top avalanches shifted down.

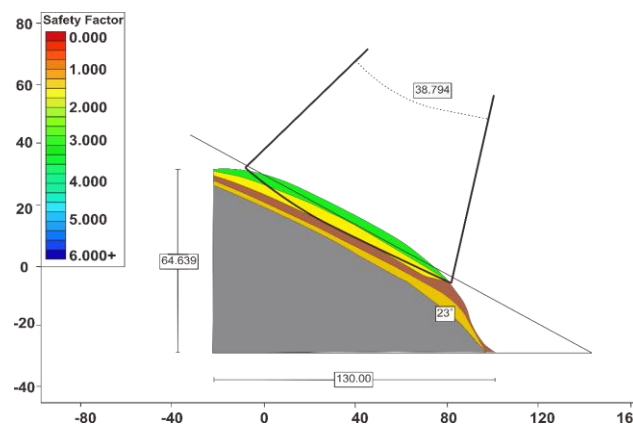
Figure 9. Result of simulation with General Limits Equilibrium after landslide.

This study was limited on explore aspects of weathering, so the inundated condition and crops are not taken into the calculation, then the top landslide shifting is expected because of crop and hydrological not taken into the calculation. But from the simulation results, it can be concluded that with the calculations of other factors such as horticultural and changes in pore water, the the top of avalanche passed through zones 6,5, and 4 then stopped in zone 3.
