Assessment of injury and mortality from rapid decompression on crucian carps

Abstract. Knowledge of barotrauma injury mechanisms is required in the fish-friendly turbine design. Rapid decreases in pressure is one of the main reasons that cause injury and mortality to fish that pass through hydropower machines. A steel tank and related pressure regulation components were designed to study the barotrauma injury thresholds of crucian carps. Decompression from 700 kPa to 6 kPa in 0.3 s was implemented in this system with dozens of yearling and subyearling crucian carps. The fish swim bladder and other organs were observed to find the main reason for injury after the rapid decompression. The tested fish were kept for at least 48 hours to study the physiological status in different observation periods. The direct and indirect decompression induced mortality after the test was observed and analyzed.

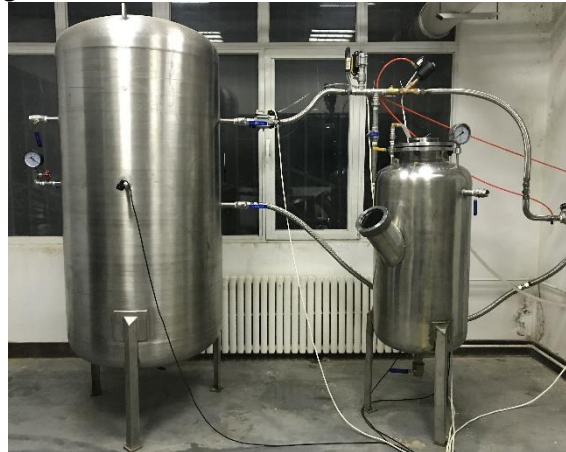
Figure 1. Observation tank and pressure control system

As shown in figure 1, a pressure control and fish holding system was designed to simulate the pressure history of fish passing through a hydraulic turbine. A tank with observation windows was connected to two larger tanks, one of them (not included in figure 1) connected to air compressors and the other (the left higher tank in figure 1) connected to vacuum pumps. With a volume of 100 l, the tank can hold fish equal to or shorter than 0.3 m. Water supply and drainage system was designed to keep the water inside the observation tank fresh and safe for fish. Electromagnetic valves were used to pressurize and depressurize the observation tank and ball valves were used to control the compression and decompression speed. The system can drop the pressure inside the observation tank from 700kPa to 4kPa (close to the vapor pressure of water) in 0.3 s.

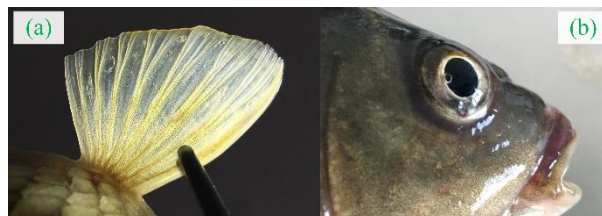
Figure 5. Bubbles in fins and fish eyes after rapid compression experiments

Swim bladder rupture, however, was not the only reason for mortality. The undissolved gas rapidly expanded not only in the swim bladder, but also inside other organs, dissolved gas become undissolved and released into tissues as the solubility of gas dissolved in blood decreases, these phenomenon can also lead to injury and mortality. Emboli in the fins and in the eyes were observed at 24th hour after experiment, as shown in figure 5.

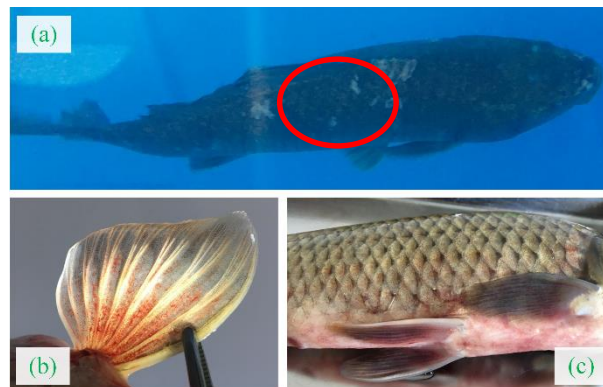
External signs of trauma was found in the third period (7 ~ 24 hours after the experiment) as shown in figure 3, 40% of Size I fish were found carried different external signs of trauma, such as faded of fish scales, loss of surface mucus and hemorrhage in fish belly near the fins. With the increase of time, the hemorrhage area expanded continuously, as shown in figure 6.

Figure 6. External signs of trauma on crucian carps
