# Study on Deformation and Failure of Toppling Deformation Slope of Miaowei Hydropower Station under Storage Condition

**Abstract.** With the completion and operation of hydropower stations in Southwest China, the stability of reservoir slope is impacted by the change of water level during reservoir storage and operation. It has become an important engineering geological problem in the design and operation of hydropower stations. Taking the Miao River Hydropower Station in Lancang River Basin as the research object, the structural characteristics of the bank slope and the influence of reservoir impoundment are analyzed. The deformation of the slope rock mass in the reservoir area is serious. During the reservoir storage, the stability of the bank slope is outstanding. In order to analyze the influence of the change of water level on the stability and failure mode of the tilting deformable body on the bank slope under the condition of water storage, through the numerical simulation analysis, using UDEC discrete element software after impoundment, it is concluded that after water storage, the strength of rock mass is reduced, and the failure mode changes from sliding failure to coll

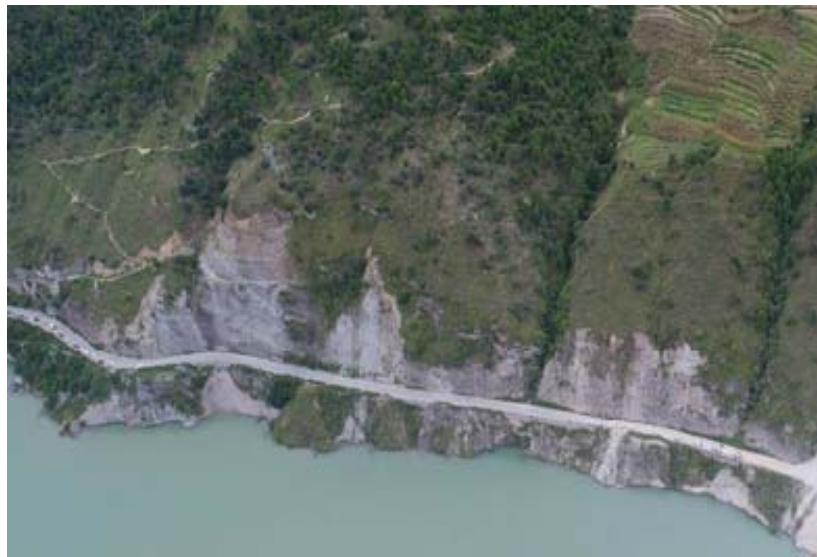
**Figure 1.** Panorama of bank slope of QD9 toppling

Miaowei Hydropower Station has developed a quantity of toppling deformation body which mainly distributes in the reach from Aaden Village to Snakeskin River. Through field investigation, and the left bank is from Tue Village to Snakeskin River, and the right bank is from Aaden Village to Well Village. The toppling deformation body is 1.0 ~ 54.6 km away from the dam. This paper took QD9 as an example to study the topography, and its full appearance of slope is shown in figure 1. The toppling deformation body of QD9 is located in the reservoir section between Lengshuichang River and Ouyang River, which is about 20.7 km away from the dam, and the toppling deformation body is distributed on the low-altitude slope. The form of this reservoir section of Lancing River is slightly crooked, and the direction of the river is SE25°~ SN. And the elevation of slope toe in the right bank is about 1340 m, and the top is about 2200 m, and the gradient of upper slope is gentle incline about 30°~ 40°, and the middle to lower part of slope lowest is a bit steep about 50°~ 60°. The slope toe has developed multiple small ditch. Most of the slope surfaces are exposed, and the toppling deformation body is strongly developed under the elevation of 1520 m.

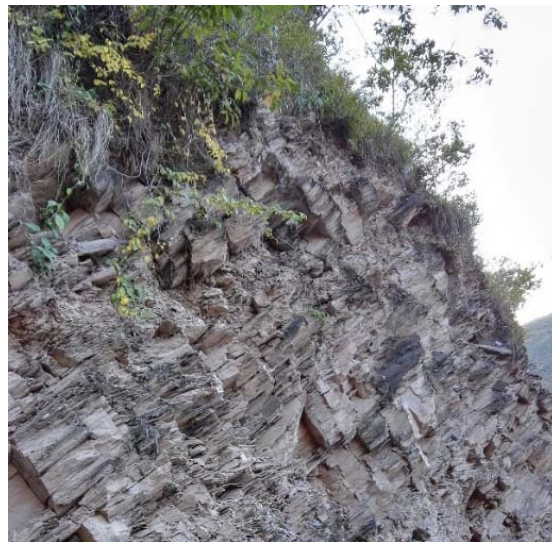
**Figure 3.** Structure characteristics of bank slope

The structure characteristic of reservoir slope mainly includes two aspects: one aspect is the slope shape, including the slope height and slope angle, and the total length of Miaowei reservoir is about 60 km, the slope heights are above 100 m, except the loose slope. The slope angles are more than  $30^\circ$ , and part of the slope can be up to  $40^\circ \sim 60^\circ$ . The second aspect includes the rock structure types of slope, the relationship between attitude of rock and slope (figure 3) and so on. The slope which develops toppling deformation body is mainly the reverse stratified rock slope and the heterotrophic stratified rock slope, and consequent stratified rock slope has rarely developed the toppling deformation body.

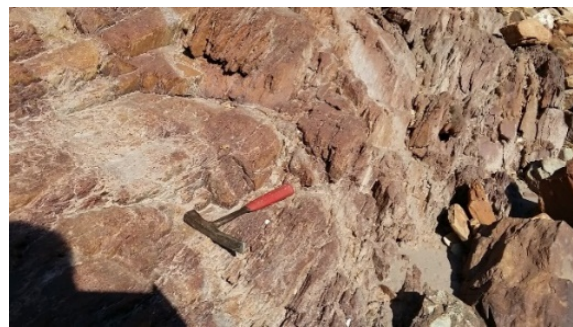
**Figure 4.** The dip angle near the riverbank

The rock layer obliquity of reverse slope of Miaowei reservoir area is about  $70^\circ \sim 85^\circ$ , closing to the upright, and a group of joint surface which nearly vertical to the layer surface has developed in the rock layer. Because the rock was toppled and deformed, the angle of rock layer becomes to decrease, and apart of them becomes nearly horizontal, and the joints that are near perpendicular to the plane before the toppled are turned into an advantageous structural plane (figure 4, figure 5). The angle of this group structure surface is often close to the slope angle, or even greater than the slope angle, which is the controlling factor of the secondary failure of the toppling deformation body. After reservoir impoundment, on the one hand, the structural plane is full of water, the normal stiffness and the tangential stiffness will reduce greatly. On the other hand, because of the lacking of slope toe caused by bank collapse, the rock of upper slope toe lose the support, and the blocks formed by two groups of structural planes are more prone to slide or collapse.

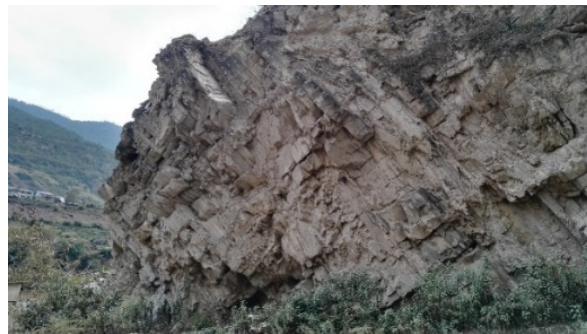
**Figure 5.** Rock mass structure of bank slope
