Research of Full-scale Transmission Tower Deformation Caused by Unbalanced Tension

Abstract. An experiment of the full-scale transmission tower is carried out to study the deformation of the tower under unbalanced tension. By adding extra load on the transmission wire connected to the tower and using distributed angle sensors to record the continuous changes of deformation, the deformation rule of the full-scale tower under the unbalanced tension is studied. The experimental results show transmission tower has some complicate performances as a kind of statically indeterminate structure under unbalanced tension as it will incline, twist and vibrate under unbalanced horizontal tension and the creep happen partially in the tower, which reveals the limitation of simulation and the necessity of real tower tests. The results can be used as the theoretical basis of monitoring and optimization of the transmission towers' health status.

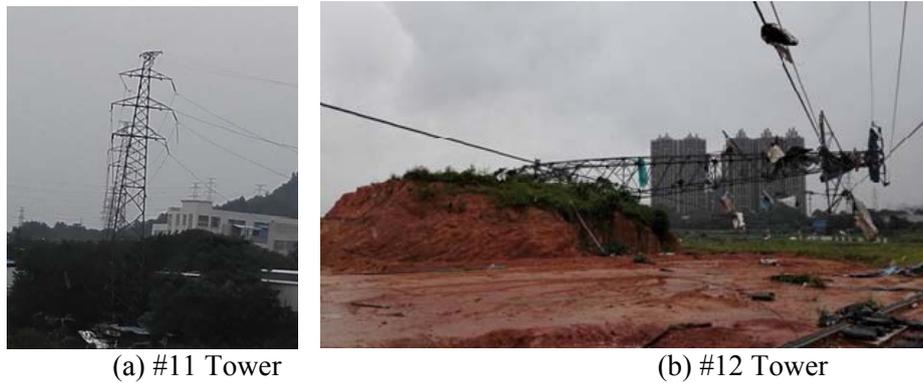
(a) #11 Tower

(b) #12 Tower

Figure 1. The damaged tower “110kVYinxinYi#11&12”

According to figure 1, the #12 tower toppled totally and exerted large force on the ground cross-arm of #11 tower through the power transmission wire between these two towers, resulting in the deformation of #11 tower. The damage of the two towers further caused other towers' deformation. Therefore, it is obvious that the deformation caused by the unbalanced tension of transmission tower has a serious impact on the safety of transmission lines. It is of great significance to understand the complicated deformation rules to design and reinforce transmission towers.

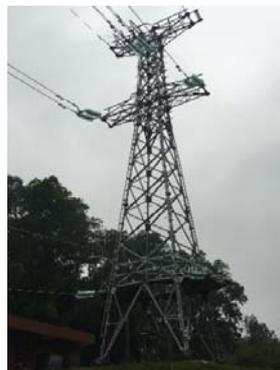
**Figure 2.** Single loop testing tower

The uncharged tower-line system for teaching in Guangzhou University of South China University of Technology was selected for the test (Fig.2). The tower is an 110kV single-loop steel pipe combination of dry-type tower (25 meters of total height, 16 meters of practical height, 3.5 meters of root span). The conductor type is $4 \times \text{JL} / \text{G1A-240/30}$ ACSR and the ground wires are respectively $\text{JL} / \text{G1A-70/40}$ ACSR and LBGJ-70-30AC aluminum clad steel strand. The testing site of the wires and the adjacent tower are as Figure 3 (b).
