## Utilization of greenbelt zone around the dam Study case: Logung Dam, Kudus Regency, Central Java

**Abstract** : Dams have an important role, especially in Indonesia, not only as a water source, agriculture also plays a role in controlling floods and hydropower. Many dams have been built and some are under construction. In line with its existence and function, the existence of dams also faces several problems, one of them is erosion problem which threatens the sustainability of the dam function. Land conversion in upstream and around areas contributes to erosion. Natural landscape around the dam must certainly be maintained into the Greenbelt zone. On the one hand its existence must remain part of the natural landscape but on the other hand it will still function as part of the settlement area. The study is intended to map the greenbelt area that must remain natural and which areas can be utilized. Research begins by identifying physical conditions along the edge of the dam, then analyzing it and combining it with existing land use data, resulting in a map of utilization along the edge of the dam (greenbelt).

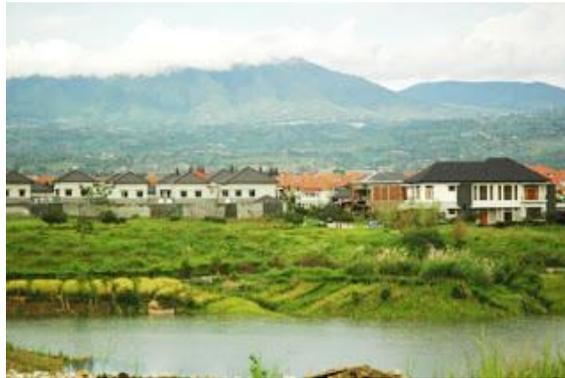
**Figure 1.** A new housing area build near waterbody of Saguling dam that increase erosion risk to waterbody (image source : <http://triindonesia.blogspot.com/2011/08/tanggung-jawab-penataan-kawasan.html>)

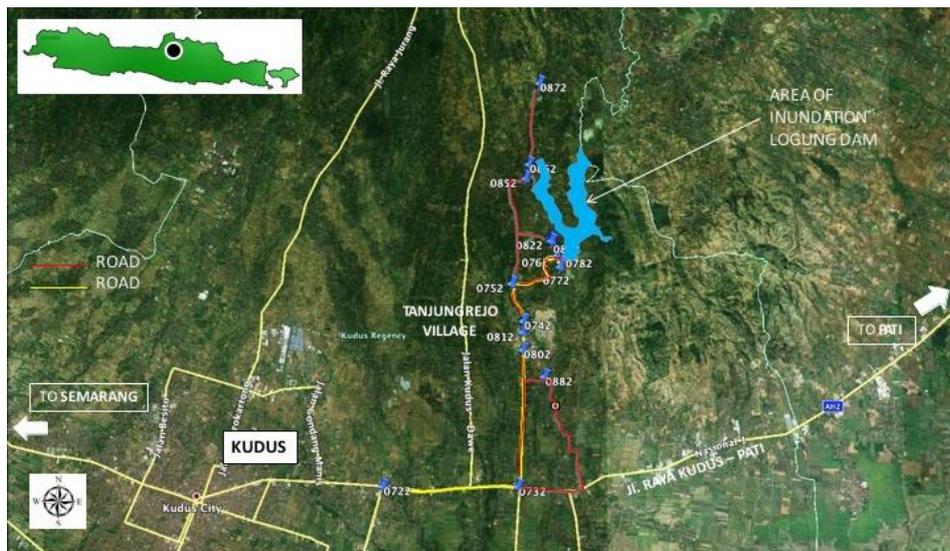
**Figure 2.** Location of Logung Dam near Kudus City.

Logung dam is located about 15 km at north east of Kudus Regency, Central Jawa. Refer to Taufiq and et al, (2017) the dam/reservoir would covers the area : 144 ha, covers area of Tanjungrejo and Kandangmas village.

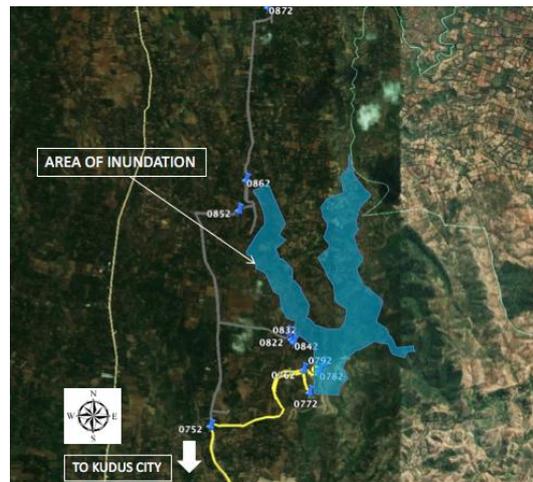
**Figure 3.** Area of Inundation Logung dam

For the purpose of analyzing the edge of dam, the area is divided into 4 zones : East zone, Centre, North and West zone.

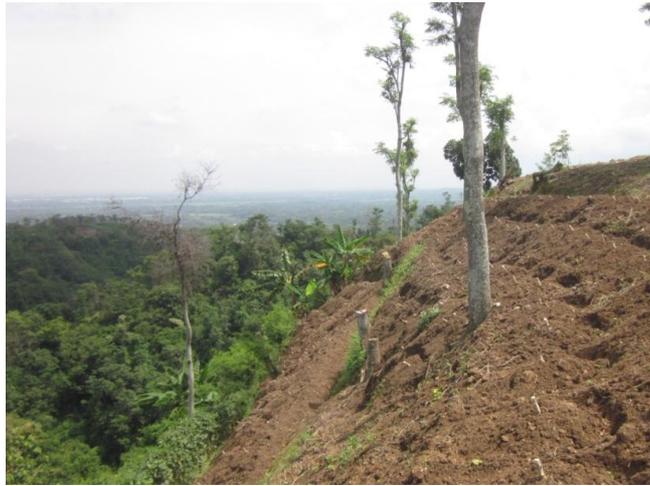
**Figure 4.** Cropland in east zone (behind green belt zone) on steep slope.

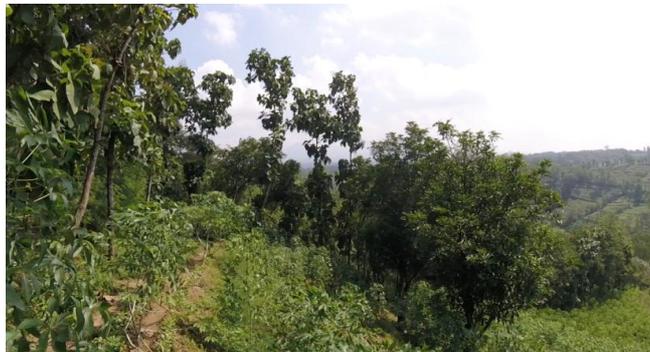
**Figure 5.** Forest mix with cropland in greenbelt zone along west zone (slope classification : moderate).
