Tree management at Boulevard landscape of Alam Sutera Serpong, a new city area in Tangerang

Abstract. Alam Sutera is an integrated area in Serpong, Tangerang. Alam Sutera has various of green open space areas. One of the greenery open spaces is streetscape, which consists of many trees species with various characters, shape, age and specific maintenance. The objective of this paper were to carry out tree road analysis and to describe the evaluation results on tree management including recommendation for tree management. The International Tress Evaluation Method (ISTEM) was used as assessment approach in order to know the trees valuation. Some physical trees characters such as diameter of the breast height (dBH), trees quality condition, tree class and constanta of price unit were considered in this valuation. Based on the results, a lot of tree pests, diseases and a bit mechanical damage were found in boulevard landscape. Tree pests and diseases such as termites, caterpillars, caterpillars sac, aphids, ants, fungi, powdery mildew, leaf rust and stem cancer were controlled mechanically, physicall, biological, quarantine, cultivation techniques and by using an environmental friendly

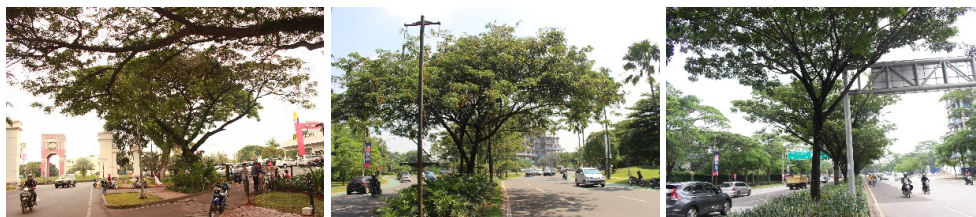
Figure 3. Landscape and road trees condition of Alam Sutera Boulevard.

Seventy trees were observed in Alam Sutera Boulevard distributed 14 trees at the right and left side of the road, and 15 trees at the median road front of main gate of Alam Sutera. Twenty two trees were in front of Living World, and 19 trees were on the median road in the front of Alam Sutera Sport Center (figure 2 and figure 3). All those trees were identified in order to know their level of pest-disease destruction and mechanical damage.

The percentage of tree damages due to pest and diseases was classified as "too many" in Alam Sutera Boulevard (table 3) having the 4th damage rank (73%). Mechanical damage was ranked the 2nd with a value of 50%. Based on this, the condition of the tree in Alam Sutera Boulevard was classified in the 4th rank with a total damage of 100% (damage condition of the tree "very many"). Road tree encountered here was only 1 species, which was monoculture of *Samanea saman*, whereas, for landscape sustainability and conservation of the urban landscape environment, it should have been supported by urban biodiversity. Ten tree species were the species most often found at the road side green belt in Jakarta, i.e. *Swietenia macrophylla*, *Pterocarpus indicus*, *Mimusops elengi*, *Polyalthya fragrans*, *Cerbera manghas*, *Ficus benjamina*, *Dialium indum*, *Ryostonea regia*, *Polyalthya longifolia*, and *Bauhinia purpurea* [6]. The high diversity of tree species could reduce outbreak diseases, as different types of plants endured different pest and disease attacks.

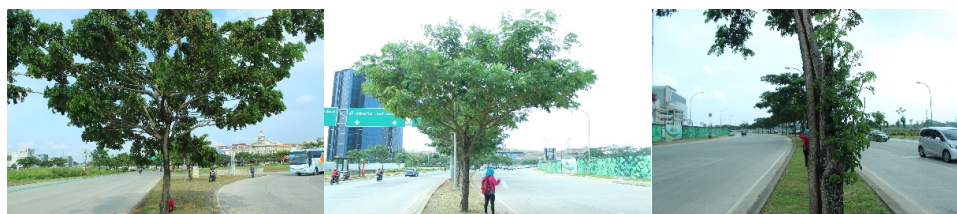
**Figure 5.** Landscape and road trees condition of Jalur Sutera Boulevard.

The observed tree of Jalur Sutera Boulevard was located at a road median with a total of 52 trees (figure 4). Trees were located along the road to Synergy Building. The general condition of these trees were younger than those in the Alam Sutera Boulevard (figure 5).

Percentages of pest and disease damage to trees on the Jalur Sutera Boulevard were numerous (table 4). It was investigated that pest and disease damage were in the 4th rank (46%). Mechanical damage was ranked 2nd (77%). Based on this condition, the tree on the Jalur Sutera Boulevard was ranked 2nd (98%). This indicated that the trees in the Jalur Sutera Boulevard were in a state of minimal damage. It was known that *Samanea saman* was one of the introduced tree species. The use of native or indigenous species is encouraged in urban greening programs in order to maintain ex situ species conservation. Furthermore, native species are inherently well suited to their original habitat [6].

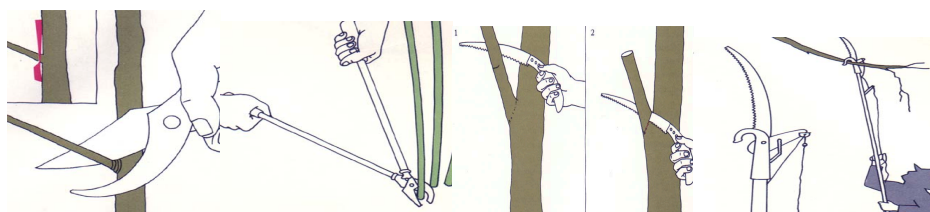
Figure 6. Tree branches and stems pruning methods. Source: [3]

Pruning: Types of tree pruning could be distinguished by their purposes, i.e. pruning for tree health, tree performance, and user safety [3]. To avoid damage to the bark, the method of pruning branches and tree trunks should be held properly (figure 6).

Proper pruning treatment, both on and after, can increase the strength of branch growth. Pruning as a disease control is done by cutting the stem is stricken up to 10 cm below the affected or infected. Then, the cut wound is smeared with 70% ethyl alcohol. Should be avoided pruning when the leaves

are still wet because parasitic organisms will be easy to develop [3]. All 122 trees require pruning due to the condition of the tree when observed to be damaged by pests and diseases and stems and dried branches.

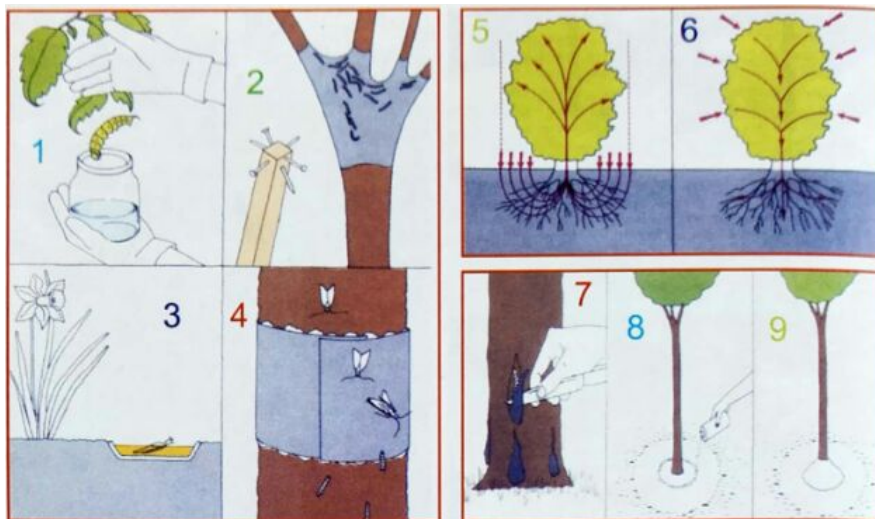
Figure 7. Various ways of pest & disease controls. Source: [3]

Pests and diseases can attack all parts of the plant, ranging from flowers, fruits, leaves, branching, stems, to the rooting. This damages the aesthetic appearance and can lead to death in the tree. Trees that need to be reduced are dead, harmful, coincident, disease-threatening and can threaten other trees or disrupt electricity and telephone lines. The ranking of damage caused by pests and diseases that require rapid handling was ranked 3rd and 4th, whereas damage attacks were numerous and very many. In the ranking there were a total of 102 trees with the highest number on Alam Sutera Boulevard as many as 63 trees and on Jalur Sutera Boulevard of 39 trees. Control of pests and diseases could be done mechanically, physically, biologically, through quarantine, cultivation techniques and chemicals by using pesticides. The control of pests and diseases on trees in Alam Sutera Boulevard can be done mechanically which is the easiest way. The trick is to take an attacking pest, then kill it with a hand or a certain tool, then remove the sick or damaged plant parts (figure 7). Physical control method can be done through stages as followed: (1) Manual take by hand; (2) Shut-down with a nail-striker; (3) Blocking with physical boundary traps; (4) Making of a trap that will be visited by insects; (5-6) Chemical way with rooting and spraying; (7) Cleaning the affected part of the insect; (8-9) The treatment of chemical pesticides by rooting.

Remarks: (1) hand manual; (2) nail-striker; (3) boundary traps; (4) insect trap cover; (5-6) Chemical way with rooting and spraying; (7) Cleaning the affected part of the insect; (8-9) The treatment of chemical pesticides by rooting.
