An Unusual Source of Multiple ESD Events in Electronic Equipment

Abstract. Small wall mounted power supplies that plug directly into AC power mains and furnish power, usually low voltage DC, to equipment over a low voltage cable are ubiquitous in the electronic field. It is shown that these low voltage supplies can be the source of multiple ESD events that are fed to the connected system on the low voltage cable when an ESD event is applied to the system or directly to the power supplies. The multiple ESD events produce nasty current waveforms. Examples of these waveforms and the measurement method are given. The results have been duplicated in three laboratories, results are presented from two of the three.

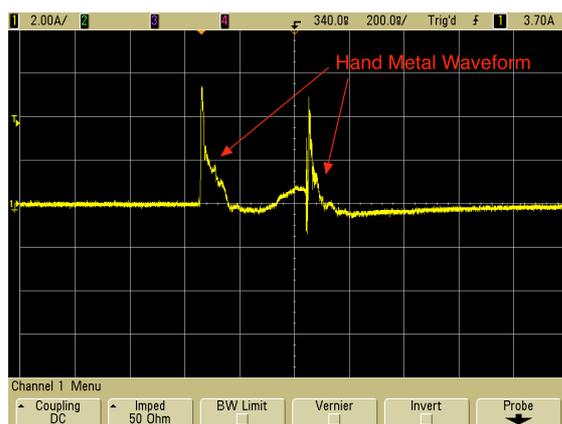
Figure 7 shows an initial applied current waveform *and* a secondary one having the appearance of a human metal waveform, similar to that described in IEC 61000-4-2.[1] However, a secondary event shown in Figure 8 has the appearance of a cable discharge event, having a flat region of current corresponding to the discharge of a common mode transmission line.[2] Note the duration of about 20 nanoseconds. This is the expected time delay around the loop of the low voltage power cord of the power supply and the ground lead of the ESD simulator.

Figure 7. Secondary event showing human metal waveform characteristics. Scale factors: 2 A/div and 200 ns/div.

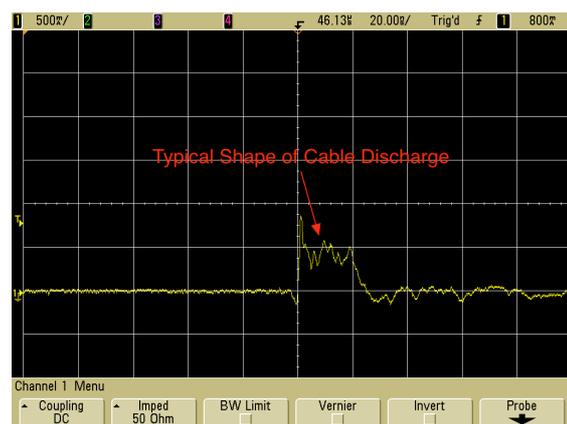
Figure 8. Secondary event showing cable discharge waveform characteristics with 20 ns width. Scale factors: 500 mA/div and 20 ns/div

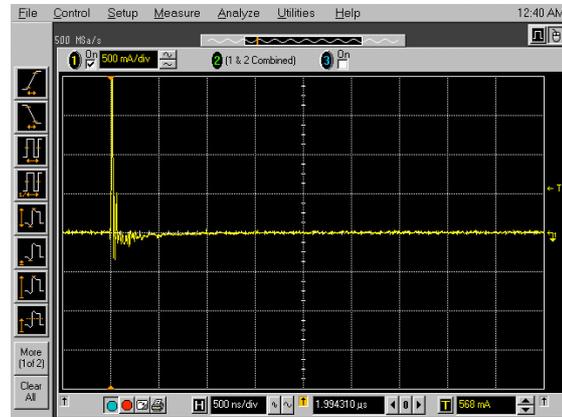
Figure 9 shows a similar waveform to those above, but taken at a different laboratory using different equipment except for the current probe. To make sure the current probe or scope was not contributing significantly to the observations, Figure 10 shows the current waveform when the ESD

simulator ground lead was connected to the simulator tip with the F-65 current probe measuring the current in the loop. As one can see, there is no evidence of any secondary events.

Figure 10. Current measured in ESD simulator ground lead shorted to the simulator tip showing no secondary discharges. Scale factors: 500 mA/div and 500 ns/div.
