# New insights into the Mechanisms of Cavitation Erosion

**M Dular, M Petkovšek**

Laboratory for Water and Turbine Machines, Faculty of Mechanical Engineering,  
University of Ljubljana, Askerčeva 6, 1000 Ljubljana, Slovenia

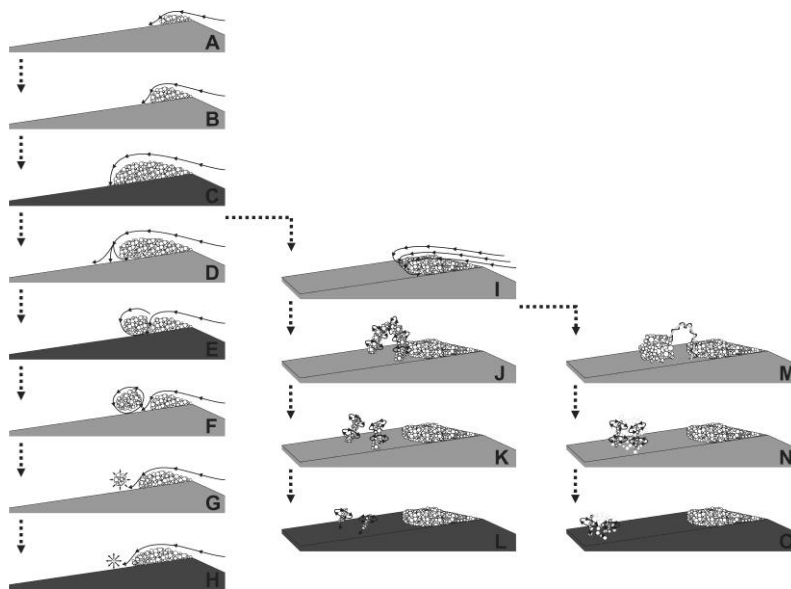
The instants (C, E, H, L and O) when the damage occurs are highlighted by the darker colour.

**Figure 1.** Representation of observed mechanisms that lead to occurrence of cavitation erosion.

Not less than 5 different mechanisms that lead to the formation of the pit were determined, although it is possible that the physical background of some is more or less the same.

### 3.1. Closure of the attached cavity (C in Figs. 1 and 2)

During the shedding process the outer flow, due to the pressure difference between cavity exterior and interior, deviates towards the solid surface and creates a stagnation point with elevated pressure. For erosion to occur small scale cavitation structures (single bubbles, which sporadically break off from the attached cavity) must enter the region of higher pressure in the vicinity of the solid surface, and violently collapse. This, however, occurs very rarely due to the fact that the developing re-entrant jet blocks the shedding of small scale structures.

### 3.2. Cavitation cloud separation (E in Figs. 1 and 2)

As the re-entrant jet loses momentum it turns upwards cutting the attached cavity into two parts. At this moment the gap between the cloud and the attached cavity is filled up with liquid causing an increase of the pressure. Again small scale structures that are present in the gap collapse and cause pit formations.

### 3.3. Spherical cavitation cloud collapse (H in Figs. 1 and 2)

Most often erosion is associated with the collapse of primarily cloud cavitation, referring to the fact that collective collapses of interacting bubbles in the cloud are shown to be very effective in focusing collapse energy into a small spot, and typically generate significantly larger collapse pulse amplitudes than singly connected cavities. According to the energy cascade approach [2] the pressure waves emitted at the cloud collapse spread and cause implosion of micro-scale single bubbles in the vicinity of solid structures – causing pitting and eventually erosion.

### 3.4. Horseshoe cavitation structure collapse (L in Figs. 1 and 2)

Cavitating vortices, which appear in a form of a horseshoe shaped structure, are known to be responsible for severe erosion in fluid machinery.

We could observe that the damage occurs as the vortex begins to break up. Pits appear in the region where the vortex leg touches the surface, thus implying that the breakup of the vortex “leg” and consequent focusing of acoustic energy in space and time (as postulated by van Terwisga et al. [10]) increases the aggressiveness and causes the formation of the pit.

### 3.5. “Twister” cavitation structure collapse (O in Figs. 1 and 2)

We believe that the origin of the “twister” type of cavitation structure is the same as for the horseshoe structure. The vortex is produced at the breakup region, but it remains liquid. As it is carried downstream by the flow it interacts with the cavitation cloud, what causes it to cavitate. This, like in the case of a breakup of a horseshoe cavitation structure, focuses the acoustic energy towards the solid material.

We can again see that the damage is concentrated in the region where the twister touches the solid surface and that it generally occurs when the vortex breaks-up.

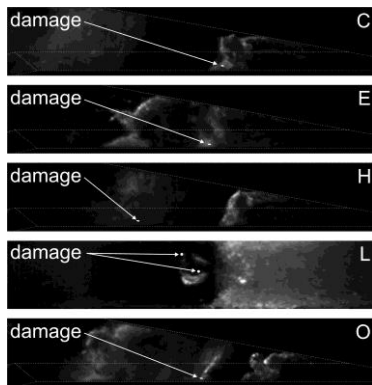
The damage in Fig. 2 is enlarged (3 times) for better representation and appears smaller in reality (its position and shape are not altered). A deeper discussion of the mechanisms follows.

**Figure 2.** Cavitation structures at the moments at which the damage appeared on the foil. The position and the size of the damage were obtained from the images of the foil and were superimposed to the images of the structures.

In the following we present the results of extensive image analysis. In the process, first the instant of the damage occurrence was determined by comparing pairs of successive images of the foil. Then the evolution of cavitation structures during this period was analyzed and correlations between the two were investigated. Figure 1 represents the time evolution and the variants of the shedding that lead to different mechanisms of cavitation induced damage, which were observed during our study (Fig. 2).

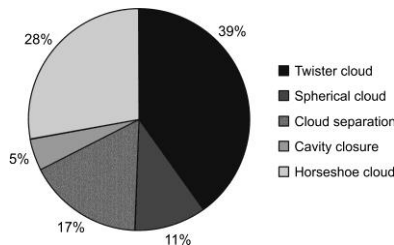
The importance of individual mechanism can be defined by the product of its probability of occurrence and the damage (averaged damaged area sustained during individual events) it causes. A large ensemble of the data (over 3000 shedding periods) enables statistical evaluation of the probability of occurrence and the erosive potential of the mechanisms – Fig. 3 shows the results.

**Figure 3.** The relative importance of individual mechanism.

One can see that, the cloud implosion combined (the sum of the importance of the twister cloud, the horseshoe cloud and the spherical cloud) contributes to almost 80 % of the damage – it is clear why numerous researchers stressed so much importance to it. Between the mechanisms the twister cloud implosion is the one to be most considered. It appears frequently and is aggressive; hence it contributes to 39% of the sustained damage. A very important mechanism is also the horseshoe cloud implosion – mainly due to its aggressiveness. It is possible that its importance is even greater in channels with wider span, where the horseshoe vortex can more easily develop.

Surprisingly important is the mechanism of cavitation cloud separation from the attached part of the cavity, which was, prior to this study, probably mistaken for the mechanism of cavity closure, since they both contribute to damage in a similar region. The later is of an insignificant importance.
