Identification of Delamination in Concrete Slabs by SIBIE Procedure

M. Yamada¹, Y. Yagi¹ and M. Ohtsu²

Abstract. The Impact-Echo method is known as a non-destructive testing for concrete structures. The technique is based on the use of low-frequency elastic waves that propagate in concrete to determine the thickness and to detect internal flaws in concrete. The presence and locations of defects in concrete are estimated from identifying peak frequencies in the frequency spectra, which are responsible for the resonance due to time-of-flight from the defects. In practical applications, however, obtained spectra include so many peak frequencies that it is fairly difficult to identify the defects correctly. In order to improve the Impact-Echo method, Stack Imaging of spectral amplitudes Based on Impact-Echo (SIBIE) procedure is developed as an imaging technique applied to the Impact-Echo data, where defects in concrete are identified visually at the cross-section. In this study, the SIBIE procedure is applied to identify the delamination in a concrete slab. It is demonstrated that the delamination can be identified with reasonable accuracy.

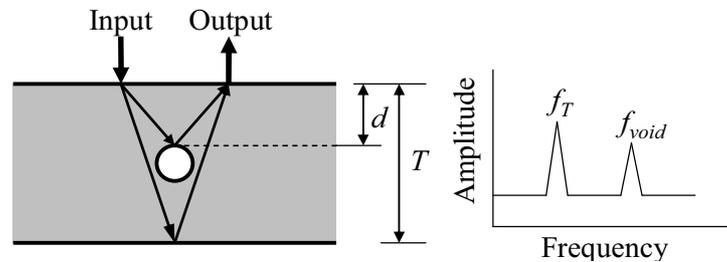
Figure 1. Principle of void detection.

The principle of void detection in the Impact-Echo is shown in Figure 1. When the elastic wave is driven, the paths of the elastic wave are shown. Frequency spectrum is analyzed by Fast Fourier transform (FFT), applying to an obtained waveform detected at the output point. As shown in the figure, peak frequencies could appear at f_T and f_{void} , which correspond to resonant frequencies due to the thickness of a plate and the depth of a void, and are calculated as,

$$f_T = C_p / 2T, \quad (1)$$

$$f_{void} = C_p / 2d, \quad (2)$$

where C_p = velocity of P-wave, T = plate thickness, and d = covered depth. The plate thickness and the cover depth are obtained by substituting f_T or f_{void} with C_p into these equations.

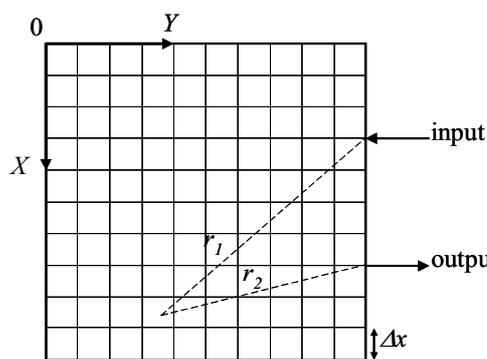
Figure 2. SIBIE imaging model.

SIBIE procedure is a post-processing technique to Impact-Echo data. This is an imaging technique for detected waveforms in the frequency domain. In the procedure, first, a cross-section of concrete is divided into square elements as shown in Figure 2[5]. Then, resonance frequencies due to reflections at the elements are computed. The travel distance from the input location to the output via the element is calculated as,

$$R = r_1 + r_2. \quad (3)$$

The resonance frequency due to reflection at each element is calculated from,

$$f_R = C_p / R, \quad (4)$$

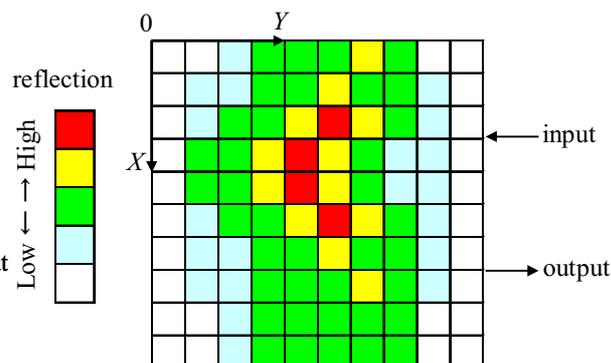
Figure 3. Example of SIBIE result.

Spectral amplitudes corresponding to the resonance frequencies in the frequency spectra are summed at the elements. Thus, reflection intensity at each element is estimated as a stacking image as shown in Figure 3[5]. The minimum size of the square element, Δx , for the SIBIE analysis is approximately equal to $C_p \Delta t / 2$.

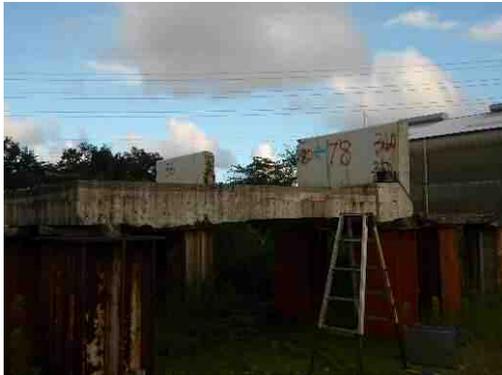
Picture 1. Deck slab

Picture 1 shows a deck slab, which was removed from a bridge. In this deck slab, delaminated areas were found at some locations. One delamination was located at 160 mm depth from the top of the slab. Tests were conducted at three area of the slab which are selected as shown in Picture 2, 3, and 4. Picture 2 shows the normal area of the deck which has the pavement of 70 mm depth and an existing slab of 250 mm thickness. Picture 3 and Picture 4 show the overlaid areas of the deck with slabs of 250 mm thickness. The former has the pavement of 70 mm depth and the overlaid slab of 90 mm thickness

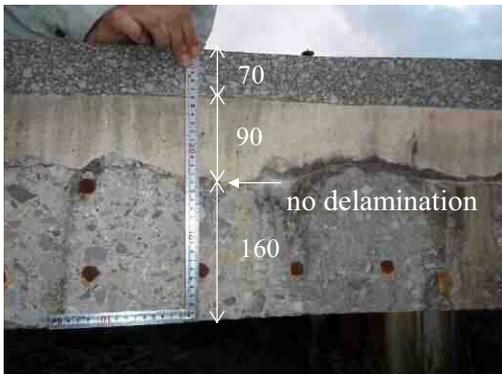
Picture 3. Overlaid area (no delamination)

without a delamination below. In the latter, a delaminated area is observed between the overlaid slab 90 mm thick and the existing slab 160 mm thick.

SIBIE result of the impact test for the case at the overlaid area (Picture 3) is shown in Figure 7. Red and yellow color of high reflection are clearly observed at the bottom of the deck again. There are no other high reflections observed at the cross-section. Thus, no differences are observed between the SIBIE result at the normal area and that of the overlaid area.

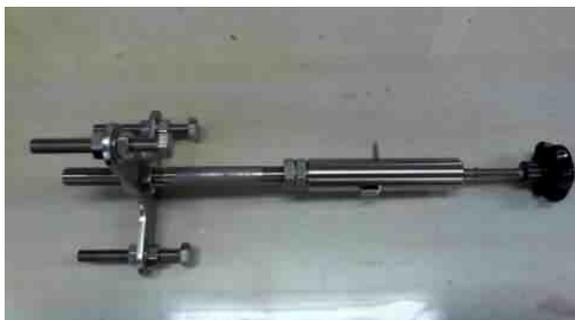
Picture 5. Impactor

Picture 5 shows the impactor, which is equipped with accelerometers. It is confirmed that the upper-bound frequency due to the impact could cover up to 30 kHz, by using an accelerometer system. Fourier spectra of accelerations were analyzed by Fast Fourier Transform (FFT).

Impact test was done once at each point, normal area, overlaid area, delaminated area, respectively. The impactor was shot by spring with 100 N to generate elastic waves. Sampling time of the wave recorded in Picture 6 was 4 μ sec and the number of digitized data for each waveform was 2048.

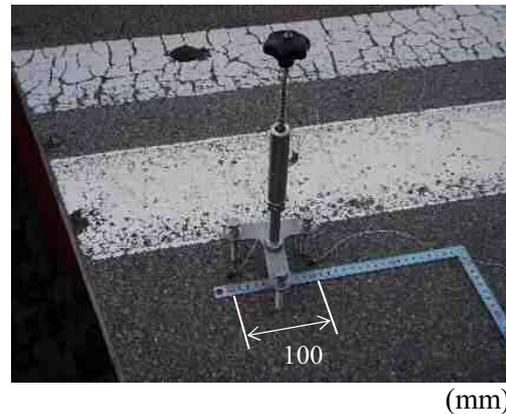
Picture 7. Impact point

The locations of impact and two detection points are also shown in Picture 7. Two accelerometers were placed at the detection points to record surface motions caused by reflections of the elastic waves. Here, the interval between the impact point and the detection point is 50mm. P-wave velocity is a very important parameter in using SIBIE procedure. P-wave velocity of the test deck slab was obtained as 4500 m/s by the Impact-Echo method [6].

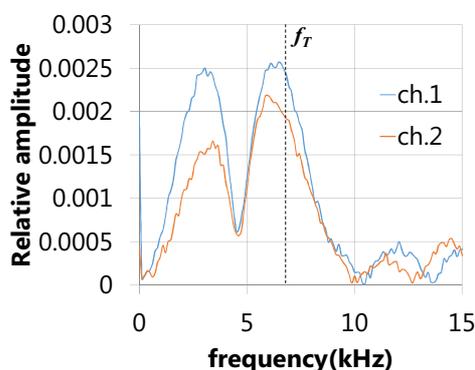
Figure4. Impact-Echo result at normal area

The result of Impact-Echo method is given in Figure 4. Figure 4 is the spectrum of the impact test at the Normal area. Calculated values of the resonance frequencies due to thickness, $f_r = C_p/2T$ is indicated with a block line. It can be seen from the frequency spectrum that there is the peak at f_r , however, it is difficult to identify the peak only from the spectrum.

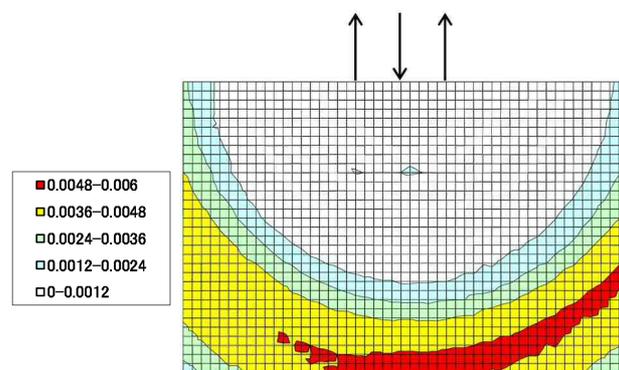
Figure5. SIBIE result at normal area

The SIBIE result at the normal area is given in Figure 5, which shows a cross-section of the deck (Picture 2). The size of cross-section is 320 mm × 500 mm. The red color regions indicate the highest reflection of the elastic wave. The impact point and the detection points are indicated by a downward arrow and upward arrows, respectively.

It is clearly seen that there exists high reflection zone only at the bottom of the deck. There are no other high reflections observed at the cross-section

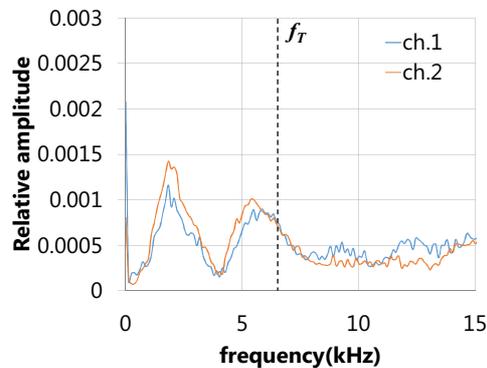
Figure6. Impact-Echo result at overlaid area

In Figure 6, frequency spectrum obtained by the impact-test is shown. The resonance frequency f_r is observed at 7.03 kHz, although it is not a strong peak.

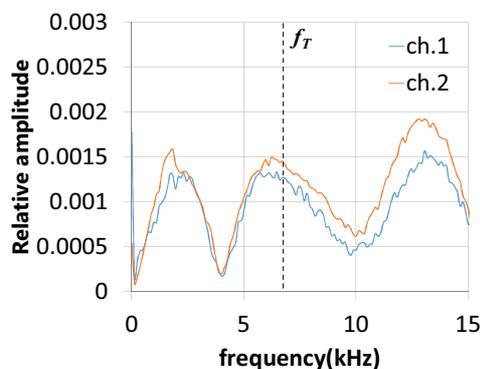
Figure8. Impact-Echo result at delaminated area

Figure 8 shows the result of Impact-Echo method at the delaminated area. The resonance frequency of delamination at 160 mm depth is calculated as 14.1 kHz is observed, and it's amplitude is higher than the resonance frequency f_r at 7.03 kHz.

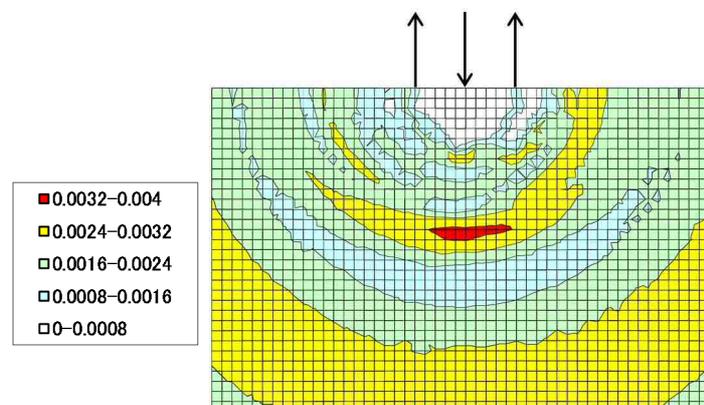
Figure9. SIBIE result at delaminated area

In Figure 9, SIBIE result of the impact test for the case at the delaminated area is observed. The high intense region due to the delamination is observed at 160 mm from the top of the deck, while the high intense red regions can not be observed at the bottom. From this result, it is confirmed that the SIBIE procedure is available for void detection.

- (1) In the concrete slab taken out of a bridge, it was found to be not easy to identify the resonant frequencies of delamination and thickness only from the spectra obtained by the Impact-Echo method.
- (2) According to the SIBIE results of normal area and overlaid area, there exist high reflection zones only at the bottom of the deck. On the SIBIE result of delaminated area, in contrast, the high intense region of reflection due to the delamination is observed clearly at 160 mm from the top of the deck. Therefore, it is confirmed that the location of the delamination can be clearly identified using the SIBIE procedure.
