Failure Analysis of Fencing Blades

Abstract. This study deals with the failure analysis of broken fencing blades (one épée and one foil). For the characterization of the broken blades, metallographic examinations, chemical analysis, hardness measurements, fracture surface examinations and tensile tests were performed. Maximum stress occurred at the outer fibres of the blades was estimated as high as 1456 MPa and 1298 MPa for épée and foil, respectively. Results showed that failure of the blades was initiated from a notch, which has been formed as the result of an impact action during training, or from the groove machined along the blade for inserting an electrical wire. In order to increase resistance of the blades against such failures, alternative blade material, modified blade geometry and a surface hardening treatment were proposed.

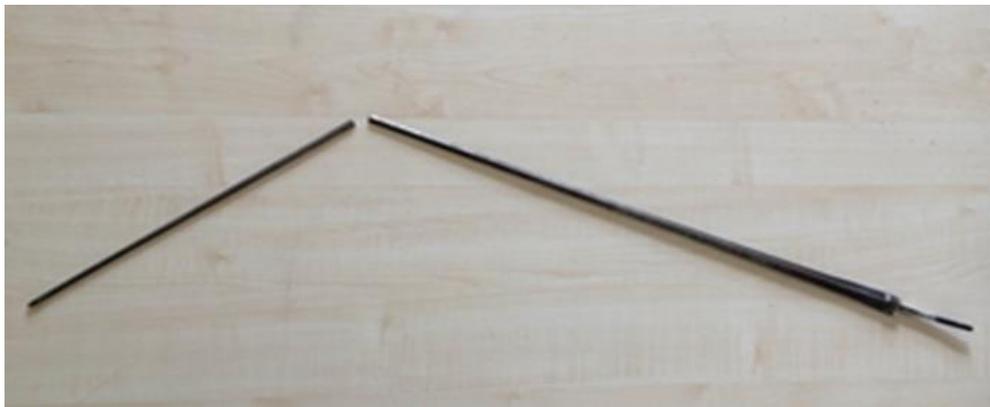
Swords which have been taken from ITU Fencing Club were examined. Some of the swords were broken during trainings or competitions as shown in figure 1. Duration until breakage can vary depending on the quality of blades. The higher the quality, the longer will be the durability of the weapon.

Figure 1. General view of a broken blade (épée).

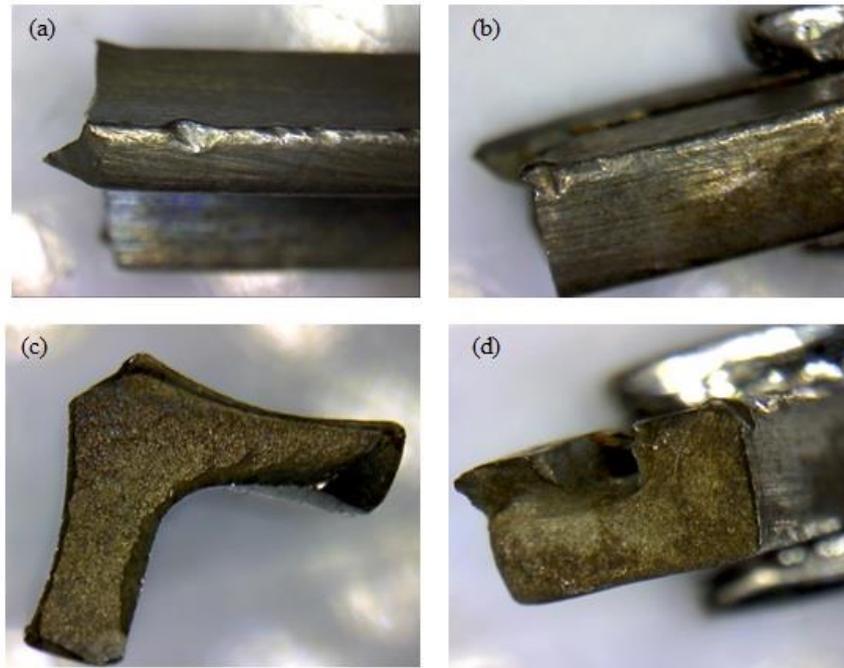
Figure 4 shows surface flaws and general view of fracture surfaces of the investigated blades. Location of the surface flaws shown in figure 4a and b were at the edges of the blades and possibly resulted from the opponent's strikes during training. These types of defects are capable of leading fracture of the blades by initiating a crack due to notch effect. Figure 4c and d demonstrate that the cracks can also be originated from the grooves, where stress concentration is high. It can be observed that fracture characteristics of both épée and foil were brittle in nature without exhibiting any significant plastic deformation as shown in figure 4c and d. SEM fractographs shown in figure 5a and b revealed that general characteristics of the fracture surface were mixed mode fracture which contains intergranular brittle fracture and dimple areas.

Figure 4. Surface flaws on the surface of (a) épée, and (b) foil, and general view of fracture surface of (c) épée and (d) foil.

Another solution to prevent failures of the blades can be surface hardening of the blades by a proper heat treatment to increase their resistance to fencer's strikes. For this purpose, the proposed heat treatment is nitriding without formation of a brittle white layer. It can be carried out by forming nitride layers composed of S-phase which is a metastable nitrogen supersaturated phase on the surface and it is possible to apply it to spring steel with either gas or plasma nitriding methods [10]. By means of

nitriding, formation of notches on the surface of the blades becomes more unlikely and fracture possibility decreases.
