The experience of Taiwan photon source commissioning and operation

Y C Liu, C H Chen, J Y Chen, M S Chiu, P J Chou, C S Huang, Sam Fann, C C Kuo, T Y Lee, C C Liang, G H Luo, H J Tsai, F H Tseng
Synchrotron Radiation Research Center, Hsinchu 30076, Taiwan

Abstract. TPS commissioning occurred between August 2014 and March 2016. The experience of phase I (bare lattice 2014.8~2015.3) and phase II (SRF and insertion devices 2015.9~2016.3) commissioning will be discussed. The Taiwan Photon Source (TPS) started user operation in March 2016 and delivery of user time has reached 3,211 hours in 2016. Continuous improvements of integrated accelerator performance and future developments are described and discussed.

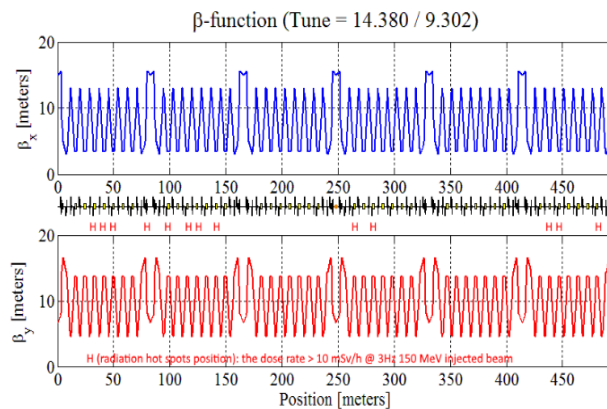
Figure 1. Booster beta functions in DC mode with the red H indicating the distribution of high radiation dose rates (> 10 mSv/h), large horizontal orbit (± 4 mm) was measured. Simulation with distorted magnetic fields indicated that linear optics were severely changed and dynamical aperture was very poor.

In the first step of booster commissioning it took three months without getting a stored beam at 150 MeV. Several improvements were implemented, including modification of the injection kicker field uniformity and post pulse residual from 2% to 0.4%, realignment of the booster vacuum chamber from ± 6 mm to less than ± 1 mm in the vertical plane, improvement of the chamber alignment by installing fixtures at both sides of dipole magnets and quadrupoles to ensure an accurate gap between chamber and magnets. Roughly 30000 turns of injected electron beam could be achieved as shown. Figure 1 shows the radiation dose distribution as measured at every booster dipole to possibly detect the most likely beam loss location.

The booster vacuum chamber was found to be magnetic by touching the vacuum chamber with strong magnets on November 12, 2014. It took one month to uninstall all vacuum chambers, to anneal them at 1050 °C for demagnetization, reinstallation and final pump down. The injected beam survived then 50 ms on December 11, and after turn on of the RF system stored beam was achieved on December 12. The beam injected at 150 MeV was then successfully accelerated to 3 GeV on December 16 [6]. After replacing several silicon controlled pulser rectifiers for the injection septum, 3 GeV storage ring commissioning started on December 31, and a stored beam could be accumulated up to 5 mA only a few hours later.

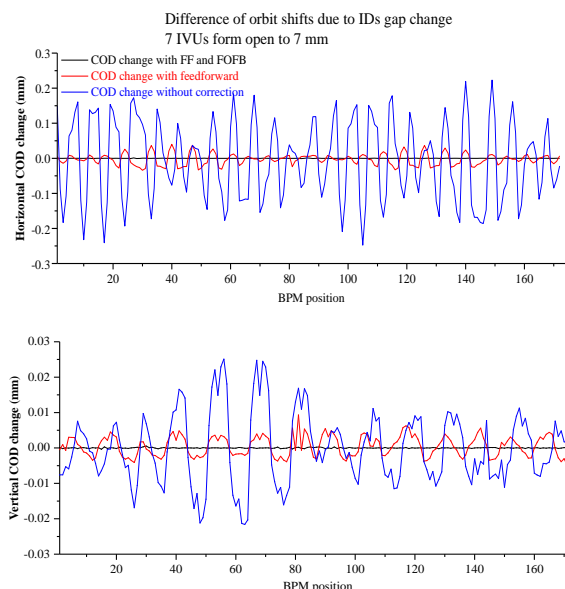
Figure 2. Difference of the orbit shift for 40 mm and 7 mm gaps of seven IVUs with and without feed forward and FOFB.

To compensate for linear optics perturbations caused by insertion devices (IDs) we employed orbit feedforward tables for all IDs as well as tune and coupling feedforward tables for three elliptical polarization undulator (EPU). The tune shifts introduced by EPUs are minimized by adjustment of local nearby quadrupole pairs, while the coupling introduced by EPUs is minimized by a pair of nearby skew quadrupoles. Figure 2 shows the horizontal and vertical orbit shifts due to gap changes of seven In Vacuum Undulators (IVU) from 40 mm to 7 mm with and without feedforward and FOFB.

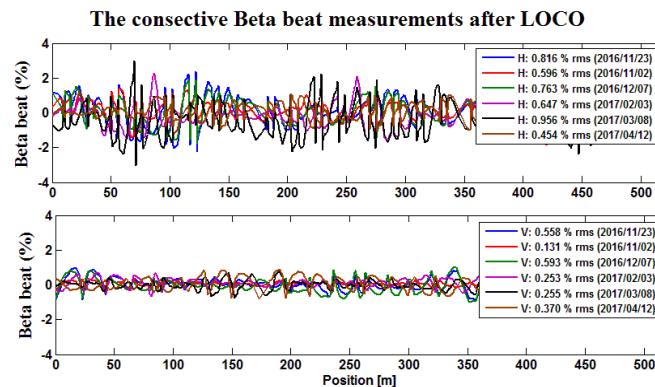
Figure 3. The consecutive beta beat measurements show that the LOCO procedure should be performed every month.

A number of procedures are now in use or under test to ensure reliable performance of beamlines. A diagnostic beamline, including a visible light synchrotron radiation interferometer and an X-ray pinhole camera, is used to measure the beam size from a bending magnet. The electron beam emittance can be determined from optical functions at the source point and measured beam sizes. The horizontal and vertical emittances are measured to be $1.64 \text{ nm} \cdot \text{rad}$ and $15.7 \text{ pm} \cdot \text{rad}$, respectively, while the emittance coupling ratio is measured to be 0.96 %. This result is in good agreement with the expected natural emittance of $1.6 \text{ nm} \cdot \text{rad}$ and 1 % coupling ratio. The linear optics of the storage ring is corrected by the widely used algorithm LOCO, “linear optics from closed orbit”. LOCO is used to calibrate the linear optics and to maintain the symmetry of the lattice and working tunes. Figure 3 shows that the LOCO procedure should be performed every month to maintain reliable daily operation.

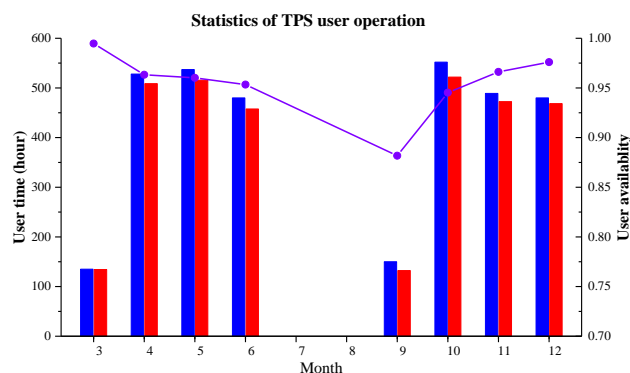
Figure 4. Statistics of monthly user beam availability.

To understand the performance of the accelerator facility, it is essential to measure three key parameters of machine operation, like user beam availability, Mean Time between Failures (MTBF) and Mean Time to Recovery (MTTR). The scheduled user beam time for TPS was 3351 hours in 2016, and the delivered beam time was 3211 hours resulting in 95.82 % beam availability for the first year of user operation, which just meets a typically expected user beam availability. The MTBF is 52.35 hours, based on a total of 64 faults and 2.15 hours MTTR. Monthly statistics of user operation are shown in Figure 4.
