Relation of dynamic parameters of brick masonry fragment at fracture under static and dynamic loading

Abstract. The article shows the results of experimental analysis of brick masonry fragments under static and dynamic loading. The measurements of fractures and natural vibration frequencies of samples have been carried out in the course of tests. It has been shown that at appearance of inelastic deformations and cracks, there is a change in natural vibration frequencies, received from the analysis of the corresponding spectra. Comparison of results of experiments of brick masonry fragments, received under action of static and dynamic loads has been carried out.

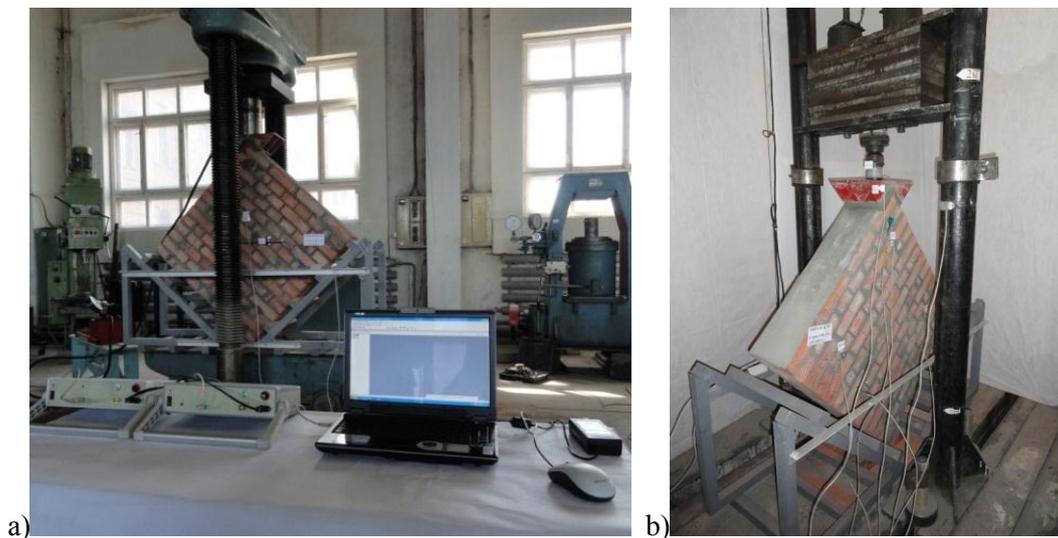
Figure 1. Overall view of testing bed: a) tests for action of static load; b) tests for action of dynamic load.

When conducting experiments on static force the load was applied from top to down along diagonal of the sample, put in load frame section of hydraulic press. Overall observation of tests is shown in Figure 1a. Fractures were measured by dial indicators and linear position sensors. Test of each sample had been carried out for 10 stages. Measurements of natural vibration frequency of sample were carried out while the increase of load at each stage of tests. These measurements allowed showing the influence of damage rate of tested samples on the change of their dynamic parameters.

Dynamic tests of studied samples were carried out on pile driver. Load action was accepted according to the scheme of static tests along a diagonal of sample (Figure 1b). The load on sample was performed by energy of falling weight. The impact accrued to the dynamometer, which was on distributing strongback. The mass of dropped weight was 500 kg, and drop height was ranging from 0,5 to 1,5 m. Series of impacts carried the samples of brick masonry to a limit state. Ultimate failure of samples or crack formation and crack opening more than 5 mm in brick masonry was accepted to a limit state. Measurements of accelerations, speeds and movements were performed during the experiment.

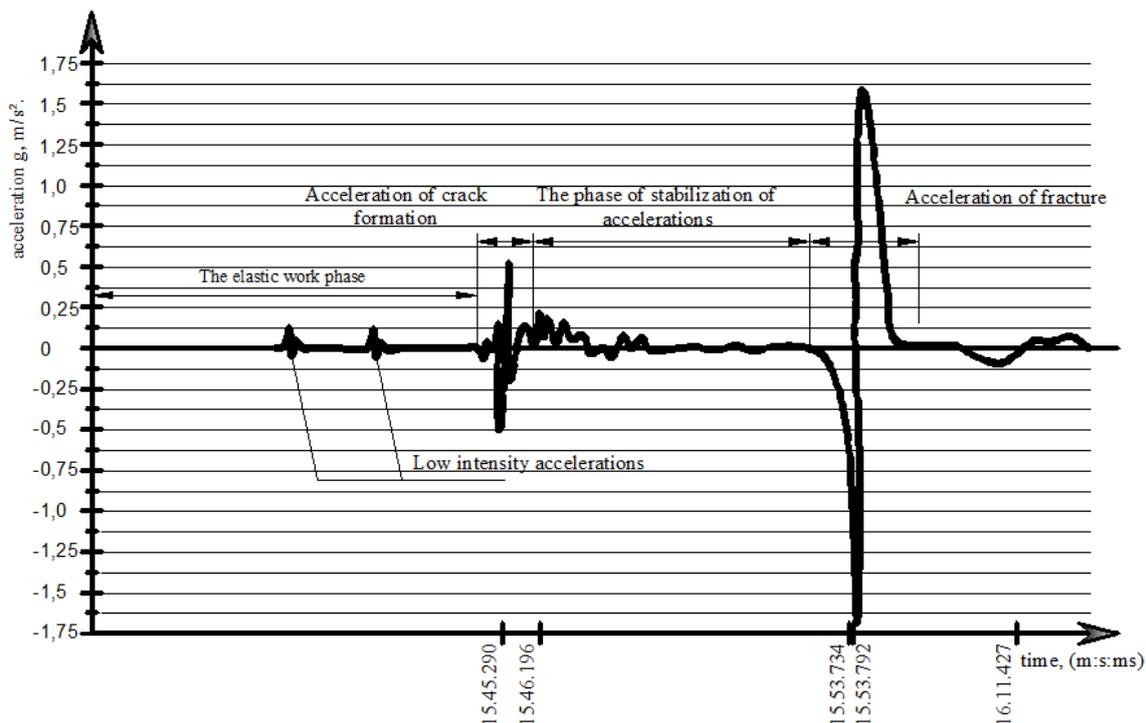
Figure 2. The chart of accelerations at masonry fracture under static load.

In order to receive information on the behavior of the sample under loading, accelerometer fixing dynamic parameters in two planes on surfaces of brick masonry in direction of sample diagonals was installed. By online measuring results, the chart of accelerations has been plotted (Figure 2). Referring to the chart, it is seen, that brick masonry fracture is accompanied by release of stored energy in the form of accelerations of various intensity [5].

With load increase to 0,6 Pfr (Pfr - fracture load), chart shows low intensity accelerations, caused by embrittlement of material and sampling of interwelded pinhole. It didn't cause decrease in natural vibration frequencies of the fragment. The load increase to 0,95 Rfr caused the appearance of inelastic deformations and vertical crack to 2,4 mm with the corresponding rush in accelerations to 0,5 g. The phase of stabilization of accelerations in the process of which there was a redistribution of internal forces in the body of masonry is characterized by the insignificant growth of fractures. The further load increase (to Pfr = 280,0 kN) led to the fast growth of fractures and loss of bearing capacity of the sample. Opening of existing cracks and formation of new ones, at the time of sample fracture, (Figure 3) caused the appearance of accelerations to 1,6 g, with the corresponding decrease in natural frequencies.

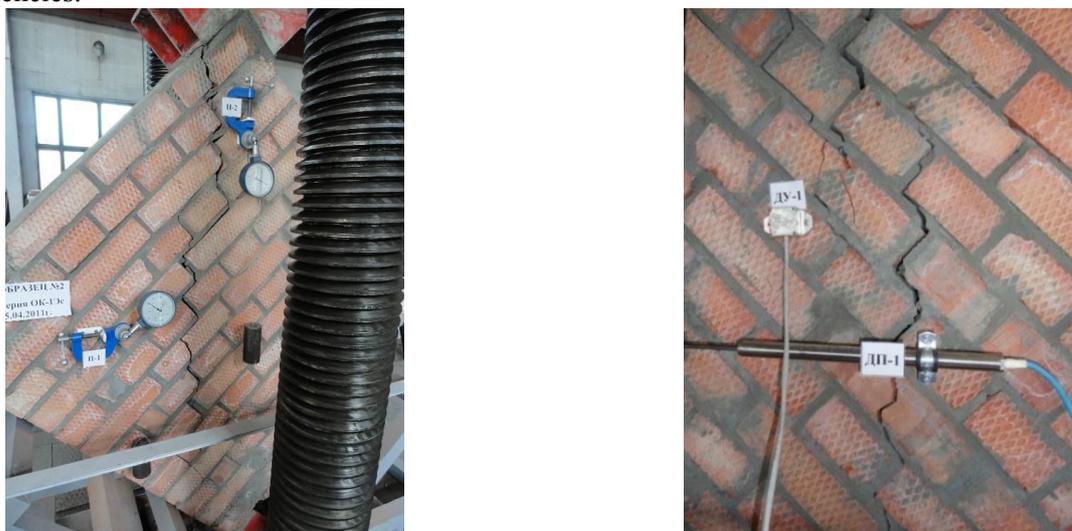
Figure 3. Fracture of samples under action of static force.

Tests showed that all samples had identical sequence of crack formation and fracture with the appearance of the first crack in the sample center along the pressed diagonal, with further crack opening up to ultimate failure. Similar nature of fracture of masonry and vibrated brickwork panels is established in works [2, 3, 4].

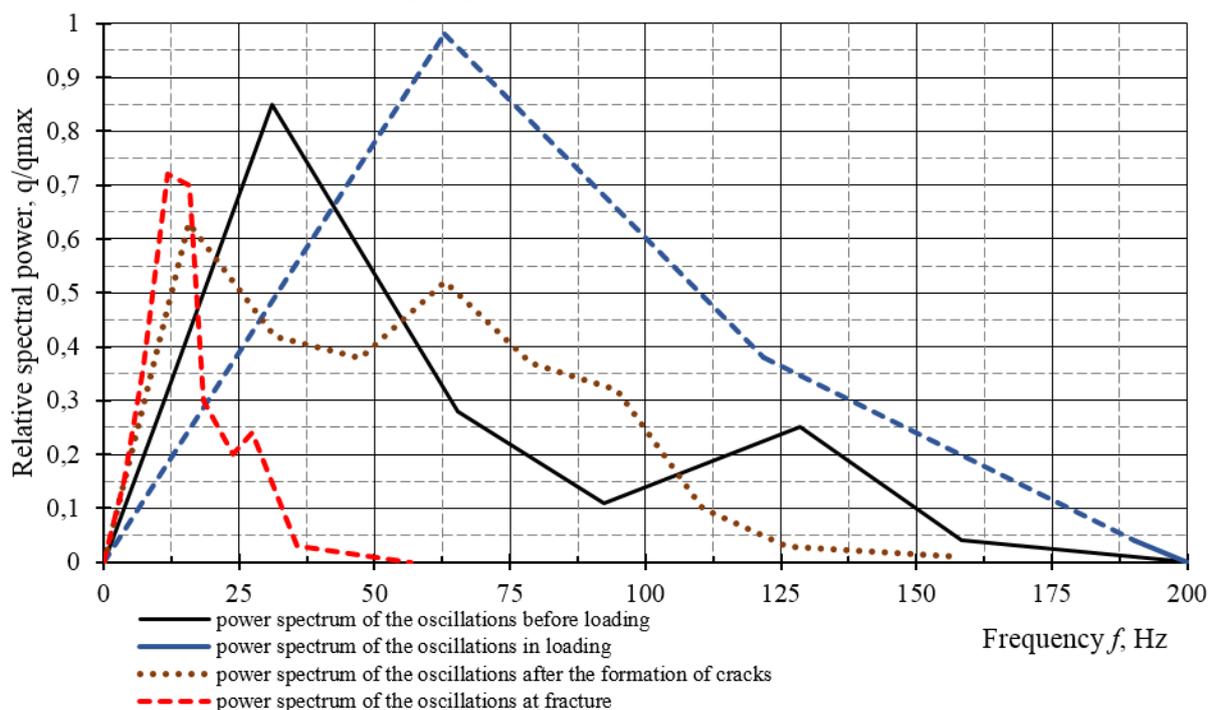
Figure 4. Ranges of vibration power of fragment at test for action of static force.

The measurement of natural vibration frequencies was carried out in the process of load increase at each stage of tests. Oscillations were excited by impact load and fixed by computing and measuring complex by means of accelerometer, installed on a lateral area of sample. The general spectrogram of natural vibration frequencies power of masonry fragment (Figure 4) has been plotted by results of measurements. The first measurement was performed while preparing of test sample. Oscillations were excited by impact load and fixed by computing and measuring complex. The "zero" load step is characterized by the corresponding range of frequencies.

Natural vibration frequency on the eigentone of not loaded sample is equal to 31,1 Hz. The static load of 32,0 kN applied at the first stage caused double increase in frequency due to inclusion of lower and upper support in work (Figure 4). At load increase to 208,0 kN there were higher frequencies on the accelerogram at almost not changing ranges of natural frequencies.

The load increase to 272,0 kN caused the appearance of inelastic deformations and vertical crack to 2,4 mm with the corresponding range expansion and its shift to the area of low frequencies (Figure 4). At the same time the lower value of frequency decreased from 60 Hz to 15 Hz.

The load increase to 280,8 kN led to sample fracture with the corresponding natural frequency decrease of the sample to 11,1 Hz (Figure 4).

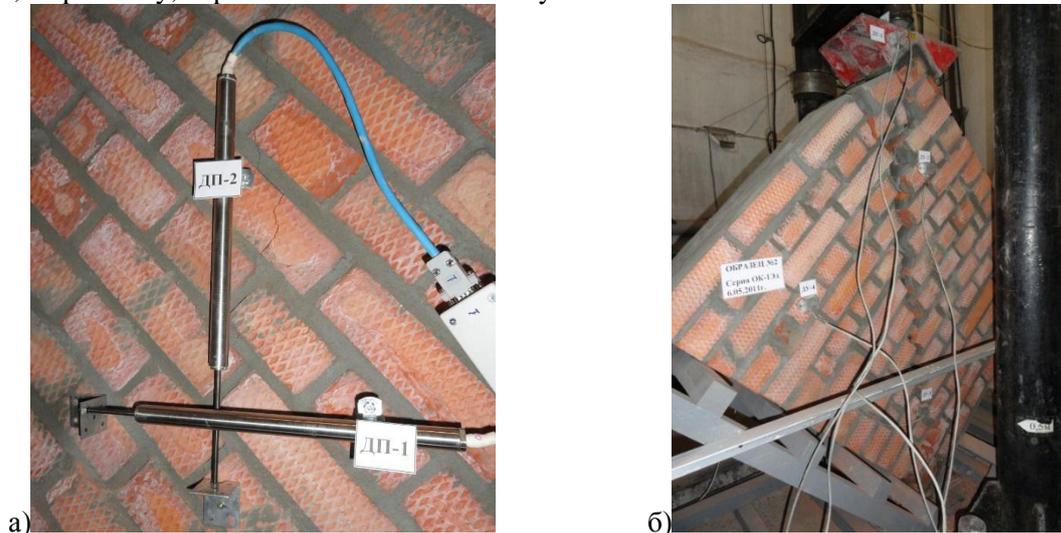
Figure 6. a) crack along the pressed diagonal after the first impact, b) masonry fragment fracture after the second impact

The first impact caused the crack appearance along the pressed diagonal the crack development was recorded by motion sensors installed in center portion of construction (Figure 6a). Crack opening width was of 1,7 mm.

Drop height of weight was reduced to 0,5 m at the second stage of tests, the mass of weight of 500 kg was not changed. Load time was of 19 ms with the maximum value of 210,8 kN. Load action on the second impact destroyed the sample in two approximately equal parts (Figure 6). Maximum value of accelerations of 49,3 m/s² was recorded in the first vibrations cycle. Action of the second impact was on the right part of fragment separated by crack. According to the power spectrum of vibrations, vibrations of the separated part generally happened on the first and third natural vibration frequency. Base frequency was of 31,11 Hz, and frequency in the third form of vibrations was of 92,7 Hz.

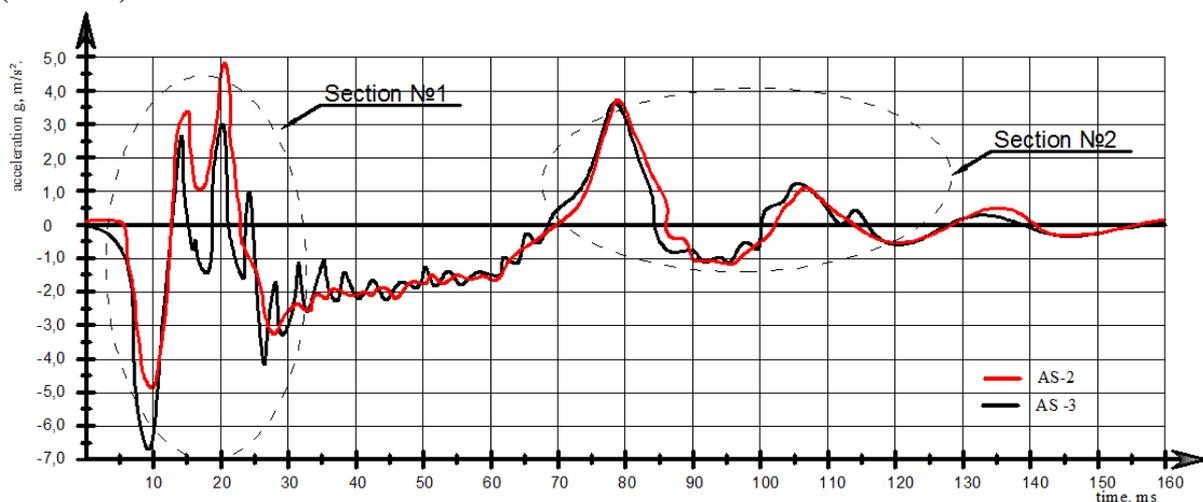
Figure 7. Vertical accelerations of sensor AS-2, AS-3 at the first impact.

Response of the sample to real load is reflected in charts of accelerations of AS-2 and AS-3 sensors, installed on the main diagonal in direction of real load (Figure 7). The specified sections of charts reflect sample variations at the action of impact load (section I) and after weight rebound (section II).

Acceleration sensor-2 (AS-2) located closer to strongback showed smaller values of accelerations in comparison with the acceleration sensor-3 (AS-3) located in the zone of structural bearing. Amplitude of accelerations of the above-located sensor AS-2 is of $48,41 \text{ m/s}^2$. Impact action caused the acceleration of structural bearing to $67,4 \text{ m/s}^2$ (AS-3). The corresponding power spectrum of vibrations is shown in Figure 8.

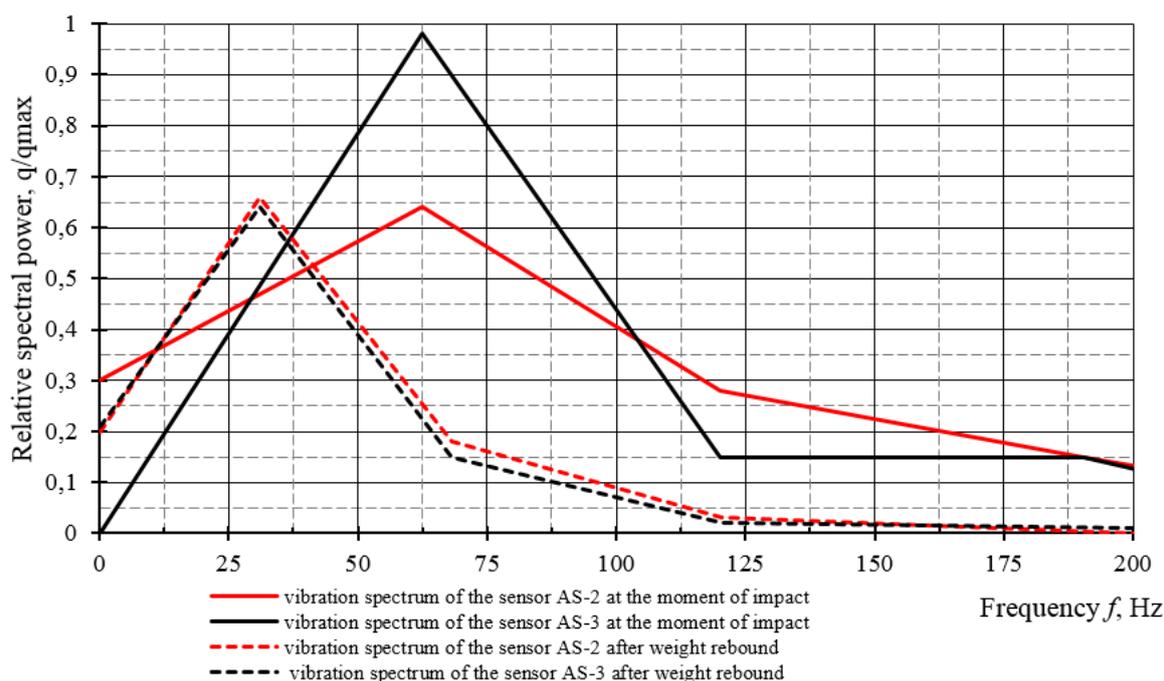
Figure 8. Power spectra of vibrations of sensors AS-2, AS-3 at the first impact.

The frequency of $62,34 \text{ Hz}$ corresponds to the eigentone of vibrations. Amplitude of vibration spectrum of sensor AS-2 is 1,5 times lower in comparison with amplitude of vibration spectrum of the sensor AS-3. It corresponds to more intensive process of deformation of sample bearing.

There were vibrations of load-free construction after weight rebound the second section of the accelerations chart in Figure 7 corresponds to this process. According to power spectrum of vibrations in Figure 8, the frequency of 31,3 Hz corresponds to the eigentone. Decrease in vibration frequencies to 31,3 Hz reflects the cracking in construction body with aligning of power spectra of vibrations of sensors AS-2, AS-3.
