# Study on Flexible Pavement Failures in Soft Soil Tropical Regions

**Abstract.** Road network system experienced rapid upgrowth since ages ago and it started developing in Malaysia during the colonization of British due to its significant impacts in transportation field. Flexible pavement, the major road network in Malaysia, has been deteriorating by various types of distresses which cause descending serviceability of the pavement structure. This paper discusses the pavement condition assessment carried out in Sarawak and Sabah, Malaysia to have design solutions for flexible pavement failures. Field tests were conducted to examine the subgrade strength of existing roads in Sarawak at various failure locations, to assess the impact of subgrade strength on pavement failures. Research outcomes from field condition assessment and subgrade testing showed that the critical causes of pavement failures are inadequate design and maintenance of drainage system and shoulder cross fall, along with inadequate pavement thickness provided by may be assuming the conservative value of soil strength at optimum moisture content, whereas the existing and expected subgrade strengths at equilibrium mo

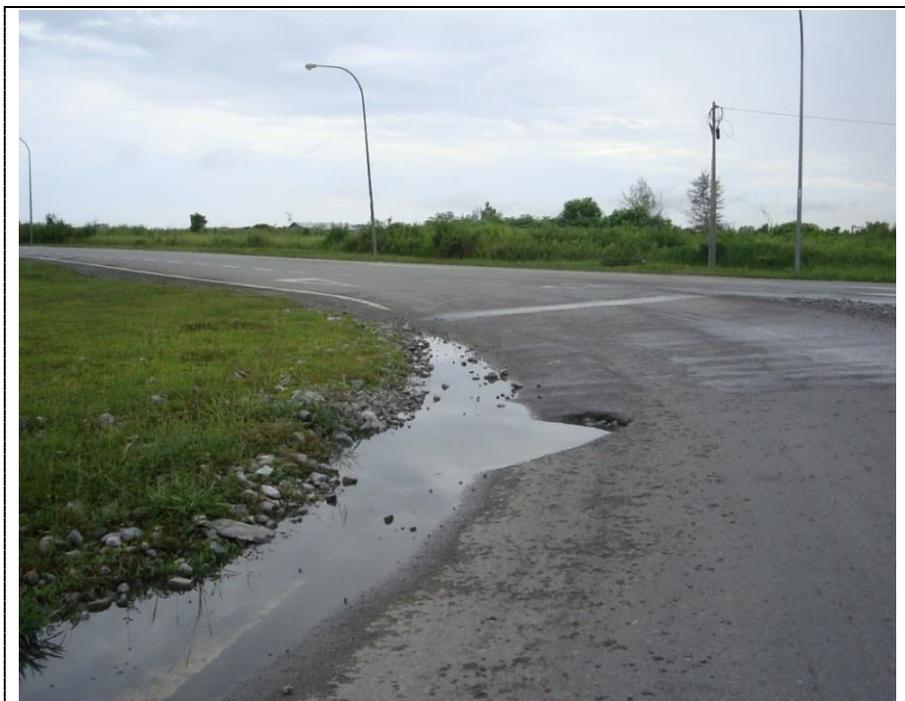
In addition to subgrade properties, inadequate and poorly maintained cross fall of shoulders and drainage systems are causing pavement failures. The pavement and shoulder condition observed at one of the junction in Road 5 during our survey is shown in Figure 4

**Figure 4.** Accumulation of water on turning junction of Road 5

As a viable solution for most of the defective flexible pavement in Sarawak and Sabah, cut the existing asphalt surface along with base material for the minimum of 250 mm depth, recycle with required amount of stabilizing materials such as cement, lime or mixture of fly ash and lime and lay as a subbase. The open graded bitumen stabilized natural gravel or crushed rock by removing the fines up to 2mm size for better permeability, is recommended as a road base. Particularly in the tropical regions for having a consistent design drainage capacity of shoulders, always maintain its cross fall, avoid planting trees or bushes at the edge of the shoulder before table drains. The trees may be planted in the reserve after the table or storm water drains.

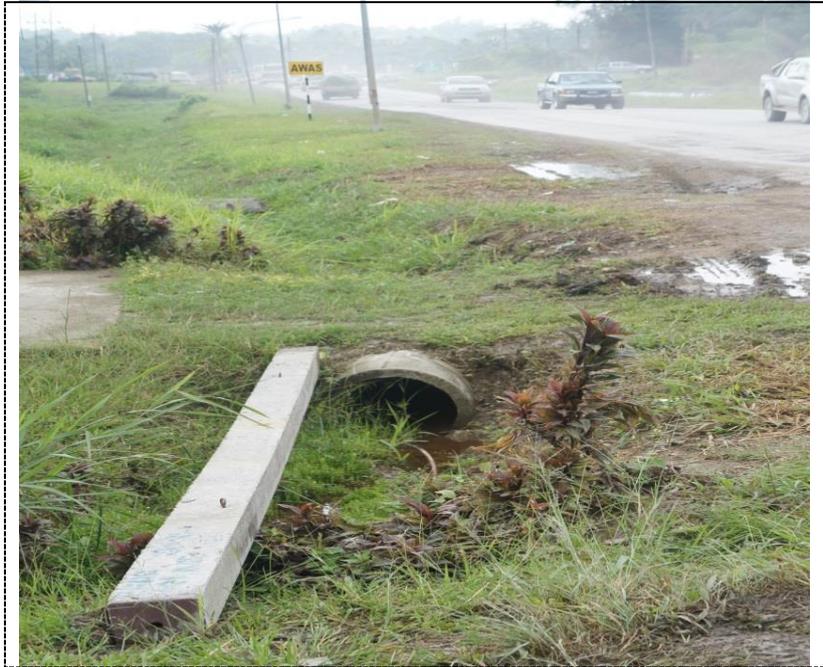
The condition of drainage structure is also one of the decisive causes of pavement failures. The main issue concerned is blockage in drainage structure due to deposition of silts, presence of excess grasses and waste products. One of the blocked drains observed at Road 2 is shown in Figure 5.

**Figure 5.** Blockage in part of a longitudinal drain in Road 2

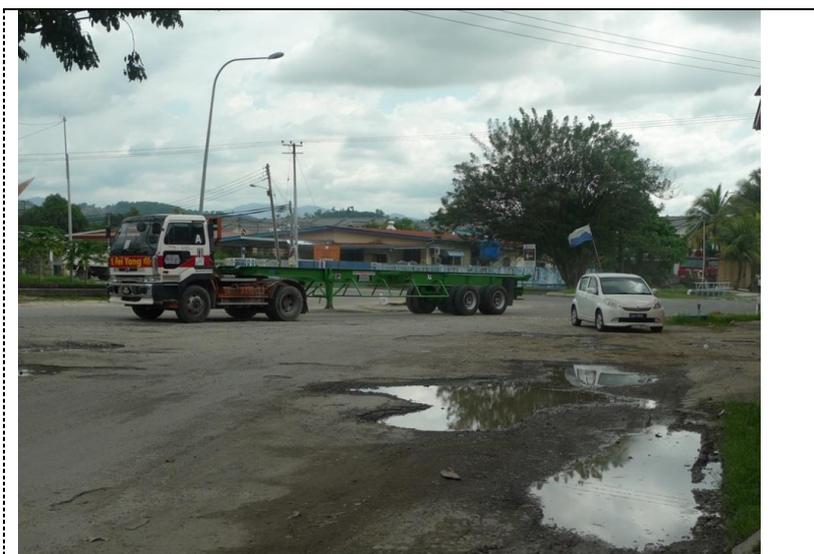
The effects of traffic loading could not be underrated along the entire life span of pavement. The heavy vehicle rolling loads are the critical causes for fatigue and rutting failures. Figure 6 shows the multi-axle heavy vehicle observed on Road 9 in an industrial area. Figure 7 shows the transportation of timber materials by heavy-loaded vehicles from Miri to Bintulu along Road 2. The pavement structures will be damaged significantly if they are not designed to carry the existing actual traffic loading capacity [14]. The soil sample collected in Road 2 showed large reduction of CBR in lab test for increasing very small amount of moisture content. The strength of the sensitive clay is highly susceptible to effect of moisture. The bearing capacity of sensitive clay would also suffer and has a constant reduction when the structure is subjected to cyclic loadings [15].

**Figure 6.** Multi-axle heavy vehicle on Road 9

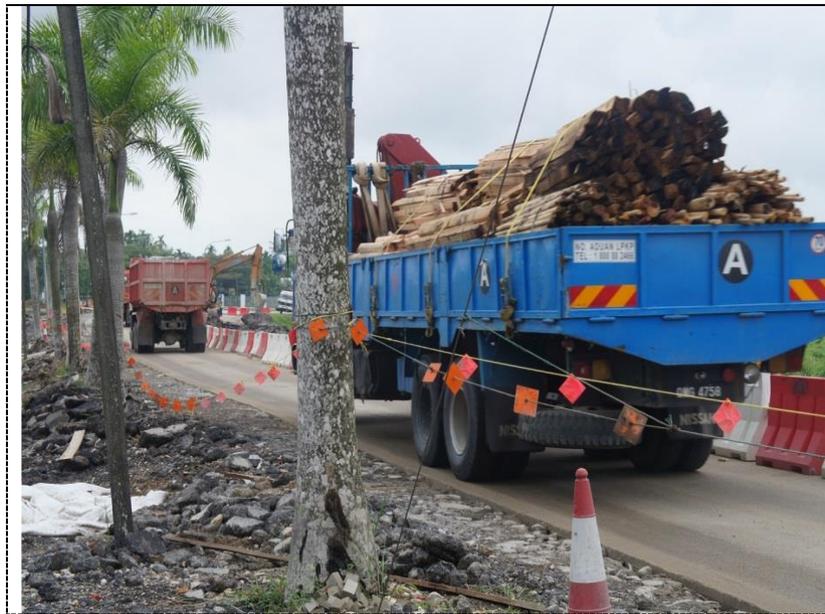
**Figure 7.** Heavy loaded vehicles were transporting timbers along Road 2
