Redesign of Transjakarta Bus Driver's Cabin

Abstract. Ergonomic risk at work stations with type Seated Work Control was one of the problems faced by Transjakarta bus driver. Currently “Trisakti” type bus, one type of bus that is used by Transjakarta in corridor 9, serving route Pinang Ranti – Pluit, gained many complaints from drivers. From the results of Nordic Body Map questionnaires given to 30 drivers, it was known that drivers feel pain in the neck, arms, hips, and buttocks. Allegedly this was due to the seat position and the button/panel bus has a considerable distance range (1 meter) to be achieved by drivers. In addition, preliminary results of the questionnaire using Workstation Checklist identified their complaints about uncomfortable cushion, driver's seat backrest, and the exact position of the AC is above the driver head. To reduce the risk level of ergonomics, then did research to design the cabin by using a generic approach to designing products. The risk analysis driver posture before the design was done by using Rapid Upper Limb Assessment (RULA), Rapid Entire Body Assessment (REBA), and Quick Exposure Checklist (QEC), while the calculation of the moment the body

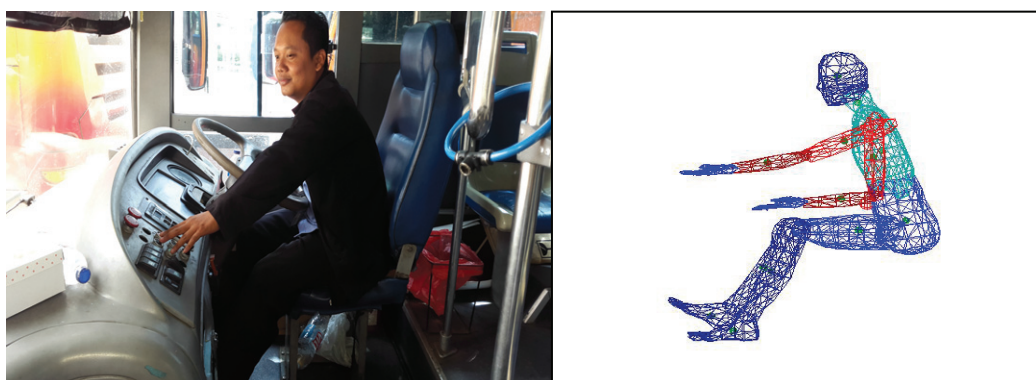
Fig. 1. Working Position of Transjakarta Bus

Viikari-Juntura (2015) stated that work modification was considered as an essential element in enhancing return to work among persons with musculoskeletal problems. Therefore, it was necessary to improve the cabin design of Transjakarta bus using an ergonomic approach. The aim of this study was to analyze the ergonomics risks of cabin design Transjakarta in corridor 9, to design and propose improvements of Transjakarta bus cabin in the form of 3-dimensional models, and evaluate cabin design with biomechanical approach. The working position of Transjakarta bus driver is shown below in figure 1.

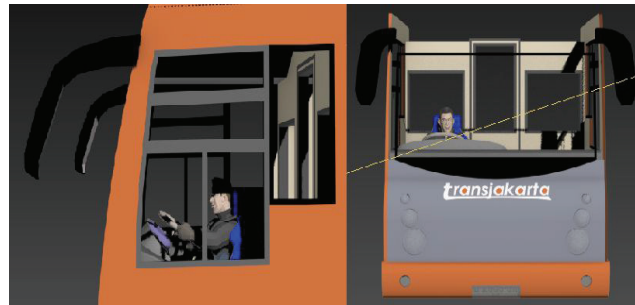
Fig 8. Improvement of Working Posture of Transjakarta Bus Driver (3DMax Animation)

At work postures that have been improved, angle of the driver's arms was 40° , forearm 30° , wrist 10° , neck 150° , the angle between the buttocks to the bottom of the knee at 100° . Then final score RULA method was 3, which means further investigation, soon change may be needed (further investigation, the changes immediately if needed). Final Score REBA method was equal to 4, which means medium risk, further investigation, change soon (intermediate risk, further investigations, immediately make the change). It meant the risk level of musculoskeletal injury was significantly decreasing. Design proposals cabin design still had the disadvantages, because the redesign was limited to part of the bus driver's cabin and modeled by 3DMax so that the productivity couldn't be analyzed.
