Damage detection of carbon reinforced composites using nondestructive evaluation with ultrasound and electromagnetic methods

A Savin^{1*}, P D Barsanescu², P Vizureanu³, M D Stanciu⁴, I Curtu⁴,
N Iftimie¹, R Steigmann¹

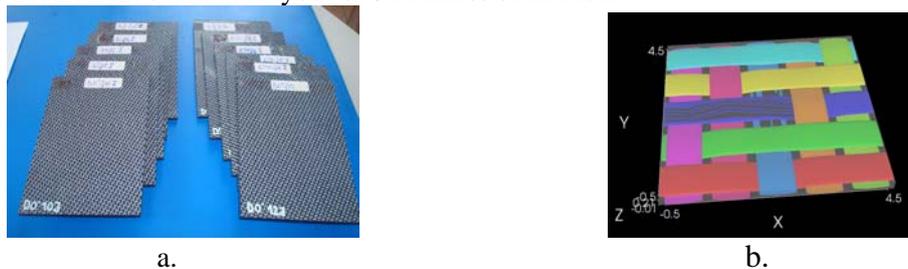
Figure 1. Studied samples: a) composite plates; b) 5 Harness satin fabric layout.

The plates taken into study have the dimensions of 150mm×100mm×4.2mm [17]. The composite, named CETEX, is made from PPS matrix reinforced with 12 layers of carbon fibers 5Harness satin fabric type. The carbon fibers are T300JB with 1.75 g/cm³ density, fabric surface density is 285g/cm² and overall fiber volume fraction 50 ± 3% [18]. In figure 1 are presented the studied samples, made by Tencate, The Netherlands and the layout of 5 Harness satin fabric.

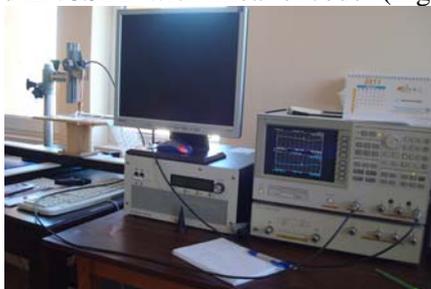
Figure 4. Electromagnetic testing.

The plates were examined using the sensor with metamaterial lens for detection. The sensor has the emission part made from a 20mm diameter coil, 2 turns of Cu wire (1.2mm diameter). The reception coil has a 1mm diameter, 2 turns of Cu wire (0.1mm diameter). In front of the reception coil is placed a conductive screen made from a flexible foil LONGLITE™200 produced by ROGERS CORPORATION USA, having a circular aperture, with 0.1mm diameter, coaxially placed at 0.05mm distance from the reception coil. The screen was grounded. The circular aperture serves for the diffraction of the evanescent waves, appeared in the slits. A conical Swiss roll [20] is placed above the reception coil and acts as metamaterials allowing the transmission of the evanescent waves [20] from the region between carbon fibers towards the reception coil (Figure 4). The transducer was fixed, being connected to the Network/Spectrum/Impedance Analyzer 4395A Agilent USA. The plate is displaced by a motorized XY stage Newmark USA, commanded by PC through RS232 interface. The command and the data acquisition were made through a GPIB IEEE 488 interface, using programs elaborated in Matlab 2014a. The surface was raster scanned using 1mm steps in both directions.
