Aspects of the passenger airbag E.C.U. location

A Soica¹

¹Automotive and Transport Engineering Department, Transilvania University of Brasov, Brasov, Romania

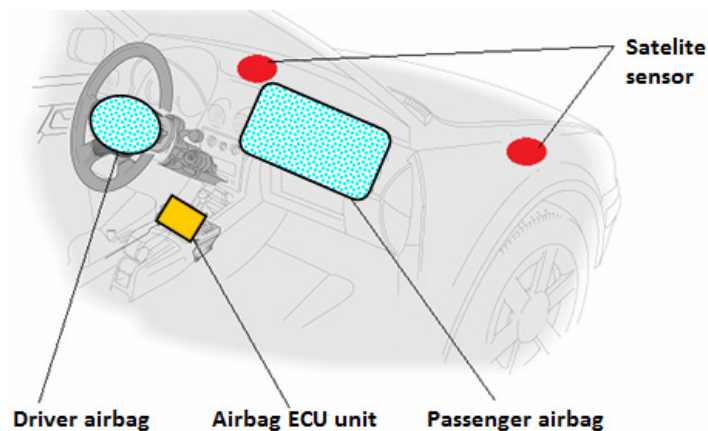
Figure 1. Component parts of the frontal airbag system.

The electronic unit of the airbag system, which determines the intensity of a collision and the need to trigger the airbags, is usually located on the central tunnel of the vehicle, in front of the gear shift, as seen in figure 1. Low cost or older vehicles have the decision to trigger an airbag based only on the sensors from the airbag ECU - Electronic Command Unit. State-of-the-art vehicles as well as older vehicles from the premium class are also equipped with additional sensors, called satellites sensors, which detect the impact and are mounted on the vehicle structure, as close as possible to the impact area. Researches on impact intensity in passenger compartment have also been mentioned in [1].

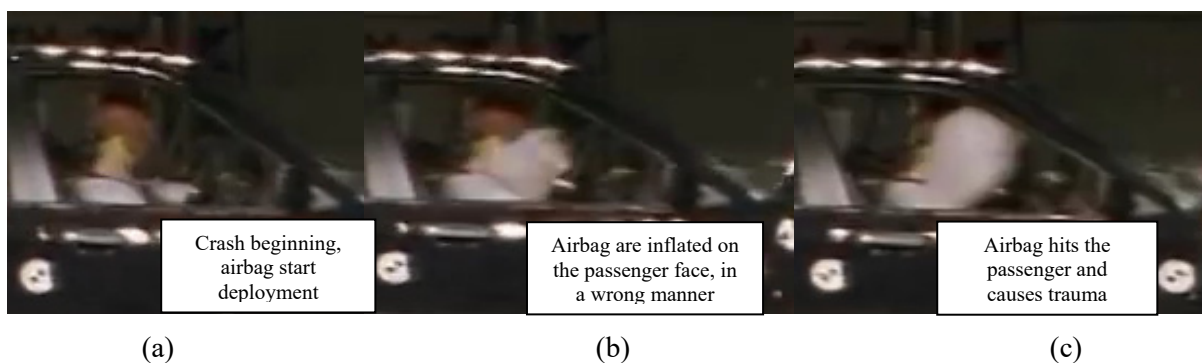
Figure 2. Airbag inflation with delay - the occupant has the body/head close to the dashboard [14].

The injuries that an airbag can cause to the vehicle occupants can be severe in particular passenger positions called out of position or when the airbag receives the inflation command with delay. This situation may occur in the absence of satellite sensors, and in the passenger compartment the threshold deceleration required to inflate the airbag is delayed, due to the various factors or even impact configuration (e.g. impact angle according to Federal Motor Vehicle Safety Standards - FMVSS 208 [2]). As an example, figures 2(a, b, c) and 3(a, b, c) present the cases of two vehicles subjected to frontal collision. In the first case we notice that the driver's airbag is inflated with delay, the body already moving forward due to inertia. The airbag inflates and hits the dummy in the face, causing injury to the head/neck. In the second case the airbag inflates at the right time and the occupant's head is protected against the hit that may be produced during airbag inflation.

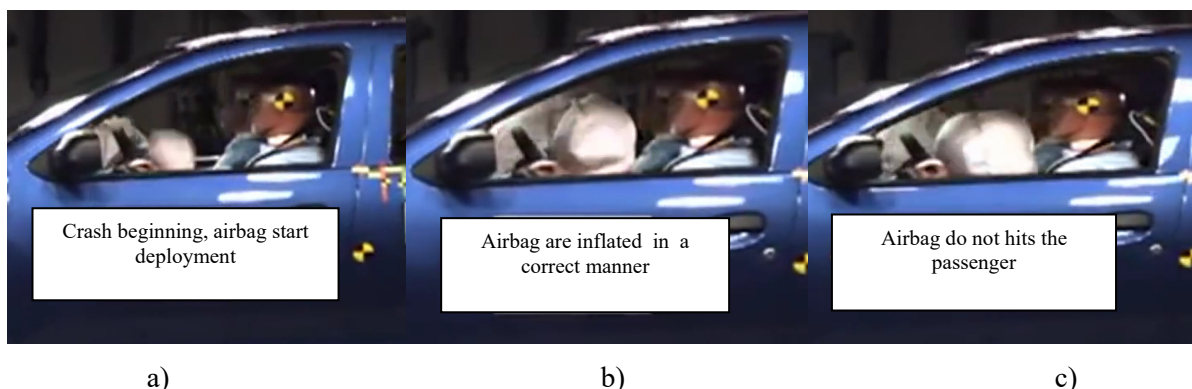
Figure 3. Proper airbag inflation – the occupant leans back against the chair back [14].

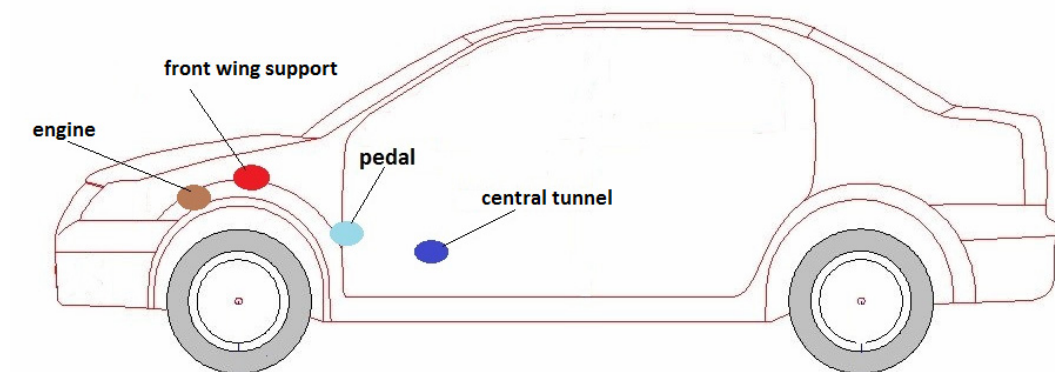
Figure 4. Sensors mounted to record data on the frontal impact.

Based on the above statements, measurements of impact intensity in the vehicle were made by mounting sensors at various points on the vehicle. In the example shown the sensors were mounted on the front wing support, in the pedals area, on the central tunnel in front of the gearshift as well as on the engine, as seen in figure 4. Data on deformation, velocity and acceleration may be recorded depending on the equipment complexity.

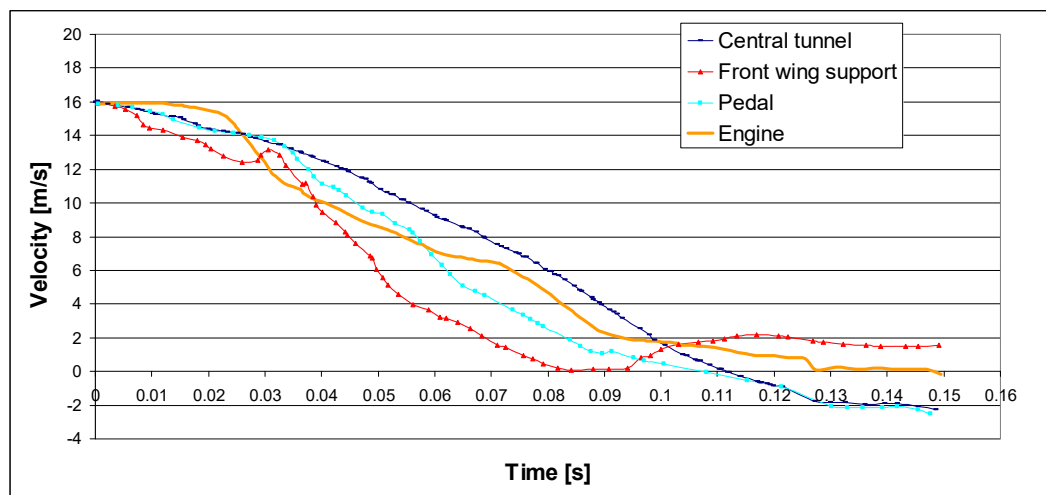
Figure 5. Speed variation in the measurement points.

Figure 5 presents the results following the measurements through a diagram of the speed variation according to time. Naturally, the impact is first felt in the front wing support, the speed at this point registering a sharper decrease within the first 20-30 milliseconds as compared to the other measurement points on the vehicle body. After 30 ms it is noticed that a decrease in speed occurs in the pedals area as compared to the area of the central tunnel.

At about 85 milliseconds from the beginning of the collision, the speed at the point on the front wing support is null, which means that the deformation ended on that area, while it continues to about 107 or 112 milliseconds for the pedals area and central tunnel.

A special case is the information from the sensor mounted on the engine. First, it is noticed that although the engine is the first element located, in terms of distance, from the impact site, it does not feel the impact, the speed variation is even lower than in the passenger compartment. This can be explained through the engine mounting on elastic damping vibration elements sent to the vehicle body. These elastic elements and the large mass of engine enable a continuation of its movement forwards, out of inertia, with relatively constant speed in the first moments of impact, approximately 15-20 milliseconds.

Throughout the impact an engine oscillation, marked by slower decreases which are then followed by some sharper decreases in engine speed is observed.

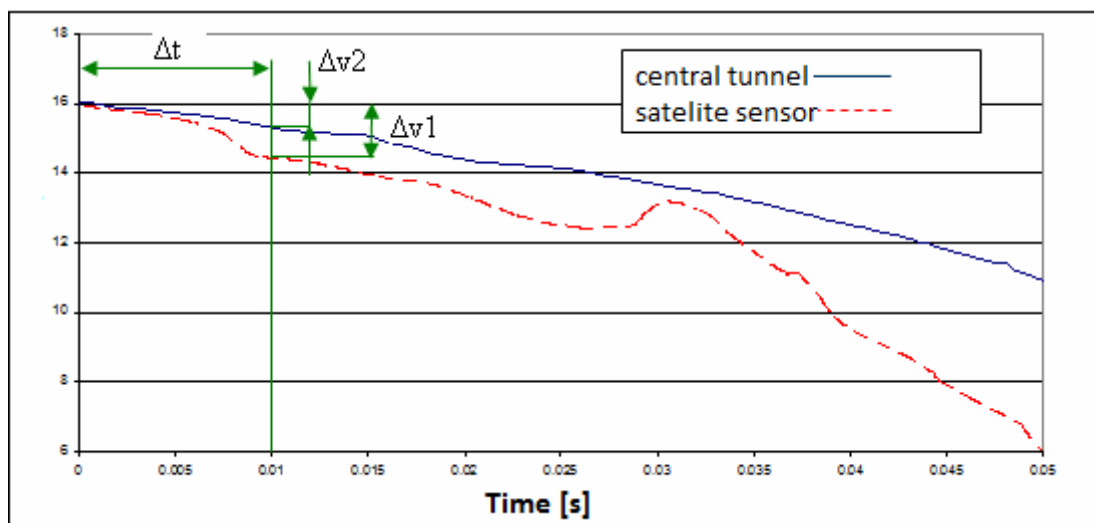
Figure. 6. Speed variation recorded by the satellite sensor and the ECU airbag sensor.

It is necessary to place particular sensors called satellite sensors in the crushable areas. These are coupled with acceleration sensors placed in the electronic control unit, usually mounted on the central tunnel. The existence of a single deceleration sensor mounted in the passenger compartment leads to a less accurate detection of frontal impacts in different angular configurations, as well as to possible severe traumas to passengers diverted from the normal position with the torso straight and tightly fixed in the chair. Thus, as shown in figure 1, the data of a collision are recorded on a motor vehicle where there is a sensor unit mounted in the airbag ECU, and a satellite sensor; these values are then represented in figure 6.

It is noticed that for the same period the average decelerations approximately measured within the vehicle passenger compartment and the satellite sensor are:

Therefore, in the first 10 milliseconds from the beginning of the impact, in the passenger compartment an $a_2=60 \text{ m/s}^2$ deceleration twice and half lower than $a_1=150 \text{ m/s}^2$ deceleration in the satellite sensor is recorded.
