The Study of Some Cracks on the Panels of a Minibus Body Using Modal Analysis

Abstract. The body vibrations caused by the disturbing forces which acts on this one cause many problems connected, generally, with the passengers confort (mechanical vibrations, noises) and also connected with the body reliability. The paper presents the study of some craks appeared on the roof panels of the body of a minibus and the study of some attempts to improve the behaviour. The study was made using the modal analysis in two steps. First was studied the behaviour of the hole structure and than was studied only the panel where cracks appear. The analysis of the first four eigenmodes confirmed cause of the cracks. Finally, it was offered an improved solution.

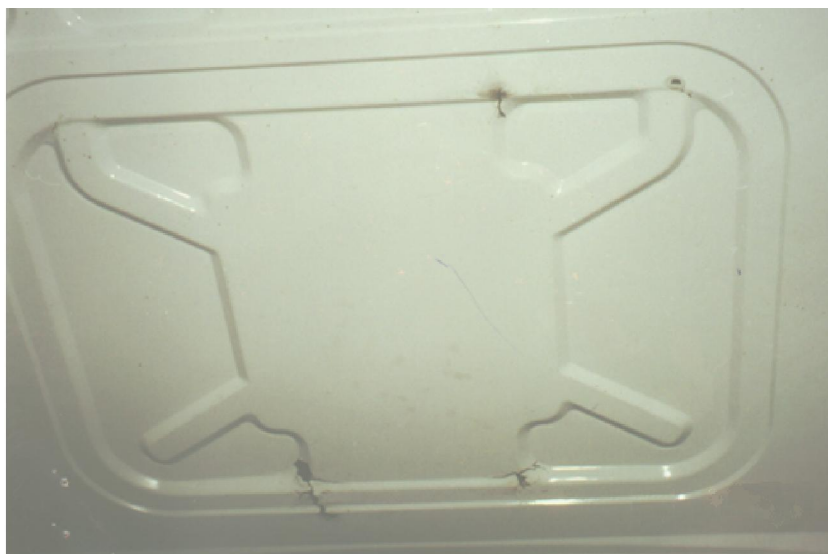
The study presented in this paper started after the observation of some cracks which are appearing after a fairly short running distance, on the first panel of the roof of a minibus (figure 1). The producer noticed that the cracks appear especially at romanian users [3].

Figure 1. The cracks observed on the roof panel

The producer of the minibus observed that these cracks are appearing only at minibuses of users from Romania, which indicates the well known problems of roads from this country. The vibrational loads which act on the minibus is much higher, favoring the appearance of cracks. The body of these minibuses have a raised roof which is less rigid and more sensitive to the vibrations.

The cracks are caused by the reduced rigidity of the structure in the area of the first panel of the roof. The shape of the stamped sheet metal, the ribs and the blends of the surfaces do not stiffen enough this panel.

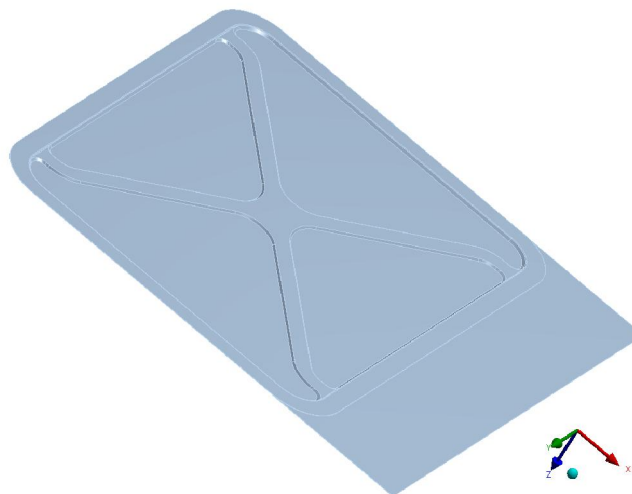
Figure 6. Proposed model with X-shape ribs

One solution for this problem could be modifying the shape of the stamped ribs in order to increase the rigidity of the panel. So, there were studied some different shapes of the stamped ribs and better results were obtained with a X-shape ribs (figure 6).
