Research on the injectors remanufacturing

Abstract. During the remanufacturing process, the injector body - after disassembling and cleaning process - should be subjected to some strict control processes, both visually and by an electronic microscope, for evidencing any defects that may occur on the sealing surface of the injector body and the atomizer. In this paper we present the path followed by an injector body in the process of remanufacturing, exemplifying the verification method of roughness and hardness of the sealing surfaces, as well as the microscopic analysis of the sealing surface areas around the inlet. These checks can indicate which path the injector body has to follow during the remanufacturing. The control methodology of the injector body, that is established on the basis of this research, helps preventing some defective injector bodies to enter into the remanufacturing process, thus reducing to a minimum the number of remanufactured injectors to be declared non-conforming after final verification process.

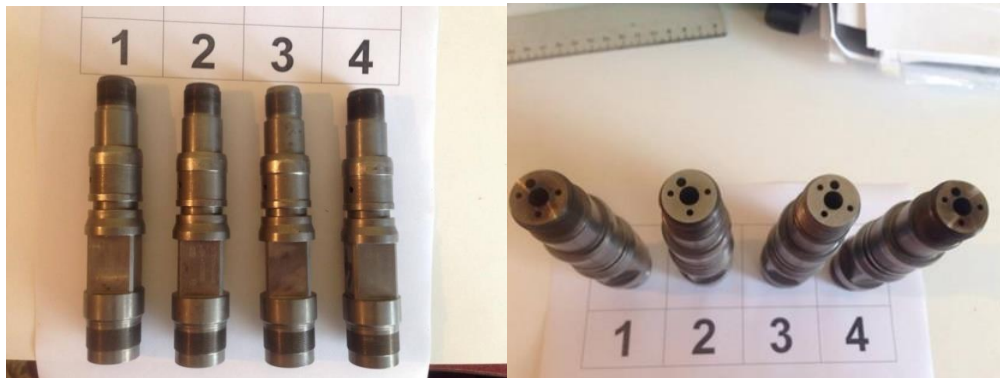
One batch of four injector bodies that are shown in Figure 1 was used for the research purposes. These are the stages proposed for the research: checking the roughness of the sealing surface of the injector body and atomizer; checking the hardness of the injector body in the sealing area and the microscopic analysis of the sealing surface.

Figure 1. The batch of the studied injector bodies

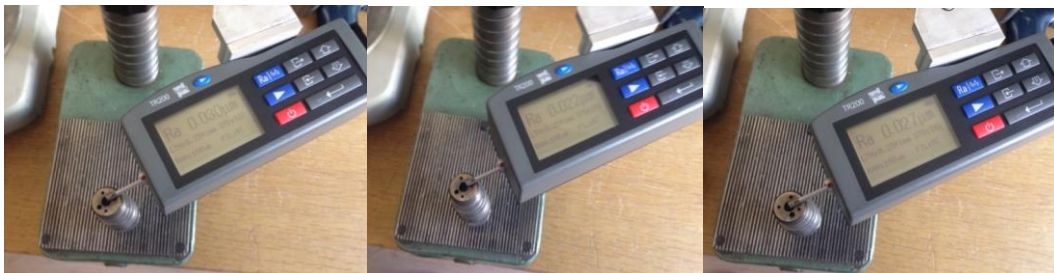
In order to check the roughness of the four injector bodies in the studied batch, an Innovatest type TR 200 electronic roughness tester was used [5]. The roughness measurement process of (Ra) is shown in the Figure 2.

Figure 2. Measuring the roughness of the injector body

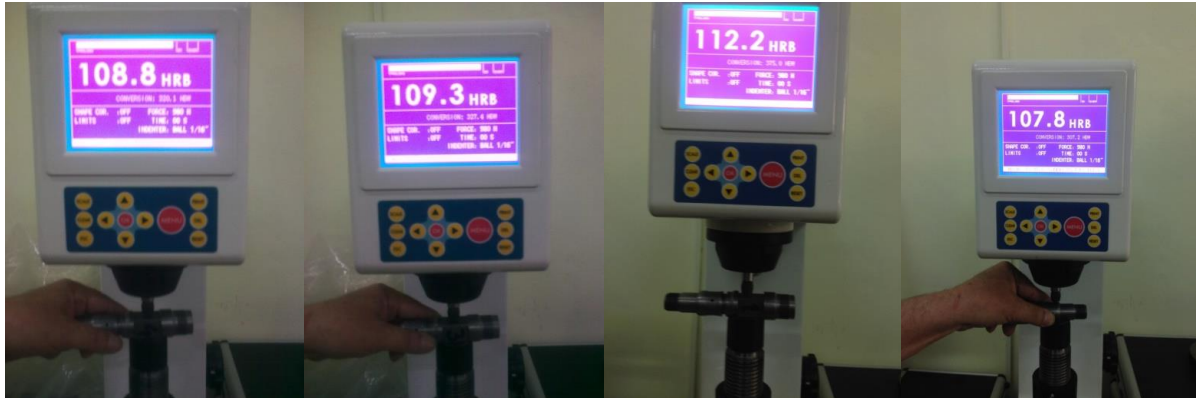
The hardness was measured using a CV-450 AAT type Vikers Hardness Tester, manufactured by CV-Instruments [6]. The hardness measuring is shown in the Figure 5.

Figure 5. Hardness measuring

Injector 1	Injector 2	Injector 3	Injector 4
112.2 HRB	107.8 HRB	109.3 HRB	108.8 HRB

Analyzing the results, it follows that no change of hardness of the studied injectors bodies appeared. The body hardness was obtained by a thermochemical nitriding treatment.

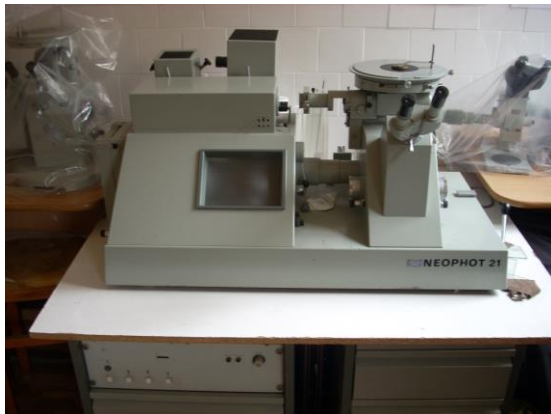
The metallographic analysis was performed with a Neophot 21 type metallographic microscope shown in the Figure 6.

Figure 6. Metallographic microscope

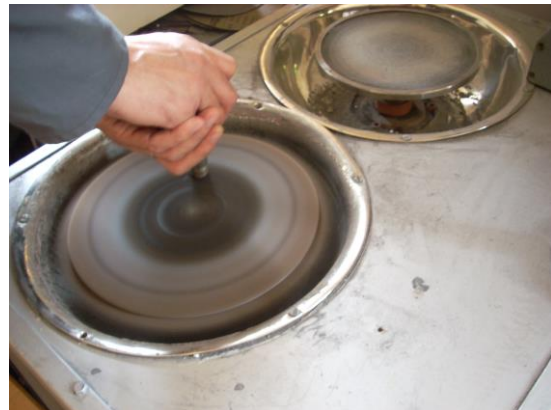
The surface preparation of the injector body that is to be studied is performed using a laboratory grinding equipment shown in Figure 7.

Figure 7. Equipment for preparing metallographic samples

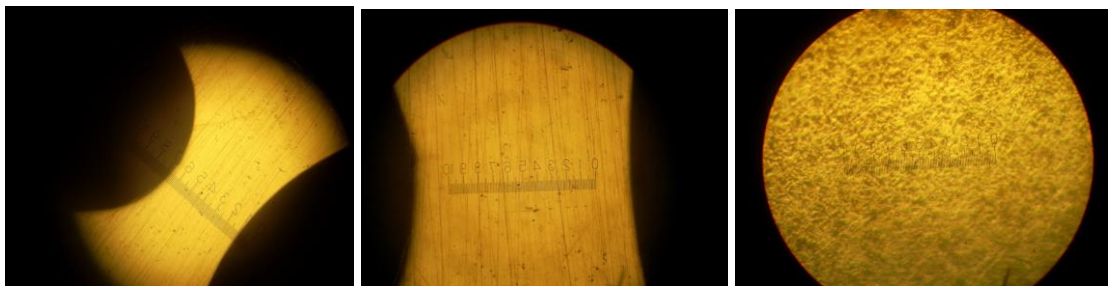
A microscopic analysis of the sealing surface, at a magnification of 1575x, without attacking the surface, in order to identify any cracks, tear or other defects that can not be seen with the naked eye was conducted in the first phase. The results of this analysis are shown in Figure 8. This stage of the study could not reveal any defects in any of the four injector bodies.

Figure 8. The structure of the material without attacking the analyzed surface
