Progressive failure of composite wind blades with a shear-web spar subjected to static testing

Abstract. Composite wind blades of 1m long comprising glass-fabric/epoxy skins and a sandwich plate-type spar were designed and fabricated for static testing. In the composite wind blades, the spar supports the top and bottom skins to form the airfoil shape of NACA4418. The blades were tested to failure and the failure modes were identified at different loading stages. A structural failure analysis method which consists of a geometrically nonlinear finite element (FE) model and appropriate phenomenological failure criteria is used to study the progressive failure behaviours of the blades subjected to different types of quasi-static loads. The experimental load-displacement curves as well as failure loads and locations for different failure modes are used to validate the suitability of the proposed failure analysis method.

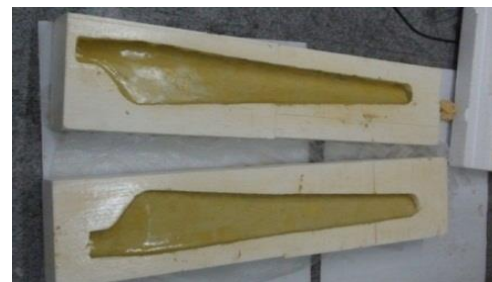
Figure 2. Mould for blade fabrication.

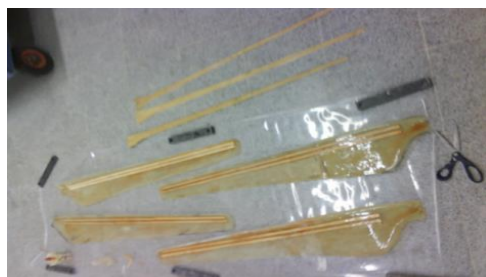
Figure 3. Parts for fabricating wind blade.

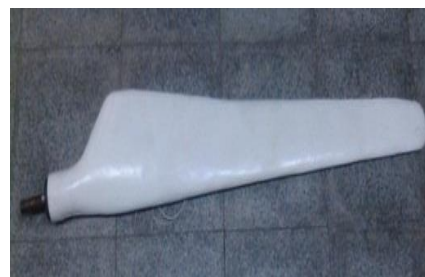
Figure 4. Assembled wind blade.

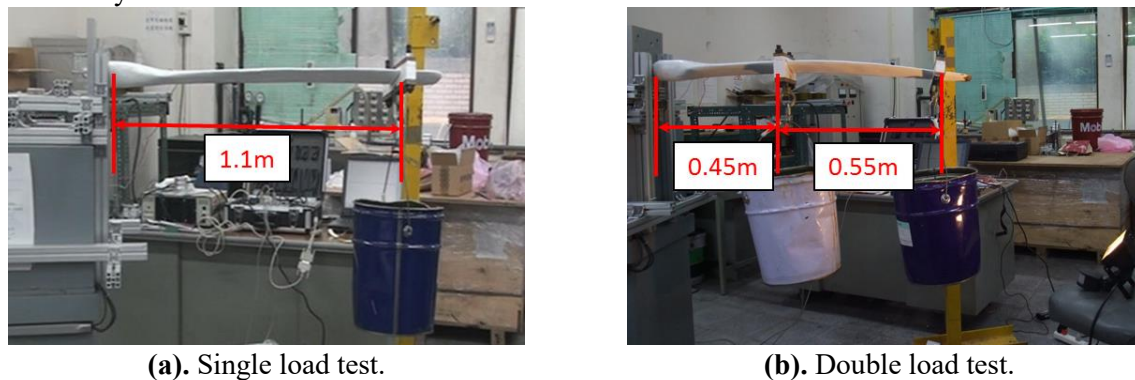
Figure 5. Load-control test of wind blade.

Several wind blades were subjected to load- and stroke testing for experimental study. In the load-control test as shown in Figure 5, the composite blade with the bottom skin facing upward was fixed at the root end. Several strain gages were mounted on the blade surfaces to measure the blade surface strains during testing. In the double load test, with same increment the total weights of the steel balls in the buckets were increased incrementally. For each blade under load-control testing, when the load was increased to a certain value, the incipient buckling of the front (top) skin of the blade would occur by inducing several dimples on the skin as shown in Figure 6. The location of each dimple was determined by measuring the distance between the dimple center and the blade root. The load that caused the incipient buckling of the blade was identified via the observation of the sign changes of the measured strains. As the load was kept increasing, the failure of blade materials such as skin glass fabric/epoxy lamina (first-ply failure) or adhesive at the interface between skin and spar (skin-spar interfacial debonding) might occur before the total fracture occurs at the blade root. On the other hand, for the blade subjected to stroke-control test as shown in Figure 7, with the front (top) skin facing upward, the blade was fixed at the root end while the blade tip was clamped using a rigid gripper in the form of the blade airfoil shape. The gripper was connected to the MTS material testing machine via a rigid link which consisted of three steel rings in chain. The link with its two ends working as two pin joints, respectively, transmitted an axial force from the testing machine to the blade tip. The
