Alternative welding reconditioning solutions without post welding heat treatment of pressure vessel

Abstract. In pressure vessels, working on high temperature and high pressure may appear some defects, cracks for example, which may lead to failure in operation. When these nonconformities are identified, after certain examination, testing and result interpretation, the decision taken is to repair or to replace the deteriorate component. In the current legislation it's stipulated that any repair, alteration or modification to an item of pressurised equipment that was originally post-weld heat treated after welding (PWHT) should be post-weld heat treated again after repair, requirement that cannot always be respected. For that reason, worldwide, there were developed various welding repair techniques without PWHT, among we find the Half Bead Technique (HBT) and Controlled Deposition Technique (CDT).

The paper presents the experimental results obtained by applying the welding reconditioning techniques HBT and CDT in order to restore as quickly as possible the pressure vessels made of 13CrMo4-5. The effects of these techniques upon the heat affected zone are analysed, the graphics of t

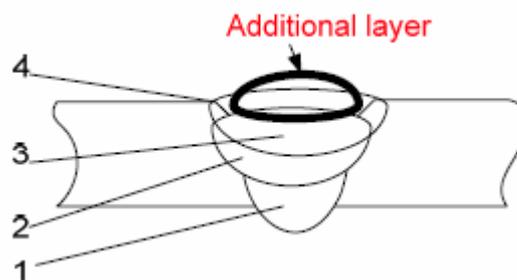
Figure 3. Application scheme of "Weld Toe Tempering Technique"
 1 – Layer of root; 2 –filling layer; 3 –closure layer; 4 – layer of heat treatment.

- Weld Toe Tempering Technique. This technique involves depositing a layer or a passage of heat treatment on the surface of the welding joint to ensure the tempering of the HAZ created by depositing the previous layer. The mode of deposition is very important in order to achieve this requirement [8], figure 3.

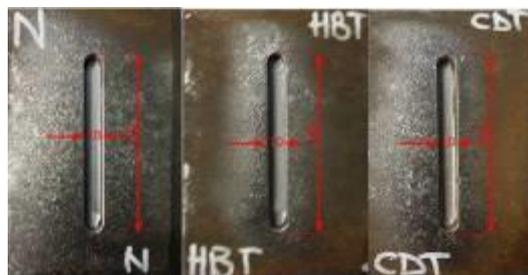
Figure 4. The canals of the N, HBT and CDT samples (canal depth: 10 mm).

In order to apply the 3 methods mentioned above, normal deposit (N), half layer deposit (HBT) and controlled deposit (CDT), the samples were provided with canals, having the following dimensions: 10mm depth, 10 mm width and 100mm length. The samples resulted after processing are presented in figure 4.

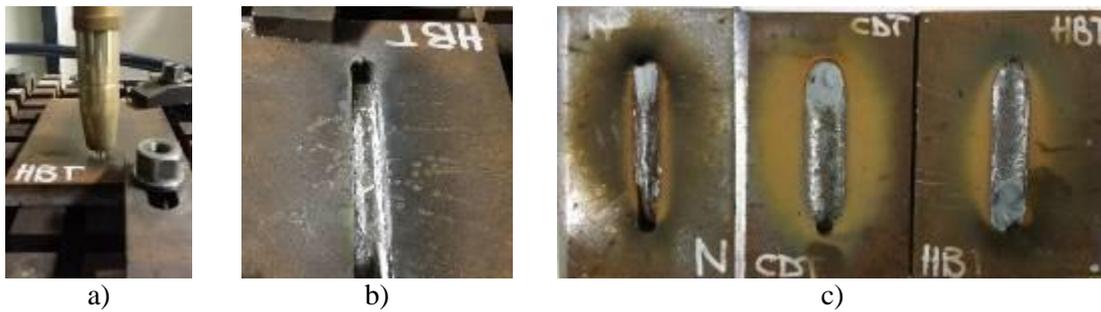
Figure 5. Images taken during and after finishing the experiments:

- a) Positioning of the welding gun;
- b) Layer 2 after the mechanical processing – Sample HBT;
- c) The resulting samples.

Sample pictures taken during and after the repair by welding, are shown in figure 5.

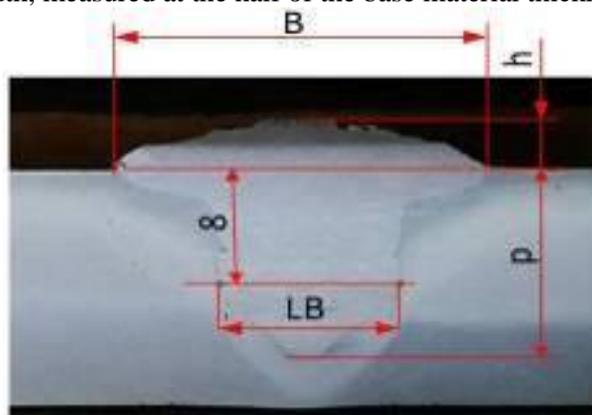
- Welded seam width, B ;
- reinforcement, h ;
- penetration, p ;
- Welded seam width, measured at the half of the base material thickness, LB .

Figure 6. Indication of the areas of interest.

After obtaining the macroscopic images with the help of a software the following characteristics were measured (figure 6):

^a Values measured in the base material at a depth of 8 mm from the surface, see figure 6

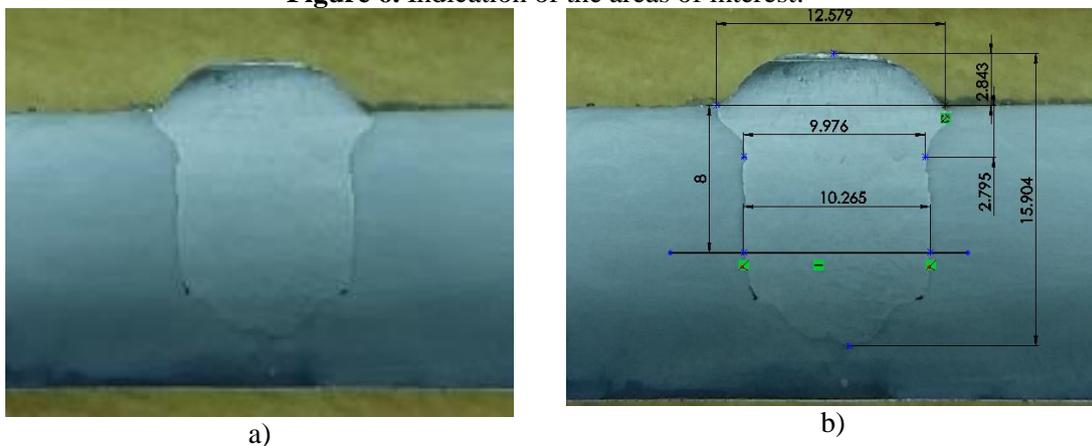
Figure 7. The dimensions of the area of interest – Sample N:
 a) Macroscopic image; b) Image generated by the soft.

Obtained results after the measurements, as it can be seen for each sample in figures 7, 8 and 9, are presented in table 4.

Measured characteristic	N	CDT	HBT
B[mm]	12.579	22.072	19.987
p [mm]	15.904	12.886	13.151
h [mm]	2.843	3.651	1.377
LB ^a [mm]	10.2365	10.612	11.679

- By changing the technique applied for the reconditioning by welding, dimensional changes appear in the size of the HAZ, as can be seen from the analysis of the figures 7,8 and 9;

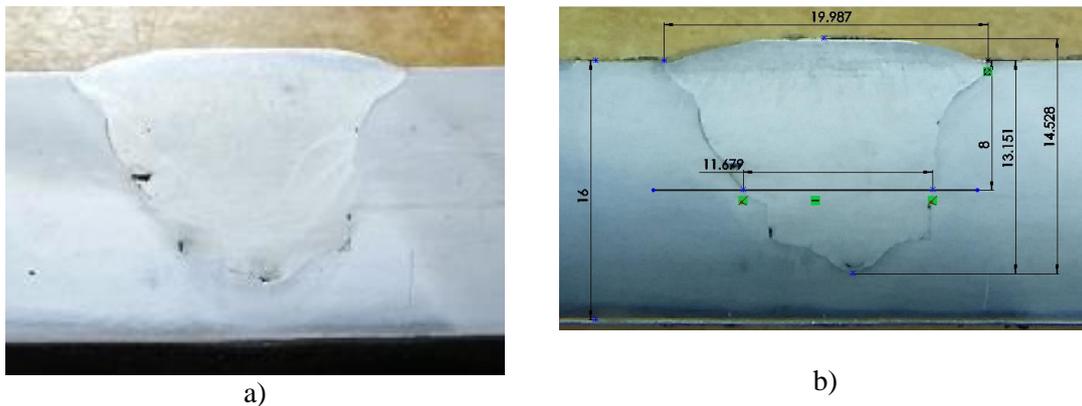
Figure 8. The dimensions of the area of interest – Sample HBT:
 a) Macroscopic image; b) Image generated by the soft.

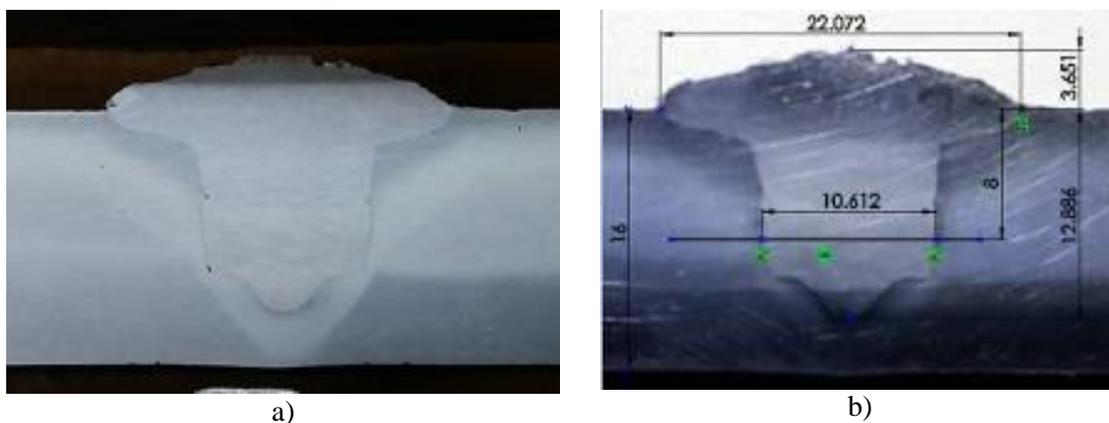
Figure 9. The dimensions of the area of interest – Sample CDT:
 a) Macroscopic image; b) Image generated by the soft.

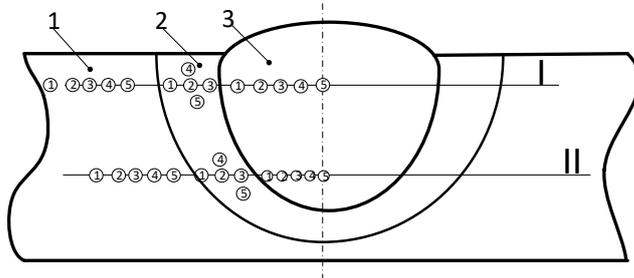
Figure 10. Localization of the measurement points for hardness 1- base material; 2 – heat affected zone; 3 - welded seam; I, II – directions of measurement for hardness.

For analysing the effects of the applied methods of reconditioning by welding, there were determined the hardness values, in five distinct points, in the base material, the HAZ and in the welded seam (see figure 10).

The measurement was carried out on the two directions, I and II, in accordance with Figure 10, and the results obtained are indicated in table 5.

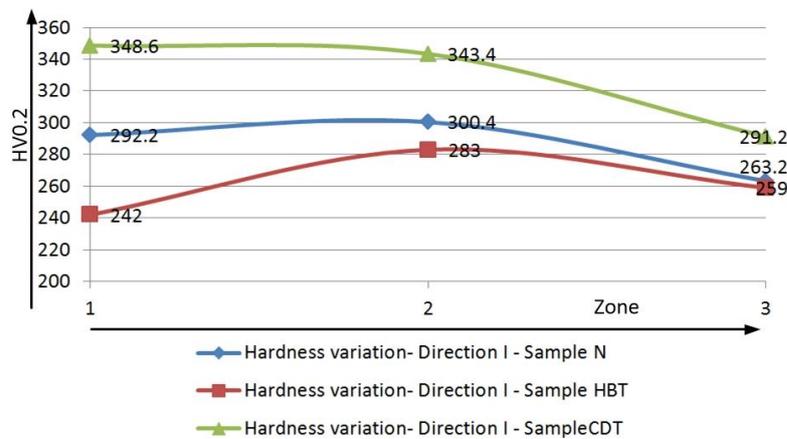
Figure 11. The variation of the hardness average values on the direction I, in the base material, in the HAZ and in the welded seam - for all samples.

The graphical representation of the variation of hardness on the two directions presented in figure 6, it can be observed in the following figures. The figures 11 and 12 present the variation of the hardness average values for all samples taken in the base material, the HAZ and the welded seam.

From analysing the figures 11 and 12, and also the indicated values in table 5, it can be drawn the conclusion that the maximum average value of hardness on the direction of measurement I, in zones 2 and 3, was obtained for the sample CDT

The differences between the values of the hardness's can be explained by the different quantities of heat inserted in the material by the welding technology, the different way of heat diffusion to the surface of the sample, as well as the different number of passes needed to fill the canals

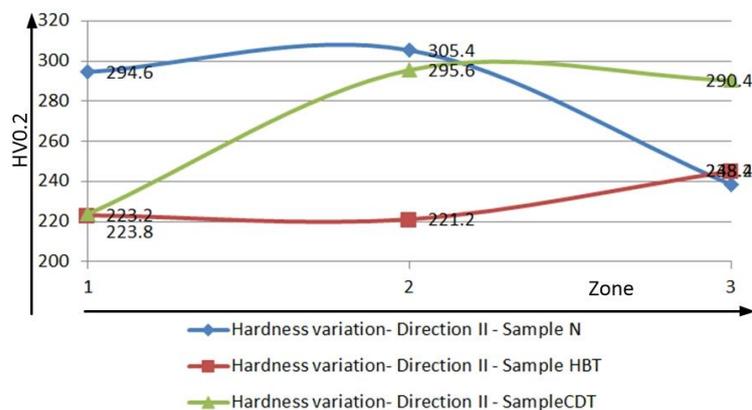
Figure 12. The variation of the hardness average values on the direction II, in the base material, in the HAZ and in the welded seam - for all samples.

For the direction of measurement II it can be observed that the maximum average value of hardness was obtained in zone 2 for the sample N and in zone 3 for the sample CDT.
