Repair welding of cast iron coated electrodes

Abstract. Welding cast iron is a complex production procedure. Repair welding was used to repair damaged or poorly made castings. This is due to a tendency to cracking of the material during welding as well as after it. Welding cast iron can be carried out on hot or on cold. Hot welding requires high heat material and the use of welding material in the form of cast iron. In the case of cold welding, it is possible to use different materials. Mostly used filler metals are nickel and copper based. The work shows the course of research concerning repairment of ductile iron with arc welding method. For the reparation process four types of ESAB company coated electrodes dedicated for cast iron were used with diameter 3.2 and 4 mm: ES 18-8-6B (4mm) , EB 150 (4mm), OK NiCl, EŻM. In the cast iron examined during the testing grooves were made using plasma methods, in order to simulate the removed casting flaws. Then the welding process with coated electrodes was executed. The process utilized low welding current row of 100A, so there would only be a small amount of heat delivered to the heat affected zone (HAZ). Short stitches were made, after

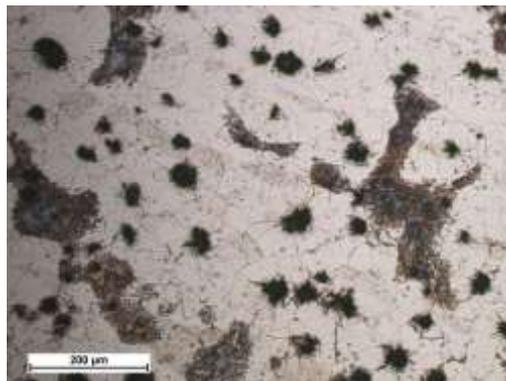
Figure 1. Microstructure of examined ductile iron.

The article shows the process of research repair welding of ferritic-perlitic ductile iron GJS 350-22, utilizing the method of coated electrode (the chemical composition of cast iron was shown table 1 and the microstructure on the figure. 1) in samples taken with the use of plasma-arc gouging method. Table 2 describes the parameters of the plasma gouging. The groove was made in order to simulate the removed casting defects, Half of the gouging was mechanically grinded in order to remove the layer after gouging. Then the welding process took place in accordance to EN 1011-8. Material was not preheated. Electrodes selected for this studies were EB150 4mm, EŽM 3, 2 mm OK NiCl 3.2 mm, ES 18-8-6B 4mm (typical composition and properties in tables 3 and 4). In order to introduce a small amount of heat low current parameters were used. During the welding one stich was made. Each overlay weld was hammered in order to prevent cracking. The welding parameters were presented in table 5.

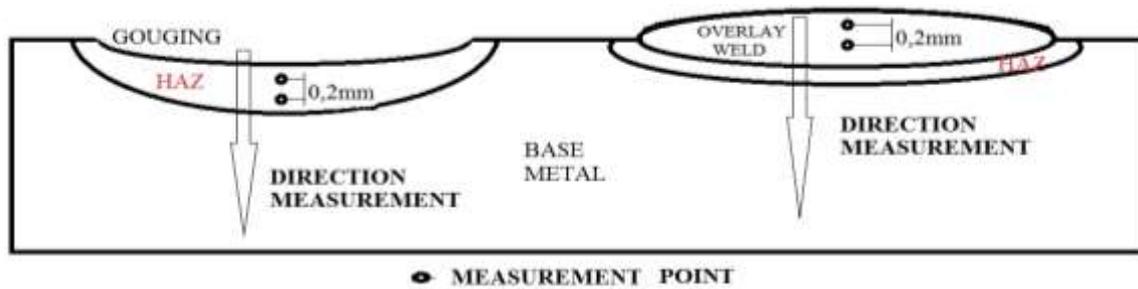
Figure 2. Scheme of measurements points.

After plasma-arc gouging occurrence of hardening zone can be noticed. It was revealed in cutting line as martensitic structure, part of the graphite began to dissolve, some of metal is melted in the process and crystallized as ledeburite (figure 3). Hardness in the cutting line reaches up to 650HV and the HAZ is present in the material on about 0.5 mm (scheme of measurement figure 2). Visual testing and penetration testing did not reveal the cracks in the plasma grooves.

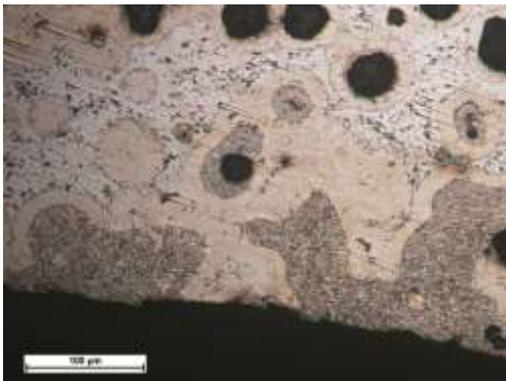
**Figure 3.** Microstructure of cutting HAZ.

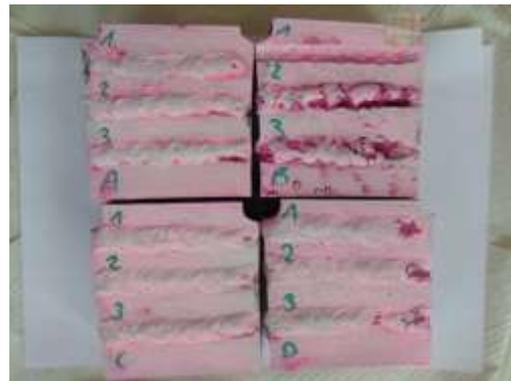
**Figure 5.** View of penetration testing.

After the execution of the welding process with coated electrodes visual testings were carried out (figure 4 shows padding weld). Welding with electrodes EŽM, NiCl, ES 18-8-6B resulted in non-complete fulfilment of the groove, the remaining welds were laid correctly. The biggest problem was, however, in the case of electrodes EŽM. In the case of penetration testing cracks on the padding weld were encountered while utilizing EŽM electrodes as well as several indications in the padding weld while using EB 150 electrodes. The indication of the crater was only in the case of electrodes EB 150. Figure 5 show results of penetration testing.

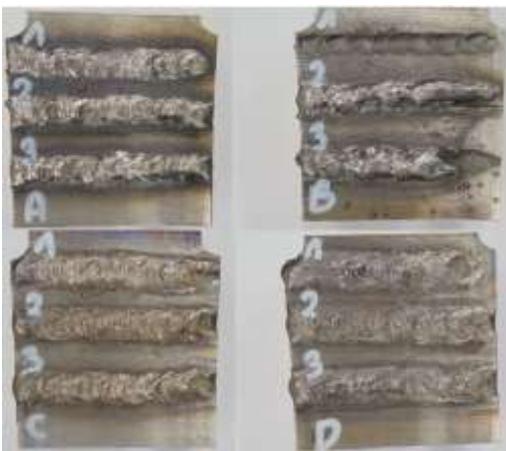
**Figure 4.** Padding weld after welding.

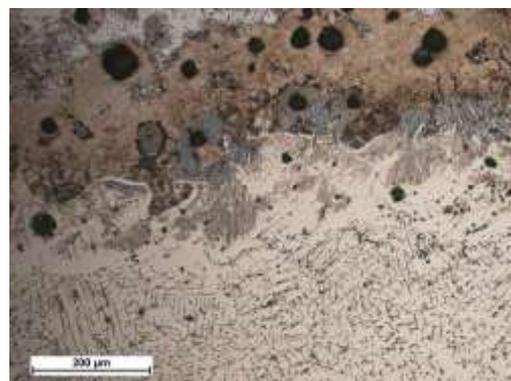
**Figure 6.** Microstructure of fusion line NiCl padding weld.

Macroscopic and microscopic studies revealed a very narrow HAZ, in every case hard spot in the area of the weld (fusion line) was noticed. Fusion line is show on figure 6. The largest part of hard spot was evident in the case of electrodes EB150, in each case also a martensitic structure was disclosed in the HAZ. The deposit made in the groove without grinding had wider area of hard spot As a result of microstructure examination the presence of austenitic structures was reviled for welding electrodes EŽM, NiCl, ES 18-8-6B, in the case of electrodes ES18-8-6 visible are large dendrites were noticed (figure 7). Welding electrodes EB 150 resulted in obtaining a martensitic structures with very large dendrites (figure 8). In the case of welds performed with EŽM slag inclusions were observed in the vicinity of the fusion line (figure 9).

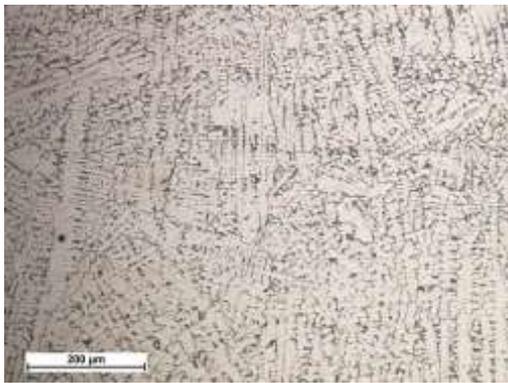
Figure 7. View of dendrites in padding weld ES 18-8-6B.

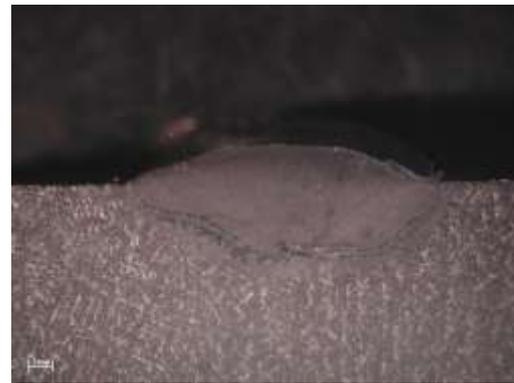
Figure 8. View of microstructure of EB 150 overlay weld.

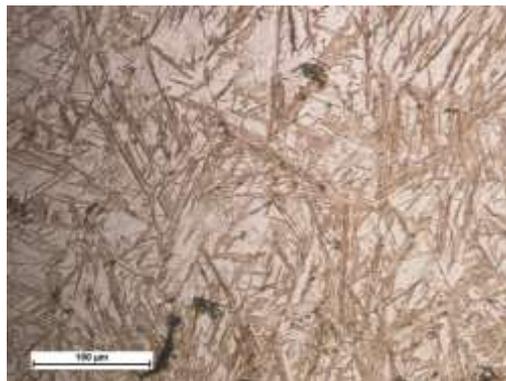
Figure 9. Slag inclusion in padding weld.

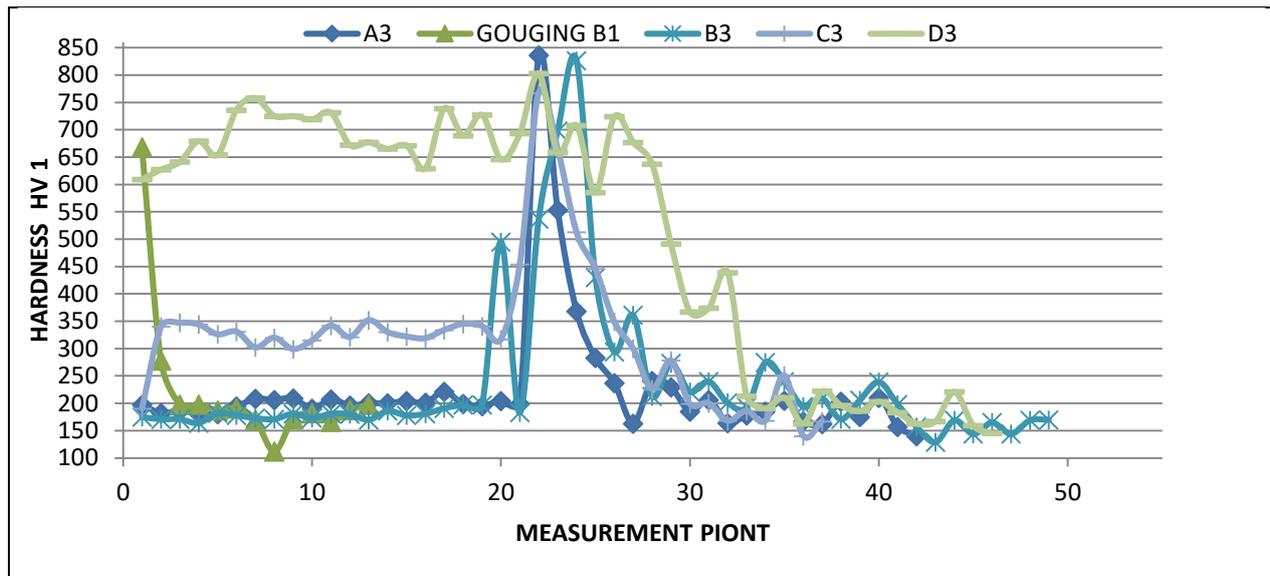
Figure 10. Hardness distribution in gouging and grinding groove.

The results of research hardness examination (figure 10) did not show visible changes between padding weld when laying the grooves in the ground and with no ground. Achieved hardness of the welds varied at different levels, so in the case of welds electrodes EŽM and NiCl obtained hardness was about 200HV which gives large possibilities when it comes to post-processing mechanism. Overlay weld of electrodes ES 18-8-6 increased hardness to approximately 350HV. Although on the surface appeared area with hardness of up to 500HV. With the deposit weld metal electrodes EB 150 best they had the greatest hardness was achieved of up to 750HV, resulting in inability to further

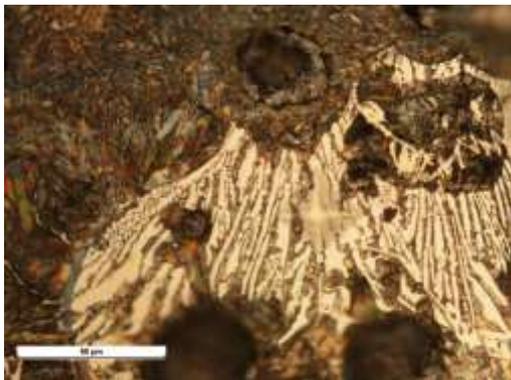
Figure 11. Hard spot in padding weld.
Measured point 707 HV 0.5.

machining. Such hardness results from the high carburizing of the welds. In any case hardness values of hard spot it 600-800HV (figure 11), martensitic zone in HAZ reaches about 600 HV. Due to the fact that the material of the structure was ferritic-perlitic and because of the heterogeneity of castings hardness of the base metal ranged at around 160 to 200HV.

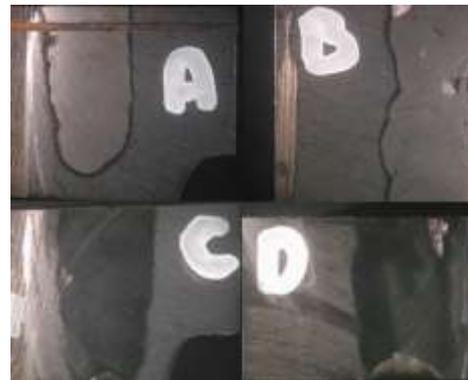
Figure 12. View of padding weld colour.

Comparison of colours of the padding weld and base metal the best colour was obtained for electrodes EB 150 and ES 18-8-6B, in the other you can see a lighter shade of the deposit. Figure 12 show differences of deposit colour.
