Research on corrosion mechanism of suspension insulator steel foot of direct current system and measures for corrosion inhibition

Abstract. There are increasingly serious electrocorrosion phenomena on insulator hardware caused by direct current transmission due to the wide-range popularization of extra high voltage direct current transmission engineering in our country. Steel foot corrosion is the main corrosion for insulators on positive polarity side of transmission lines. On one hand, the corrosion leads to the tapering off of steel foot diameter, having a direct influence on mechanical property of insulators; on the other hand, in condition of corrosion on steel foot wrapped in porcelain ware, the volume of the corrosion product is at least 50% more than that of the original steel foot, leading to bursting of porcelain ware, threatening safe operation of transmission lines. Therefore, it is necessary to conduct research on the phenomenon and propose feasible measures for corrosion inhibition. Starting with the corrosion mechanism, this article proposes two measures for corrosion inhibition, and verifies the inhibition effect in laboratory conditions, providing reference for ap

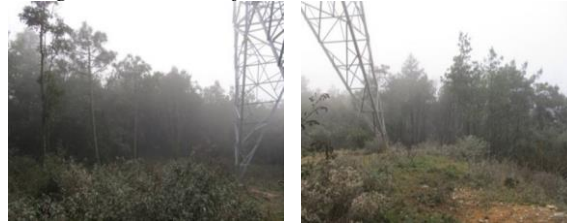
Fig.1: Typical Inducing Environment for Steel foot Corrosion

According to comprehensive analysis on typical topographic conditions and meteorological environment in regions with serious insulator steel foot corrosion, the following typical characteristics shown in Fig.1 can be acquired: (1) on shaded side of plateau mountainous regions; (2) large air humidity and plentiful rainwater; (3) frequent continuous heavy fog weather, difficult to disperse.

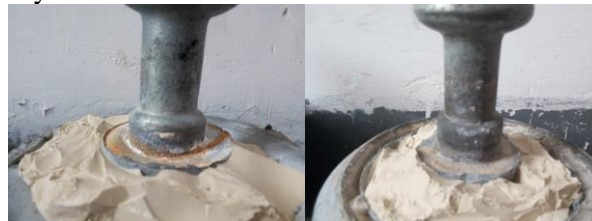
1. The leakage electric charge quantity of 2# sample is 8135C (equivalent to the field operation of 5.5 years). Make comparisons with the insulator (6#) taken down from Chusui direct current line with actual operation length of 5.5 years.

Fig.6: Samples of Corroded Insulators 2# (left) and 6# (right)

According to preliminary observation, the corrosion state of the samples of corrosion test conducted in laboratory accelerated simulation conditions is more serious than the state of field operation, in line with the selection of the annual average leakage electric charge quantity in the worst conditions as the base value. Both of them have similar corrosion regions and shapes, indicating that there is preferable equivalence between the accelerated corrosion test in laboratory conditions and that of field operation.

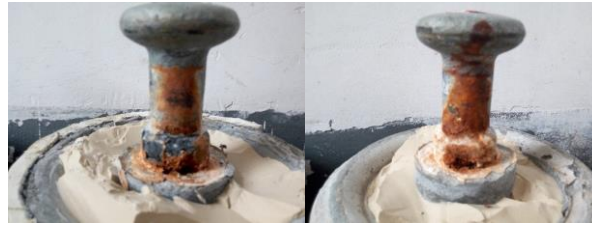
2. Stop the test at the leakage electric charge quantity of 44370C on 3# sample (equivalent to field operation of 30 years), then take down the 3# and 4# samples. The scene drawings of the two insulator samples are as shown in Fig.8, and the corresponding relationship between leakage electric charge quantity and time is as shown in Fig.9.

(1) The corrosion state of the two are serious, in which the outermost zinc cover of 3# insulator totally falls off, with the most serious corrosion state near to the cement junction. The surface layer of the zinc cover of 4# insulator is also basically corroded; there are large quantities of zinc hydroxide products attached on surface of the zinc cover away from the cement junction;

Fig.7: Samples of Corroded Insulators of 3# (left) and 4# (right)

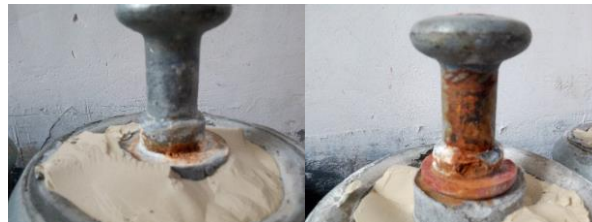
3. When the leakage electric charge quantity of 5# insulator is equivalent to that of 1# insulator during taking off, take off 5# insulator, and record corresponding time point and leakage electric charge quantity, with corresponding time node of 108.8h and corresponding leakage electric charge of 20795C. Refer to Fig.9 for comparisons between sample drawings and Fig.10 for comparisons between corrosion rates.

Fig.9: Samples of Corroded Insulators of 1# (left) and 5# (right)

(1) The insulator corrosion regions are junctions among steel foot, air and cement (protective cover); i.e., the installation of umbrella shape protective cover can effectively change the corrosion positions of the insulators;
