## Prefabricated RM Façade Panels – Search for the Safe Solution

**Abstract.** The problem, which appeared during the design works on the untypical masonry openwork of the front elevation of the academic building in Poland was presented and discussed in this paper. The original solution of masonry external façade was too risky and practically impossible for realization from the workmanship point of view. For this reason authors were proposed to make this elevation wall as prefabricated construction consisted of medium scale prefabricated elevation panels made of openwork clinker units and masonry joints with reinforcement. Two solutions of prefabricated panels were elaborated: first by the design office and second one, significantly modified, proposed by the authors. Taking into consideration fact that proposed prefabricated panels are not the typical reinforced masonry possible to design based on Eurocode 6, the methodology of “supporting design by test” was accepted to verify the correctness of proposed solutions. The carried out tests of both types of prefabricated panels with results and their discussion are also presented here. The results have shown the lack of safety for th

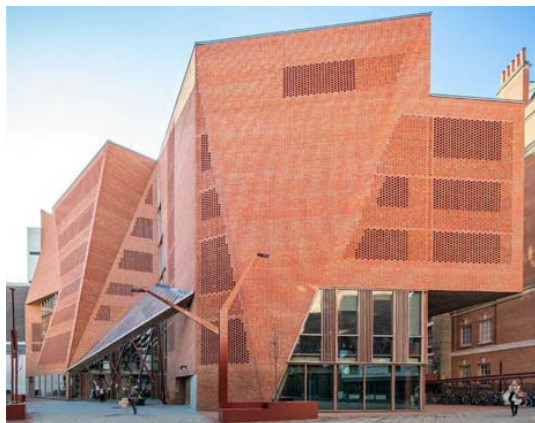
**Figure 1.** Brick Origami, London School of Economics [3]

Properly formed brick façades can pass the light following the idea that brickwork can be transparent. It is worth to mention the 2012 project of Brick Origami in the London School of Economics by architects O'Donnell & Tuomey (figure 1). The bricks on the external walls are used in a new way with an openwork pattern that creates dappled light inside; at night, when the lights are on inside, the building seen from the street looks like a glowing lattice lantern. Lighting and delicacy of the facade is also well visible in the 2010 project by Mestura Arquitectes (figure 2).

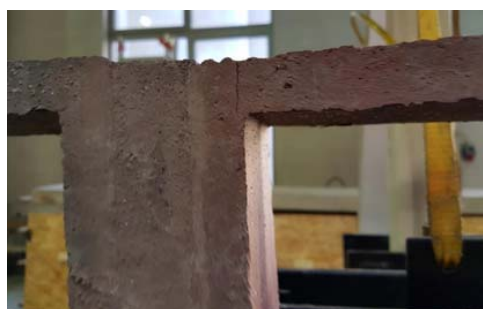
**Figure 6.** Cracking of clinker masonry unit as the result of the firing process during production

During production of the clinker masonry unit some defects, in form of small cracks sometimes with higher than 0.5 mm width, in ceramic units were observed (figure 6). The area of the elements was relatively equal, what can be seen in a figure 7. There were no major irregularities and distortion.

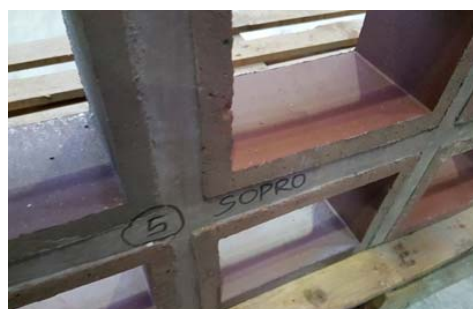
**Figure 7.** View of the element's surface

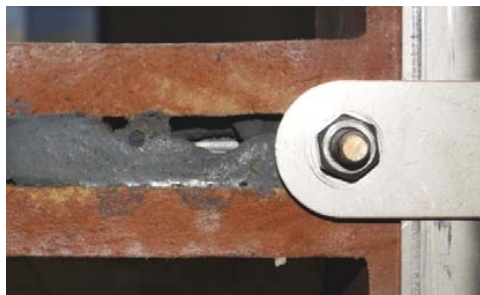
**Figure 9.** Incorrect filling of the mortar joint

Before testing, all specimens were checked. A lot of different types of defects –like absence of silicone strip between the ceramic units and frame, shrinkage cracks, incorrect filling of the mortar joints (figure 9), strong surface irregularities (figure 10) – were observed.

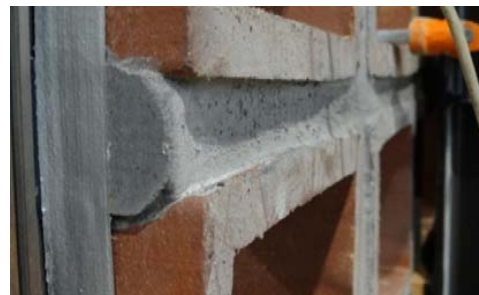
**Figure 10.** Surface irregularities

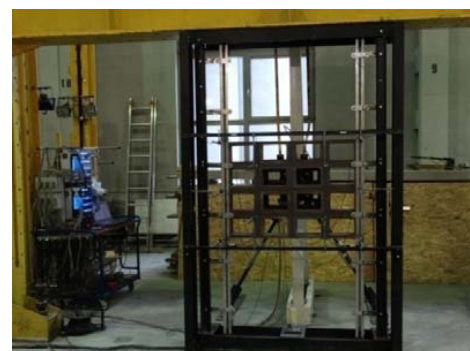
Figure 11. Specimen of *series I* prepared to test. Red dots marked points of the applied concentrate forcesFigure 12. View of the test stand with specimen of *series II* ready to test

Prefabricated panels were tested in a special designed test stand, reflected the real location of the panels on the elevation of the building. Each element was fixed to the steel transverse profiles using screws welded to the reinforcement and led out from the prefabricated panel, and steel plates mounted direct to the steel supporting profiles. In *series I* the steel plates were made of piece of steel sheet, but in *series II* a special shaped stainless steel elements were used (the cover plate is visible on figure 9). In figure 11 is shown the view of the panel from *series I* located in the test stand, just before testing. The general view of the whole test stand during the testing of *series II* is visibly in figure 12.

Both types of panels were loaded in direction perpendicular to their surface using steel traverse and hydraulic jack. The load as set of 4 concentrated forces was located on the crossing of joints, what is marked by the red spots in figure 11. The elements of *series I* were loaded in one cycle, up to the failure. However, in *series II* cyclic load was applied. The specific of loading the specimens of *series II* is listed in table 2. Two first tested panels were loaded in the same way – five cycles with the range of load amounted from 5 kN to 20 kN – but in last cycles (the sixth) the maximum load was higher; the specimen was loaded up to the 25 kN. In last tested specimen (*HL-bf-ss-4×4-SPg-5.3*) only the last cycles was different; the element was loaded up to the failure – what means up to the deformation of the vertical supported steel profile. The element was not failed completely.

During the tests, applied force and displacement perpendicular to the specimen surface were recorded. Both those values were measured with the LVDT gauges and frequency of 2Hz. The displacement was determined in eight points. Four points was on the vertical steel supporting profiles (two from every side) and four was located in the same place, where the load was applied (on the crossing of the joints – see figure 11).

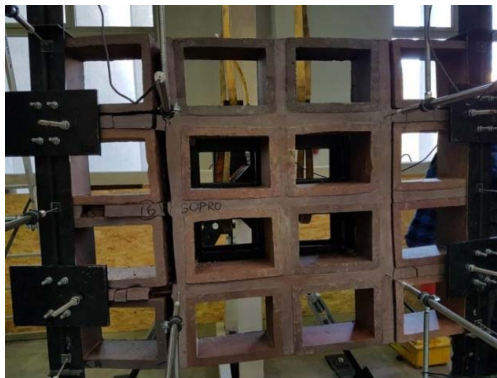
**Figure 13.** Failure of element of *series I*

Both elements of *series I* have behaved and failed in the same way. They were completely, physically destroyed. At relatively small loads some cracks, between the clinker unit and the mortar had appeared. With increasing of the load, the width of cracks was also growing up and, as a result, the external units were separated from the whole panel. In next steps of loading the reinforcement began to deform and destroy the mortar structure. Finally, the element was divided by cracks into the almost independent pieces. There was no bonding between the clinker elements and the mortar (the components could be separated without any efforts); also the reinforcement was completely separated. Some of the ceramic clinker units (located in external parts of panel – mostly at corners) were destroyed. Such a type of failure could be taken as an unsafe and danger from the safety point of view.

In figure 13 one of the specimens from tests of *series I*, just before reaching the state of failure, is shown. Figure 14 presents the view of destroyed structure of mortar and clinker masonry unit.

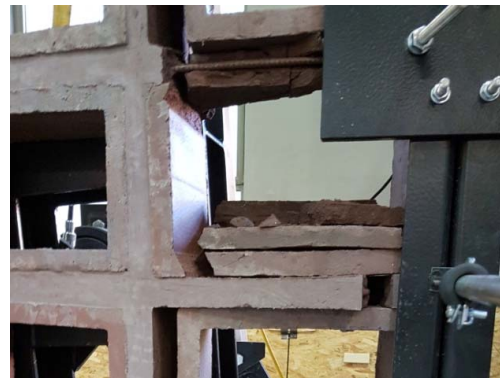
**Figure 14.** Detail of the destroyed panel

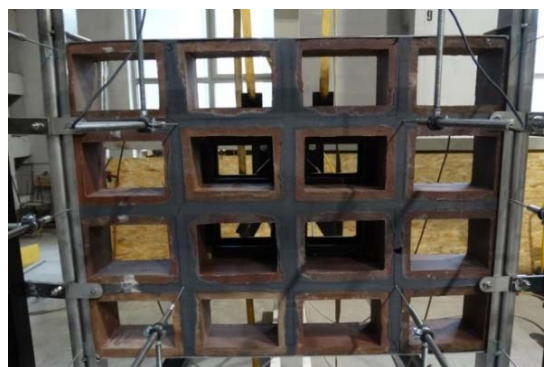
**Figure 15.** Pattern of cracks at maximum load

of a few loading cycles, followed with the relatively higher loads, the panels kept their pervious geometry. Besides many small cracks, indicated separation of ceramic units from the mortar, no components attends to falling out and even visibly getting out from the panel. Such effect was reached by using the external frame, connected with reinforcement, and glued to the panel. No real failure of panels was achieved – even in the third tested elements, where the maximum load, applied in last cycle, was the highest – because of the excessive buckling of steel supporting profiles; threaten sudden and very danger damage. In figure 15 the pattern of cracks at reaching the maximum load is shown.
