# False Windows - Yesterday and Today

**Abstract.** The article is concerned with a very interesting aspect of architectural design, namely, a contradiction between the building functions and the necessity of giving the building a desired external appearance. One of the possibilities of reconciling this contradiction is using pseudo windows that are visible on the elevation and generally have the form of a black painted recess accompanied by frames and sashes and often single glazing. Of course, there are no windows or openings in the corresponding places in the walls inside the building. The article discusses the differences between false windows and blind windows (German: blende), also known as blank windows, which, in fact, are shallow recesses in the wall having the external appearance of an arcade or a window and which had already been used in Gothic architecture mostly for aesthetic reasons and sometimes to reduce the load of the wall. Moreover, the article describes various false windows that appeared later than blind windows because they did not appear until the 17th century. Contemporary false windows are also discussed and it is shown that contrary to the common belief t

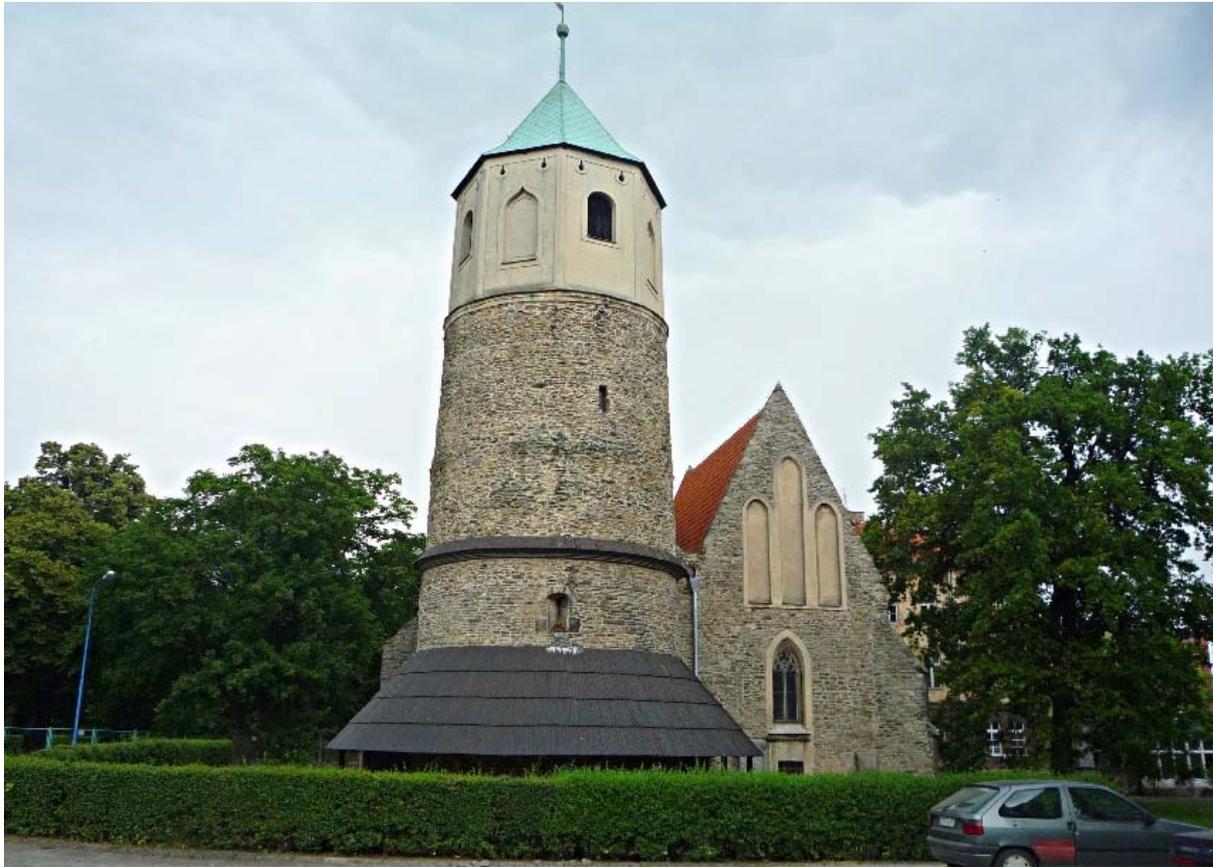
Figure 1. The Rotunda of St. Gotthard. One can see a blind window in the rotunda and three blind windows in the rectangular top part of the church

Although blind windows are typical of Gothic architecture they were already used in Romanesque architecture - the Rotunda of St. Gotthard in Strzelin constitutes a great example of this case. It was probably built in the first half of the 13th century, however, there are sources that claim that its construction finished in 1150. It is a small central-plan church [5]. Figure 1 shows the blind windows of

the rotunda. As they are extremely shallow they serve a purely decorative purpose (they were not supposed to reduce the load of the walls).

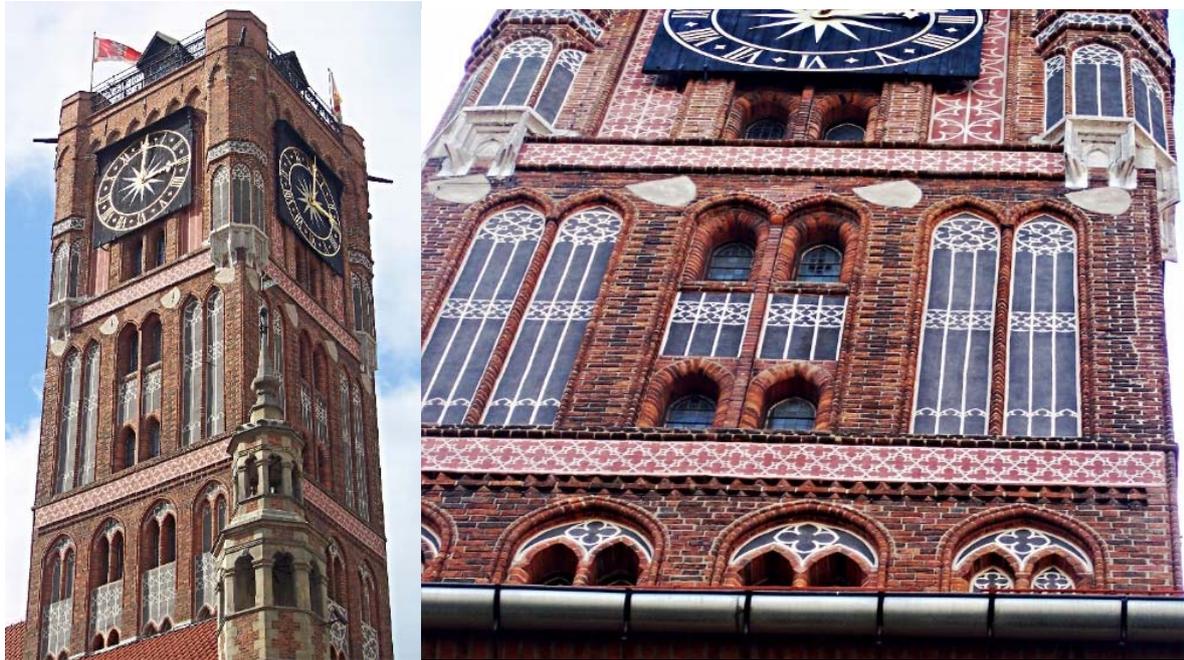
Figures 2, 3. The tower of the Gothic Old City Town-hall in Toruń; Figure 2 – a general view and Figure 3 - numerous blind windows

However, a real development of blind windows took place in Gothic architecture where the blind windows were often used as decorative elements of top parts of the buildings and were plastered white or filled with painted tracery imitating window bars. The Old City Town-hall in Toruń is an exquisite example of blind windows as it is shown in Figures 1 and 2. The town-hall in question is the main secular building of Toruń Old City and its Gothic part was executed in several stages during the 13th and 14th centuries and was remodelled in the 17th and reconstructed after it was severely damaged in the 18th century. It is one of the most extraordinary examples of medieval burgher architecture in Central Europe [3].

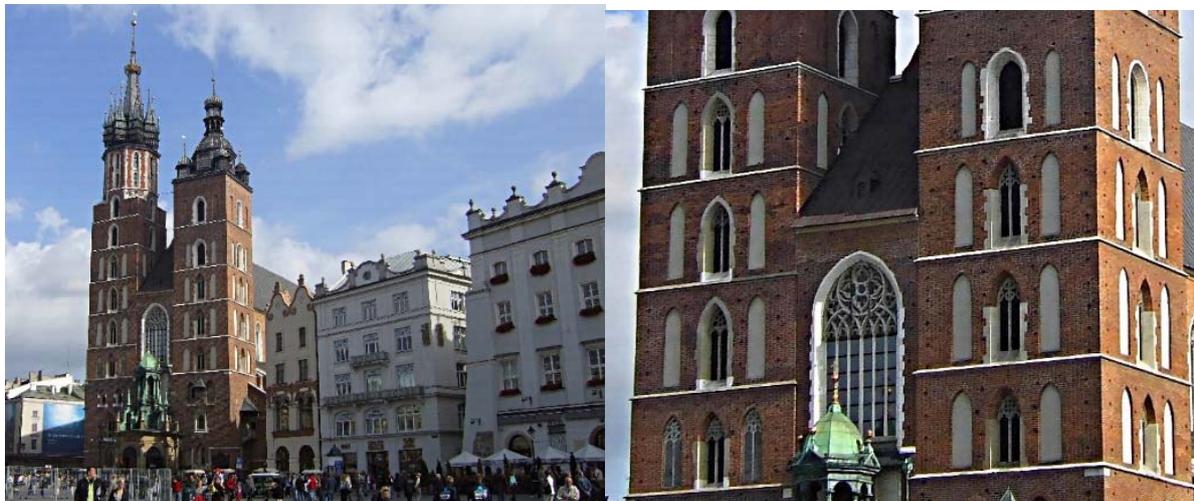
Figures 4, 5. A general view of St. Mary's Church from the side of the market and the white blind windows in its towers

St. Mary's Church is one of the most important, right after the Wawel Cathedral, churches in Cracow. It is a Gothic church from the 14th and the 15th century [2]. Its general view and blind windows are shown in Figures 4 and 5.

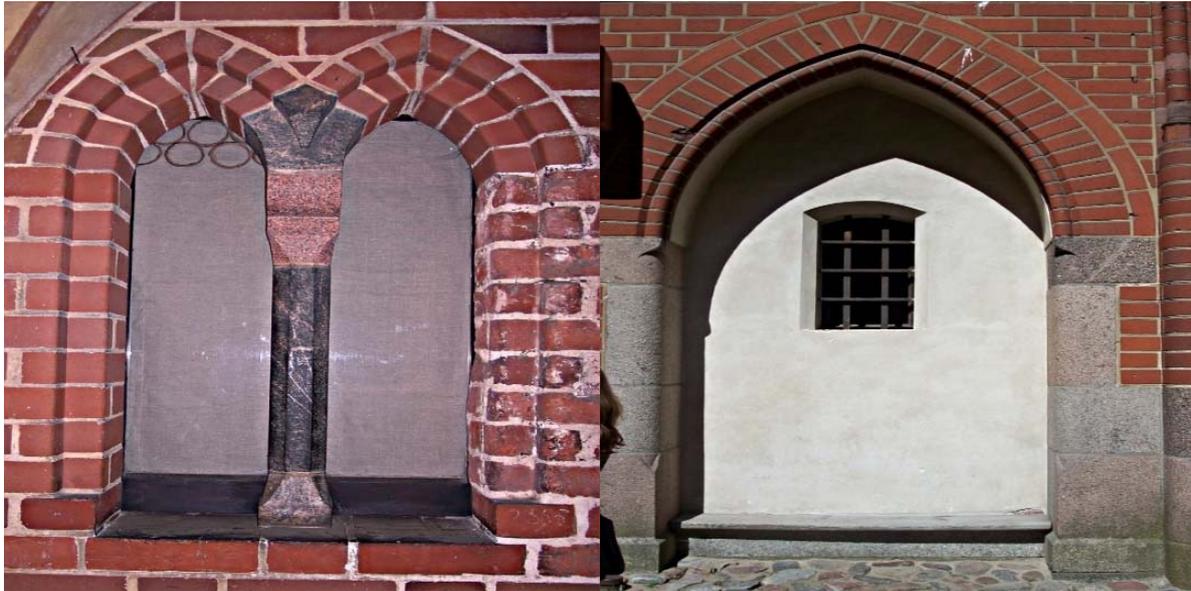
Figures 6, 7. The Malbork Castle. The example of a blind window (left) and a partially blind one (right)

There are also blind windows in the Gothic Malbork Castle which was built in several stages from the third quarter of the 13th century up to the middle of the 15th century by the Order of the Teutonic Knights [9]; some of the windows are shown in Figures 6 and 7.

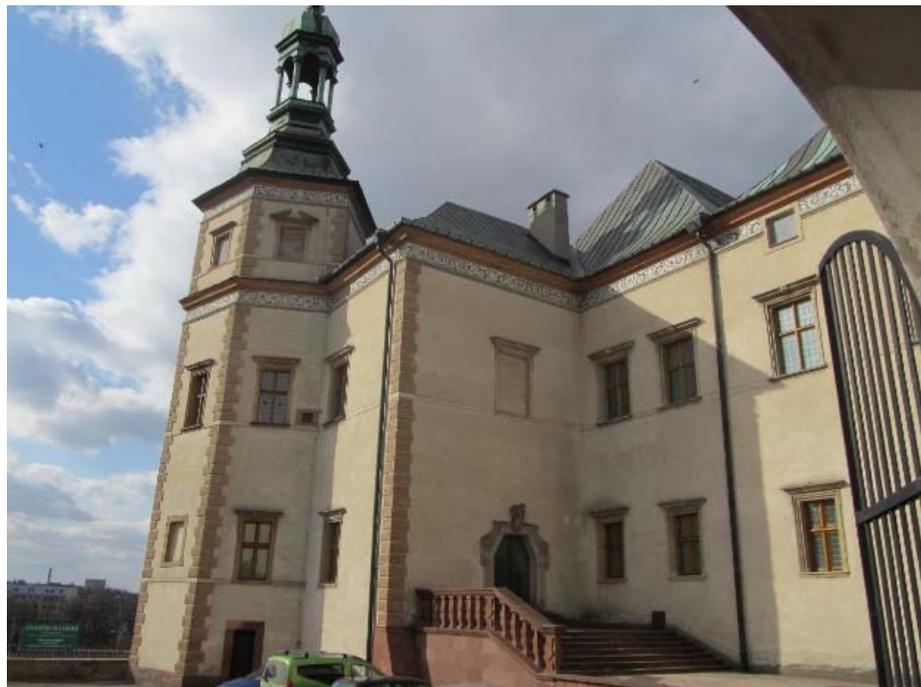
Figure 8. Blind windows in a Baroque, Palace of the Cracow Bishops in Kielce

One can find the examples of blind windows from the later architectural period in the Palace of the Cracow Bishops (Pałac Biskupów Krakowskich) in Kielce. It was the place of residence of the Cracow bishops and nowadays it is the best-preserved example of the Early Baroque residential palace in Poland. It was built from 1637 to 1641 on the Cathedral Hill (Wzgórze Katedralne). Its construction was initiated and founded by Jakub Zadzik, a Cracow bishop. Tomasz Poncino carried out the palace construction and the design was most probably created by Giovanni Trevano [1]. The blind windows of this palace are shown in Figure 8.

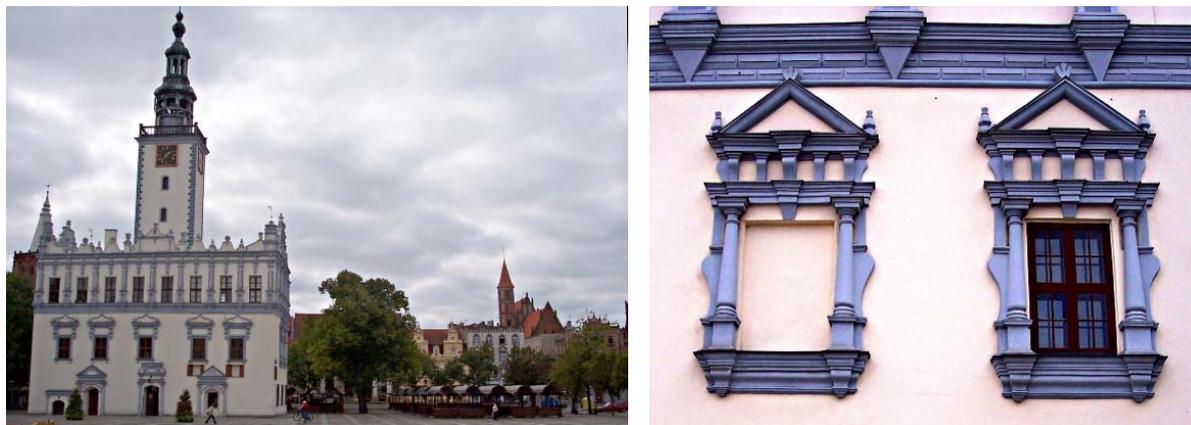
Figures 9, 10. Town-hall in Chełmno. A general view of the front elevation (left), blind window (right)

The town-hall in Chełmno was erected at the end of the 13th century and was expanded in the periods from 1567 to 1572 and from 1884 to 1887. It is one of the most valuable monuments of the Polish Renaissance and today it houses the Museum of Chełmno Land (Muzeum Ziemi Chełmińskiej) [4]. Figure 9 shows the front elevation of the town-hall and Figure 10 shows a decorative blind window on the side elevation.

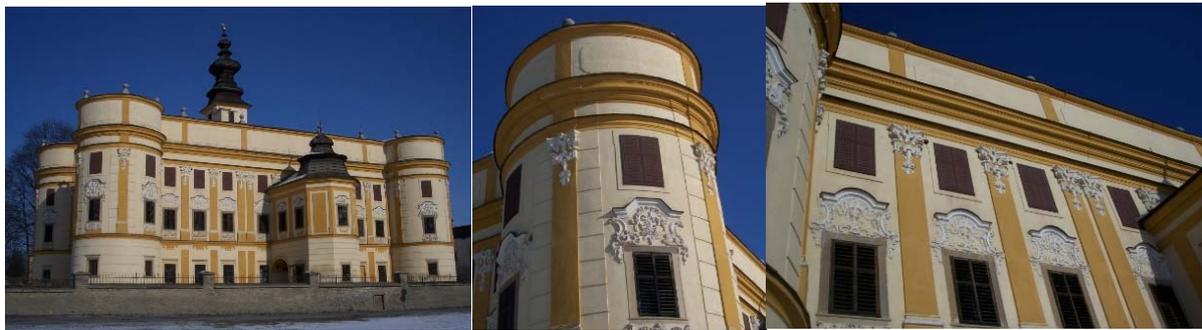
Figure 13 (left). Slovakia, Markuszowce. A Renaissance palace from 1643. All the second-floor windows are the false ones with non-openable shutters. Figures 14, 15. Markuszowce. The first floor windows have openable shutters and the false windows on the second floor have non-openable shutters.

There are very interesting false windows on the second floor of a Renaissance palace in Markuszowce (Slovakia, 1643, there was an extensive remodelling in the rococo style in 1773 [6]). To increase the owner's splendor, this one-storey palace, along with its ground floor, was decorated with an impressive attic on which the windows were painted on, in fact, the non-existent storey. Real, wooden shutters, although non-openable, were added to the false windows (Figures 13-15).

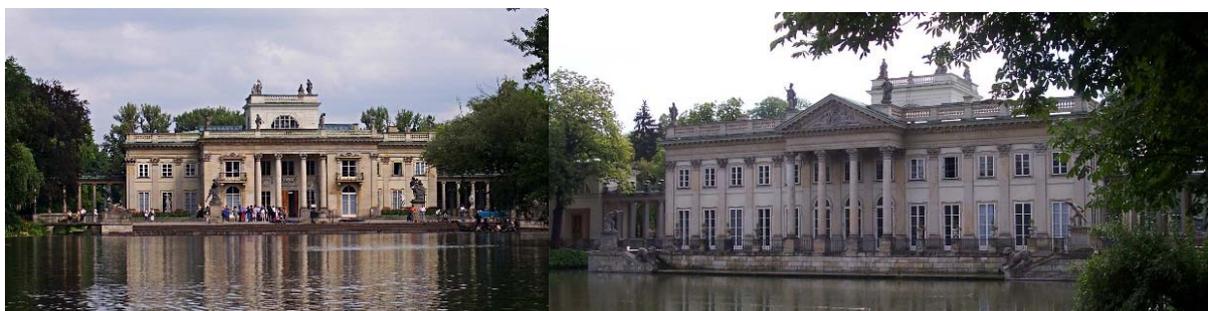
Figure 16. The Palace on the Water, the south elevation; the false windows of the Ballroom – second from the left on the first floor and the second floor: Figure 17 (right). The Palace on the Water in Warsaw, the north elevation. The false rooms of the Ballroom – second from the right on the first floor and the second floor

As it was mentioned at the beginning of this paper, one of the most known false windows in Poland may be found in the Łazienki Palace in Warsaw [8] – Figures 16-20.

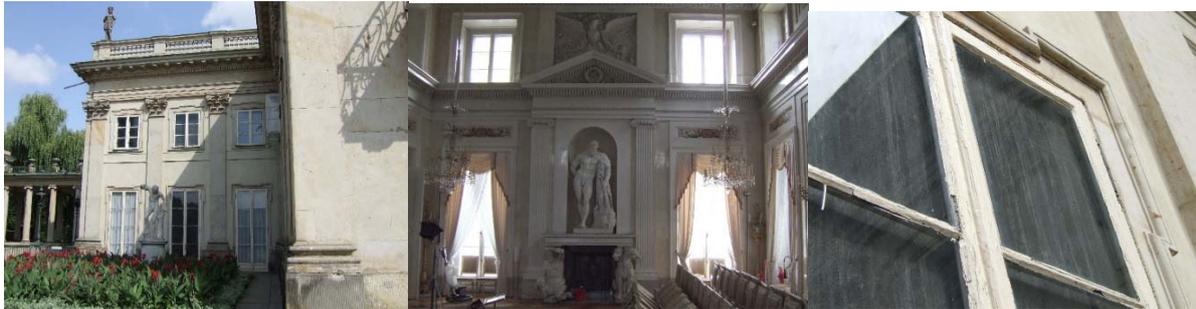
Figures 18, 19, 20. The Palace on the Water in Warsaw, the second window from left is the Ballroom false window on the first and the second floor as seen from outside (Figure 18), the fireplace with a sculpture of Hercules in the place of the false window as seen from inside (Figure 19). The Palace on the Water in Warsaw, the south elevation, a detail of the Ballroom false window on the first floor. One can see a single glazed pane and the wall behind painted black (Figure 20 -right).

In the south and north elevation, the Ballroom has got three windows on both the first floor and the second floor. However, the windows in the middle are not the real ones and have single glazed, opened outwards sashes (Figure 20). Inside the room, there are fireplaces in the place where the middle windows are – one with a sculpture of Hercules in the south wall and the other with a sculpture of Apollo in the north wall. Apart from these windows, there are also other false windows in the palace, however, the ones from the Ballroom are the most famous.

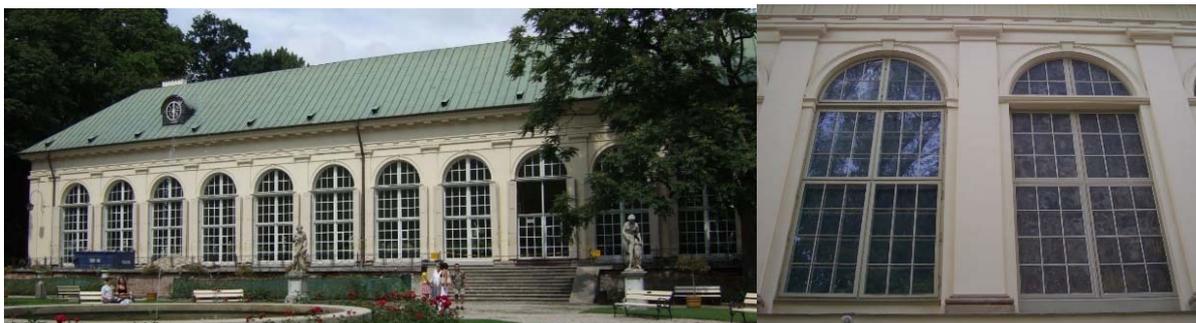
Figure 21. Warsaw, the Royal Baths, the Old Orangery, the south elevation Figure 22. The Old Orangery, on the left – a real window, on the right – a false window painted in the recess on the wall, no glazing. The main muntins of the latter one slightly protrude from the wall to intensify a 3D effect of the window, the muntins of secondary importance are painted on the wall.

Another type of false windows (cheaper because without glazing) can be seen in Warsaw, too. It can be found in the building of the Royal Baths, in the Old Orangery (1786-88, D. Merlini) [8], Figures 21-22. The main building core with the glazed south elevation is an Orangery, namely, the place where orange trees were stored in winter. There is also a court theatre – unique in the world – in the east wing, and the Gallery of Polish Sculpture XVI -1939 in the west wing (previously these were the quarters for gardeners and servants).

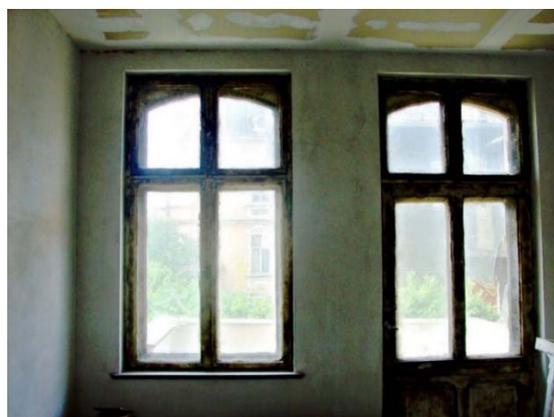
Figure 23. Fake arched windows in a redecorated building in Sopot at Al. Niepodległości; the end of the 19th century.

Later, apart from typical false windows, other architectural tricks associated with windows were used, for example, the arched windows in the elevation that, in fact, were rectangular inside the building – as it is shown in Figure 23. These windows being rectangular were a few times cheaper than the arched ones, but the visual effect was the same as in case of the arched windows.

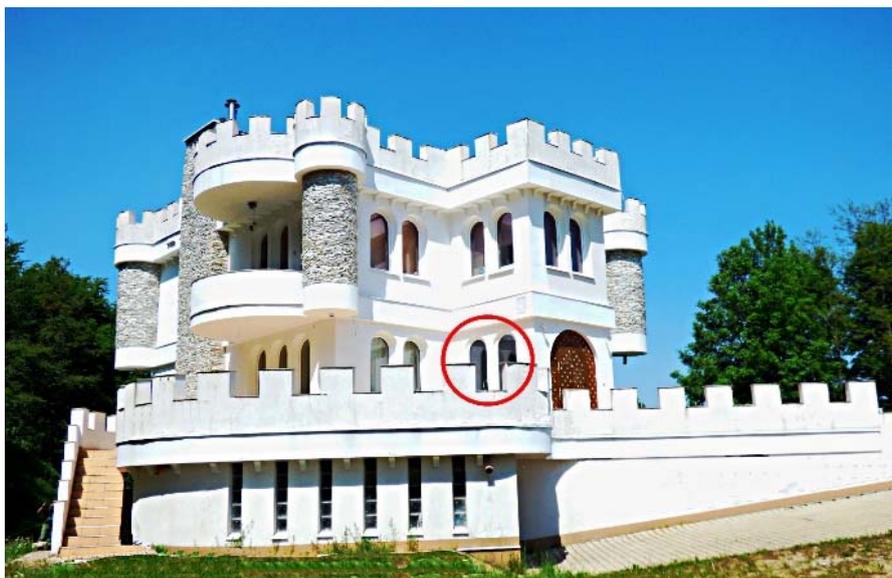
Figure 24. The “Little Castle in Dębogórze” (Zameczek w Dębogórze), a general view. Two false windows visible in the vestibule, on the first floor, left to the entrance door.

The “Little Castle in Dębogórze” (Zameczek w Dębogórze) may serve as an example of the contemporary use of “classical” false windows (the wall recess painted black along with a window frame and glazing). It is a single-family residential house – the architect’s own house - in Dębogórze, near Gdynia at 24E, Jagodowa street built in the period from 1998 to 2014. There are two false windows in the vestibule on the first floor. The windows were unnecessary inside as they would have been located right behind the wardrobe, but outside they are extremely important due to their compositional effect – see Figure 24. Therefore, the recesses were made in the wall from outside and once the building had been insulated with polystyrene foam they were painted black and the glazed frames were mounted. The window producer’s lack of experience resulted in window seal loosening in the upper part of one of the windows – inside the recesses there is a high temperature resulting from the black colour and the sun exposure – Figure 25. Thus, the ventilation openings were made in the wall into the vestibule interior, both in the upper and the lower part of the recesses. This should serve as a warning to window producers that in case of false windows it is necessary to consider significant heating up of window recesses. The window should be single glazed with anti-reflective panes and cannot be fitted in airtight sealing. The window recess should have at least the pressure gravity ventilation.

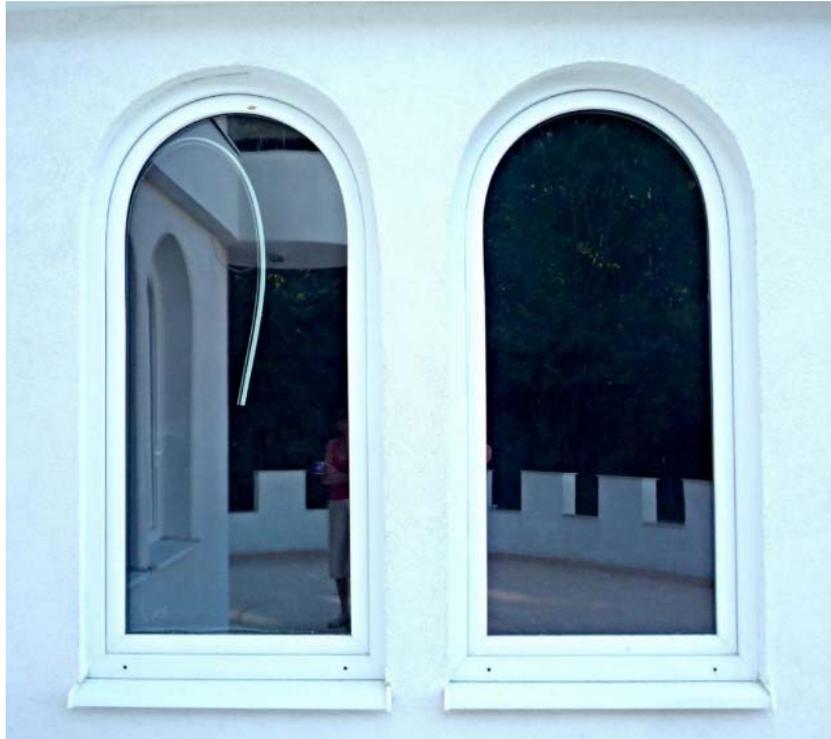
Figure 25. The “Little Castle in Dębogórze” (Zameczek w Dębogórze), two false windows. The loosened window seal resulting from high temperature in the left window.

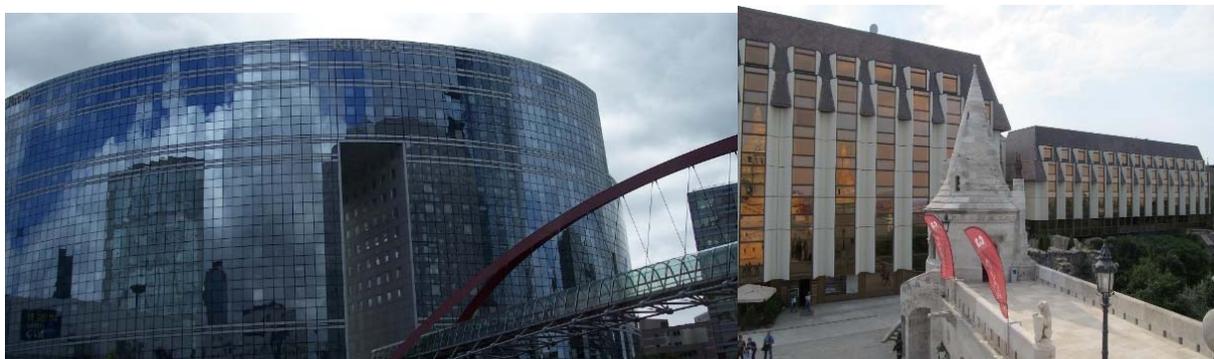
Figure 26 (left). La Defense district in Paris. The example of the extensive use of false windows in modern architecture. Figure 27 (right). Hilton Hotel in Budapest (Hungary). False windows placed interchangeably with real windows in the vertical strips of the curtain wall – the „copper” colour of the windows is worth noticing

The natural successors of the classical false windows are contemporary curtain walls, that are translucent at a height from 1.1 to 2.5 m on each storey; the strips between the windows are made of bricks, reinforced concrete or a lightweight material - they are insulated from outside and covered with non-translucent or reflective glass – Figures 26-27.
