Architectural Modelling of Alternatives for Verification of New Interventions on the Example of the Romanesque Palace at Spiš Castle in Slovakia

Abstract. The article presents the results of the first phase of the research project SK-VEGA 1/0951/16 on using transparent and translucent structures in historical buildings. The team of researchers from the Faculty of Architecture SUT Bratislava introduces possibilities of using lightweight roofs on the model example of a dominant medieval ruin (Romanesque Palace, Spiš Castle, UNESCO site). Architectural 3D-modelling of alternatives gains new methodical importance in conditions, when in real practice only safeguarding conservation approaches are preferred. Research based on design serves as a tool for decision-making on further restoration approaches to a specific cultural heritage object. The selected Romanesque Palace of the Spiš Castle has passed through many structural periods. The interior doesn't exist and the perimeter walls create a raised landscape landmark. Romanesque, gothic and renaissance periods were identifiable. It would be possible to reconstruct these periods partially hypothetically on the basis of saved archive mate

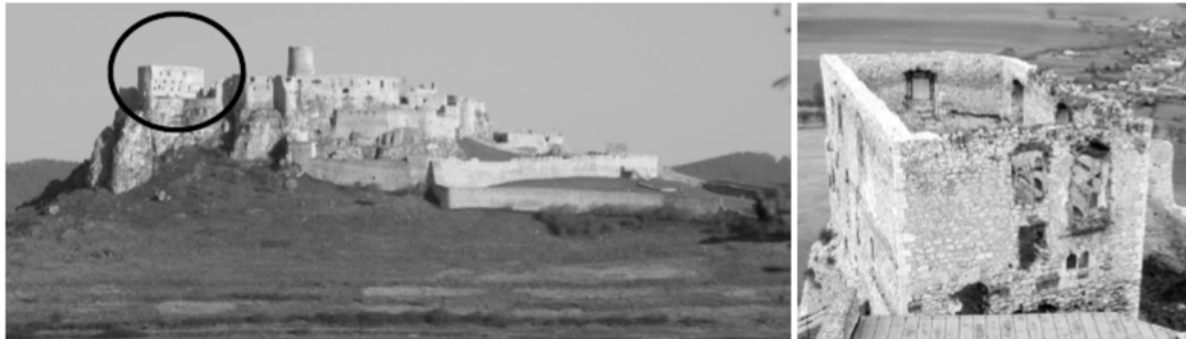
Figure 1. Romanesque Palace at Castle Spiš, UNESCO World Heritage Site since 1993.

Nowadays, the palace is a ruin, which enables the identification of particular building phases. Considering a high conservation ratio of structures from the oldest evolutionary phase, the palace is signed as Romanesque palace. Position of gothic palace topping is possible to designate on perimeter walls in contemporary state of ruin. Position of Romanesque and renaissance palace topping is possible to suppose. In the first underground storey there is conserved gothic space with arches and column's bases in the first aboveground storey. These structural elements are the guideline for further hypothesis about the types of support structures in the interior of the palace in the next building phases. All horizontal structures (roof, ceilings) are extinct. It is possible to identify the level of gothic ceilings ambiguously. The footmarks of ceilings on the perimeter walls from particular building phases are partly conserved. Vertical structures in the interior are not conserved. It is supposed, that vertical structural system is in relationship with arching structural system on the underground floor. Interior horizontal structures are supposed to be wooden beam ceilings. In the Gothic phase, it is possible that interior structural system on the first aboveground level was arching. This assumption is based on existence of conserved column polygonal stone bases on the first aboveground level. The openings in preserved walls are naked and present a separate problem. In the individual building

phases openings of previous periods had often been filled in by brick masonry according to new demands. This is the reason for the structural instability of the whole palace.

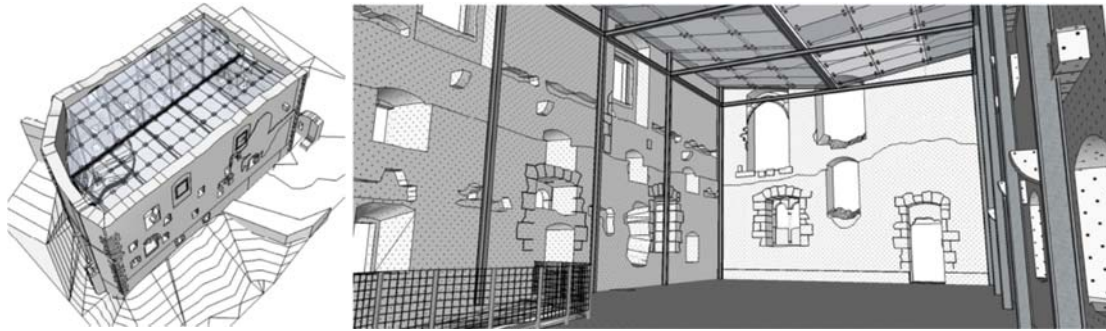
Figure 3a. Steel support structure with frames in cross-sectional direction with point fixed glazed tables allows to create open space.

Figures 3a – 3d. Designs inspired by the Romanesque roof maintaining the present day silhouette of the walls. New structures /a,b,c/ are not anchored in the perimeter walls, d/ the roof is supported by the original stone cantilevers.

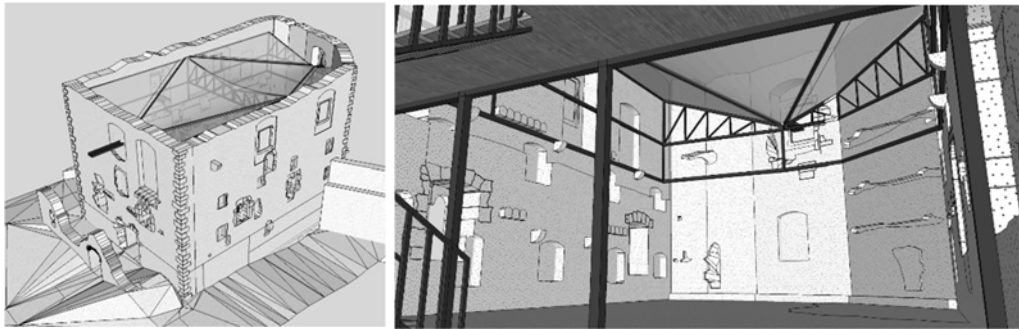
Figure 3d. Steel roof structure is laid on existing stone embedding in perimeter walls, the interior is free, roof covering is presumed as translucent textile membrane.

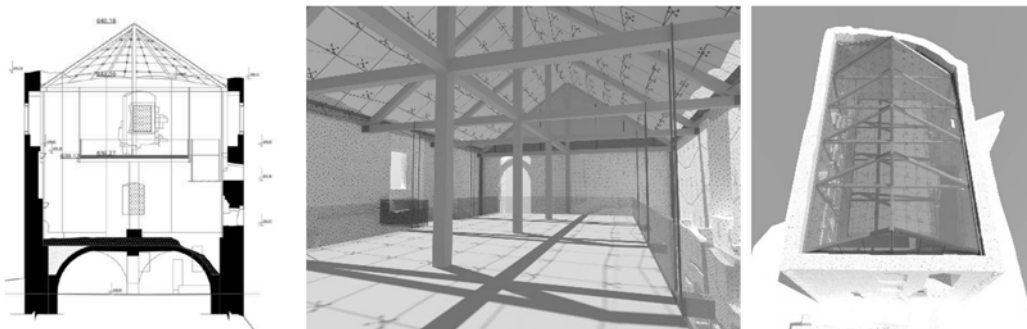
Figure 4. The design is inspired by the Gothic phase roof shape. In the origin site of gothic ceiling is inserted new timber ceiling and gable roof supported by timber columns. The covering of the roof is presumed by stressed cable trusses with struts as secondary structure.

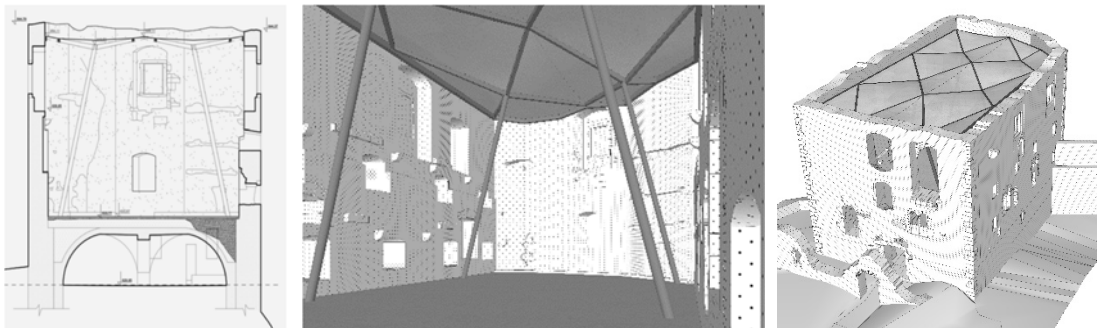
Figure 6a. Steel structure with inclined columns combined with a translucent textile membrane.

Figures 6a – 6b. Designs of new roof shapes suitable for the present state, which is understood as an evolution phase.

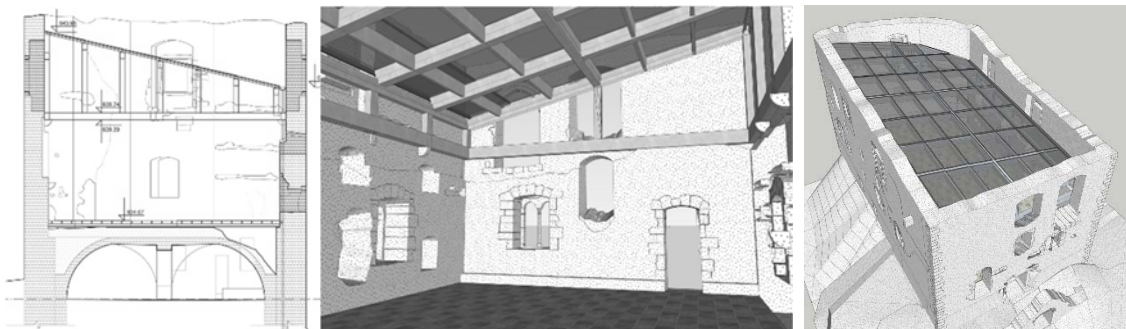
Figure 6b. Glazed roof structure is supported by original stone cantilevers, the interior is free.
