A lost Fragment and Gate of the Almohad Wall of the World Heritage City of Cáceres, Spain

Abstract. The objective of this research is the documentation of a lost fragment of the Cáceres' Almohad Wall hidden in within some houses that used it in their construction.

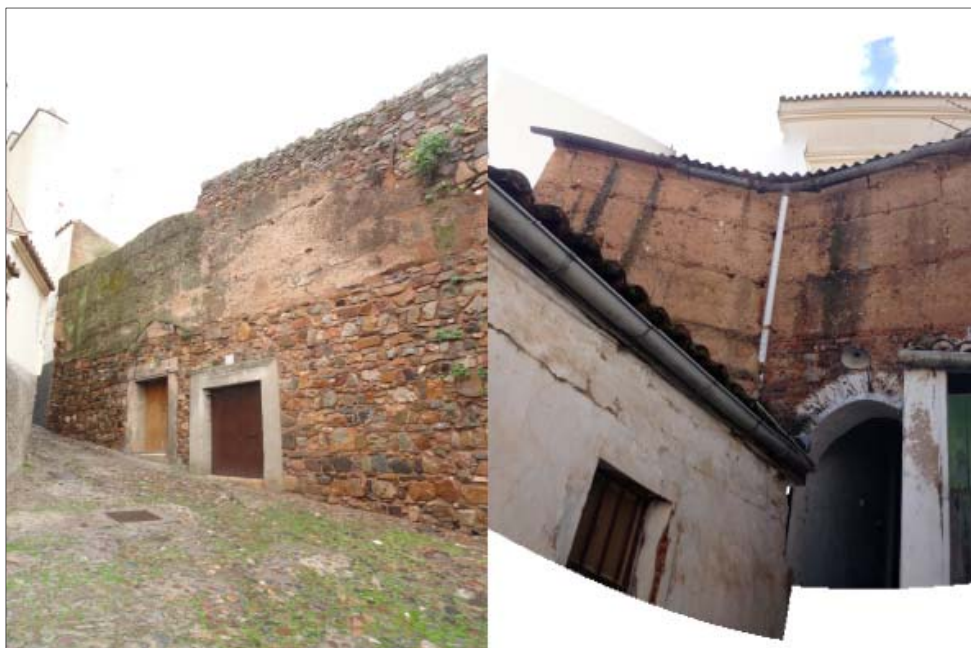
Figure 1. right - photograph original Almohad Wall adjacent to the fragment under study, left photograph wall and gate under study.

Studying the urban development of the city a façade in a building in the Street Adarve del Cristo (figure 1) was located [4]. This building presented several singularities that made us suspect that it could be part of the ancient wall. These singularities were:

- The fabric of the façade was similar to the existing Almohad rammed earth walls of the city.
- The façade still showed the regular horizontal lines and the putlog holes of the wooden formworks used in its construction and their dimensions were similar to the ones employed in the original Almohad Wall adjacent to the house.
- The façade was displaced seven meters from the intrados of the Almohad Wall breaking its continuity. This displacement was hidden by the house that had used this space to build its walls.

- The urban solution, courtyard house or “corrala” [6], was very unusual in the city of Cáceres (figures 1 and 2).
- The passageway contained a traditional brick arch in the extrados of the wall and in its intrados the entrance's lintel was made of granite ashlar with holes for staples; this could indicate an Arab and Roman origin of these elements.

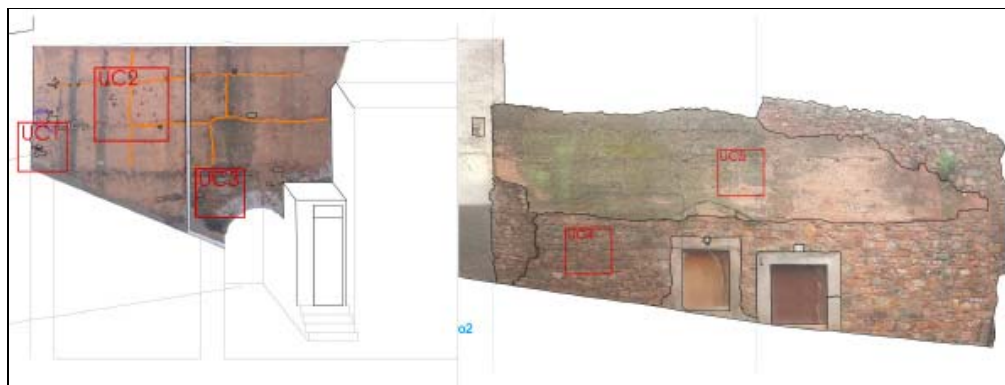
Figure 2. Dimensions of the wooden formworks of the original Almohad Wall and in the fragment under study.

- The supposed wall's fragment was made with a rammed earth fabric which apparently had not suffered significant modifications. This rammed earth fabric conserved the original wooden formworks lines and the original putlog holes that served to insert the timbers to support the formworks to raise it; additionally, the dimensions of the wooden formworks used in its construction were similar and coincided a priori with the dimensions of the ones were used to build the known Almohad Wall (figure 2).

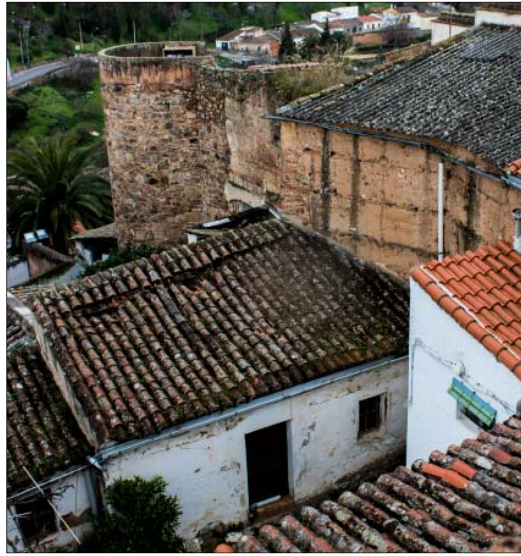
Figure 3. View of the area under study from the Air Tower.

- The formwork lines of the fragment coincided geometrically with the ones of the adjacent original Almohad Wall showing a formal continuity between the two walls formworks as it could be seen from the Air Tower (figures 3 and 4).

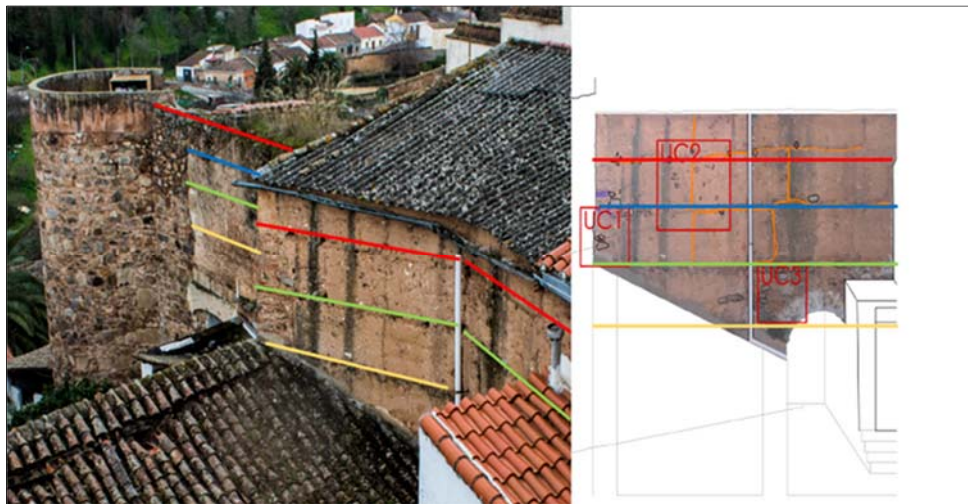
Figure 4. Continuity of the formworks between the original Almohad Wall and the fragment under study.

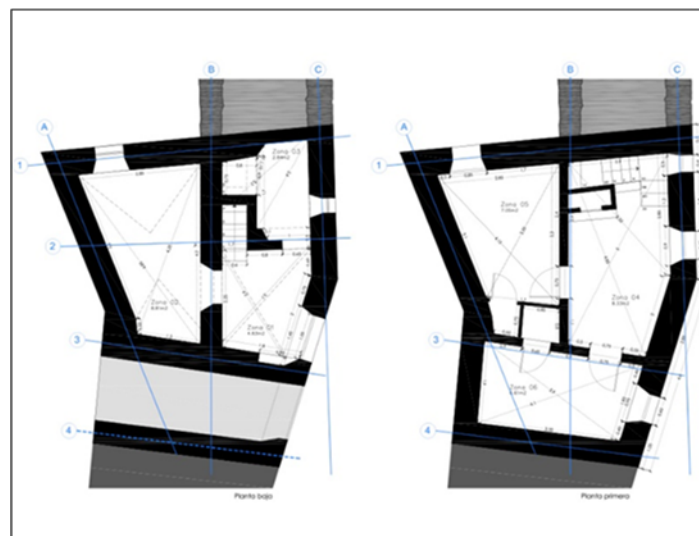
Figure 6. Planimetry of the housing

- First, that the interior load wall of the house was a continuation of the resistant extrados sheet of the "original adjacent Almohad Wall, as shown in figure 6, and with the fragment under study could have been part of the Wall. With the passage of the time the filling of the wall would have disappeared; hypothetically it could have been emptied to form a habitable space that today it was the living room of the house.

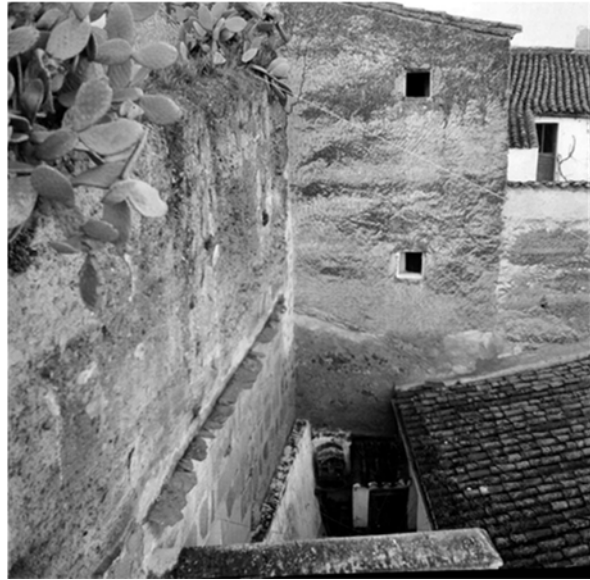
Figure 7. Old photo of the house towards the Northeast without attached constructions

- Second, the intrados resistant sheet of the original Almohad Wall also continued in the load wall corresponding to the façade of the house to the Street Adarve del Cristo. This fact did not make sense constructively unless the whole house was a cube of the original wall as pictured in the 1,845 map of the wall (Figure 5); however to confirm this hypothesis further archaeological studies were needed.
- Third, after the analysis of the photographic documentation of an ancient historian of the city, Carlos Callejo, it was found that the house towards the Northeast was originally an exempt piece, approximately four stories high. This fact indicated the existence of a promontory that

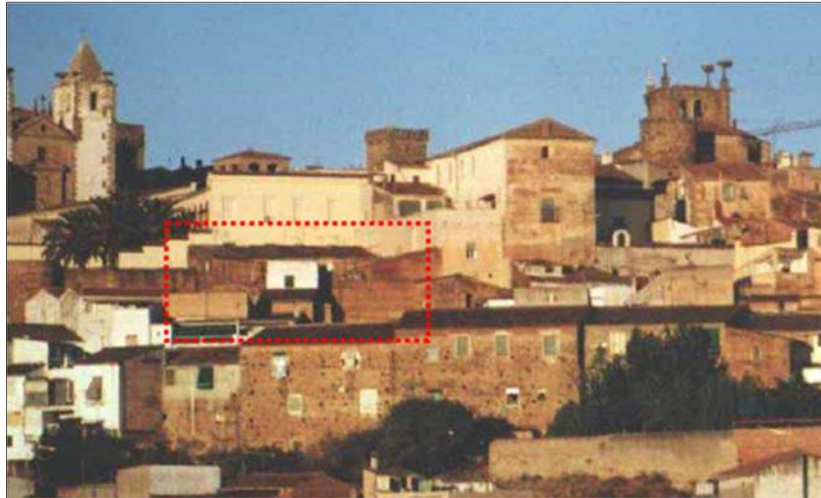
Figure 8. Old photo of the study area

- The first result was that the fragment was not an isolated element; it had a neighbouring continuity houses of the Street Adarve del Cristo that hypothetically would have used the ancient Almohad Wall to construct their façades. A result the fragment had a bigger dimension than initially thought (Figures 8 and 9).

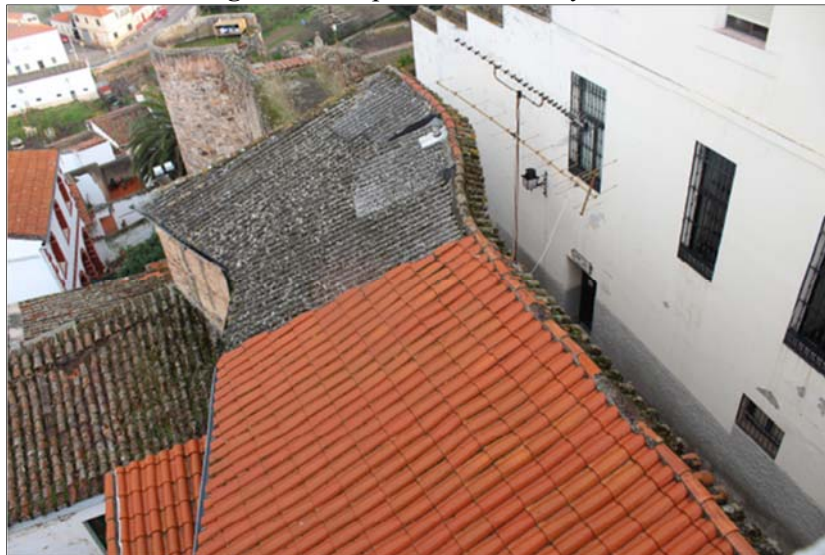
Figure 9. Continuity of the fragment.

- The second result was that the fragment of the wall under study connected with other elements of the Almohad Wall currently known thanks to archaeological interventions in the direction towards the Tower del Aire. The planimetry of the Almohad Wall indicated the existence of a wall's fragment inside the Tower del Aire. This fragment was not alignment with the Street Adarve del Cristo; however it was aligned with the fragment under study thanks to its displacement of 7 metres. This fact verified the veracity of the fragment and the displacement of the wall (Figure 9).

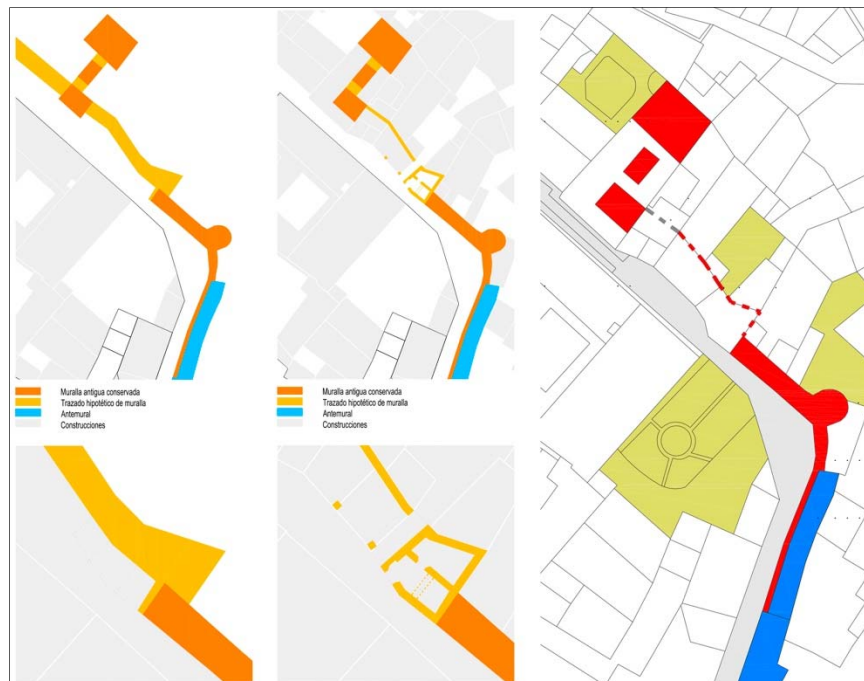
Figure 10. Surrounding analysis

would have justified the displacement of the layout of the wall to adapt it to the terrain's orography (figure 10).

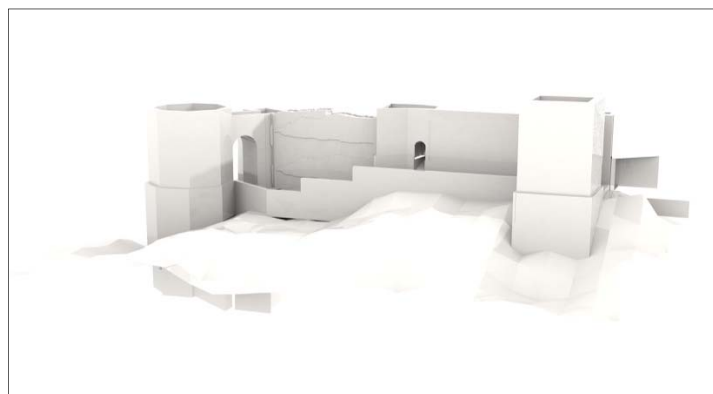
Figure 11. Idealized reconstruction of the study area

- Third, conclusion was that the assumption that the wall in this area ran straight along the Street Adarve del Cristo, forming the façades of the houses nº 5 and 7 was erroneous. The wall was actually displaced 7 metres towards the extrados; fact that was not reflected in most of the historical plans of the city (figure 11).
